Flood situation report

Area: No-flood check: Trishuli corridor, 25 Jul 2026 | Event date: 25 July 2026 | Latest radar image: 4 August 2026

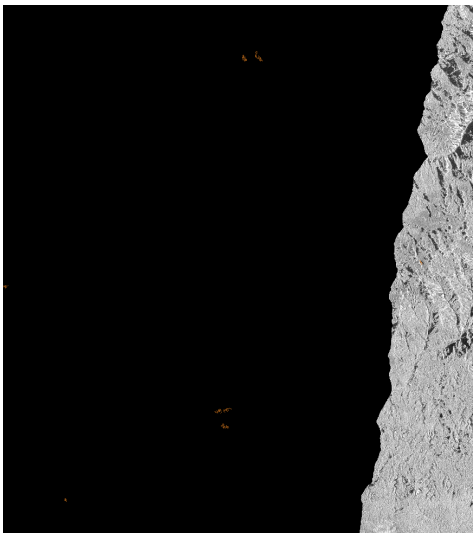
The radar shows 112 ha (1.12 km²) flooded or buried by debris. F010 F011

Of this, 5.2 ha is open water and 107 ha is debris or scour. F012 F014

Radar change map, before and after the event.
