Flood situation report

Area: Bhote Koshi–Trishuli flood, Nepal | Event date: 26 August 2026 | Latest radar image: 5 September 2026

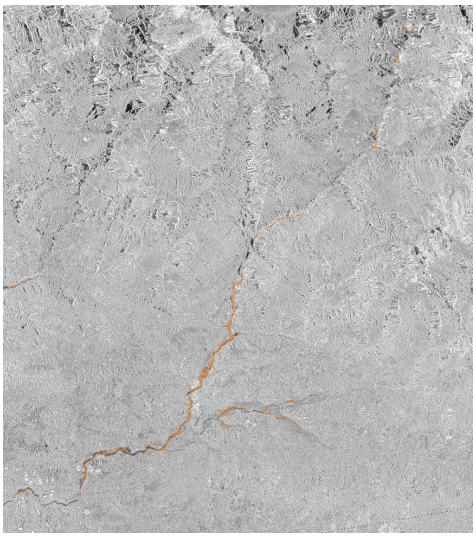
Radar change map, before and after the event.

The radar shows 1,640 ha (16.4 km^2) flooded or buried by debris. F010 F011

Of this, 230 ha is open water and 1,410 ha is debris or scour. F012 F014

The radar could not see 10,888 ha because of terrain shadow, so conditions there are unknown. F016

The places with the most likely destroyed buildings: Nuwakot, Betrawti, Bhainse, Dewighat, Nauwise Phant. F061
