Flood situation report

Area: No-flood check: Trishuli corridor, 25 Jul 2026 | Event date: 25 July 2026 | Latest radar image: 4 August 2026

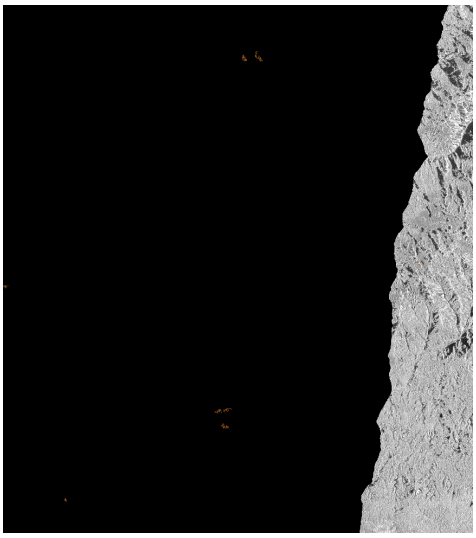
Satellite images show 112 ha (1.12 km²) flooded or buried by debris. F010 F011

Of this, 5.2 ha is open water and 107 ha is debris or scour. F012 F014

The radar could not see 10,889 ha because of terrain shadow, so conditions there are unknown. F016

Radar change map, before and after the event.
