Lifeline

Who can still reach help after a Himalayan flood. Technical report, Track B: Mapping Flood Damage from Space. Dhiraj Kavuri, October 2026.

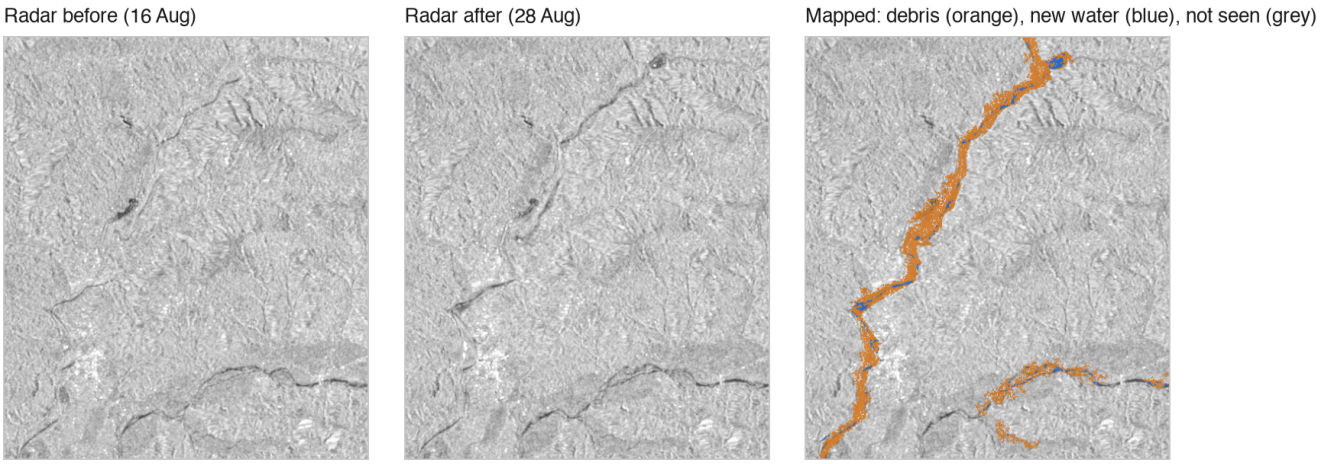
Figure 1. The Trishuli near Bidur and Betrawati, about 10 × 11 km. Sentinel-1 VV before and after, and the mapped classes. Two days after the flood most open water had drained; the event shows mainly as debris and scour.

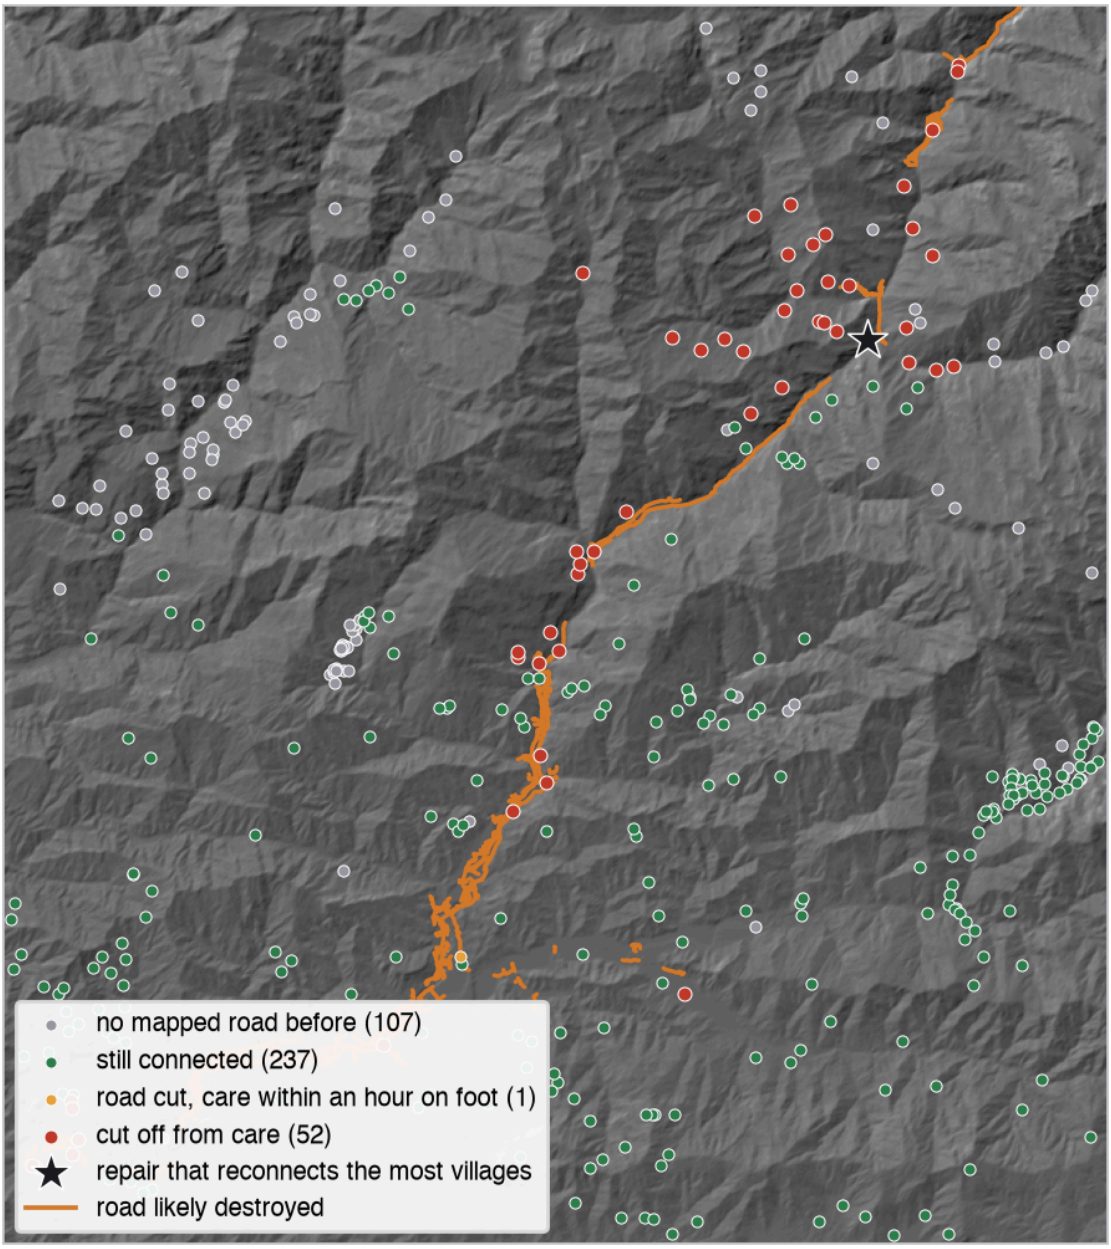
Figure 2. Settlements by access status. Red: cut off from any hospital or clinic in most draws. The star marks the top repair: a bridge and two adjoining closed stretches of the Pasang Lhamu Highway near Syapru Besi, which together reconnect 18 settlements. Orange lines: road likely destroyed.

Result. 290 of 397 settlements could reach care by road before the flood. 52 are now cut off (48 with $p \geq 0.9$, 4 between 0.5 and 0.9), 1 more has lost its road but can walk to care within an hour, and 107 had no mapped road to care even before. 12 bridges are single points of failure.

A greedy search then ranks repairs: at each step it compares reopening any one closed OSM way with reopening all the closed stretches on one cut-off village's old route, and keeps whichever reconnects the most villages. Bridges that are the only road link for a group of villages are listed as single points of failure.

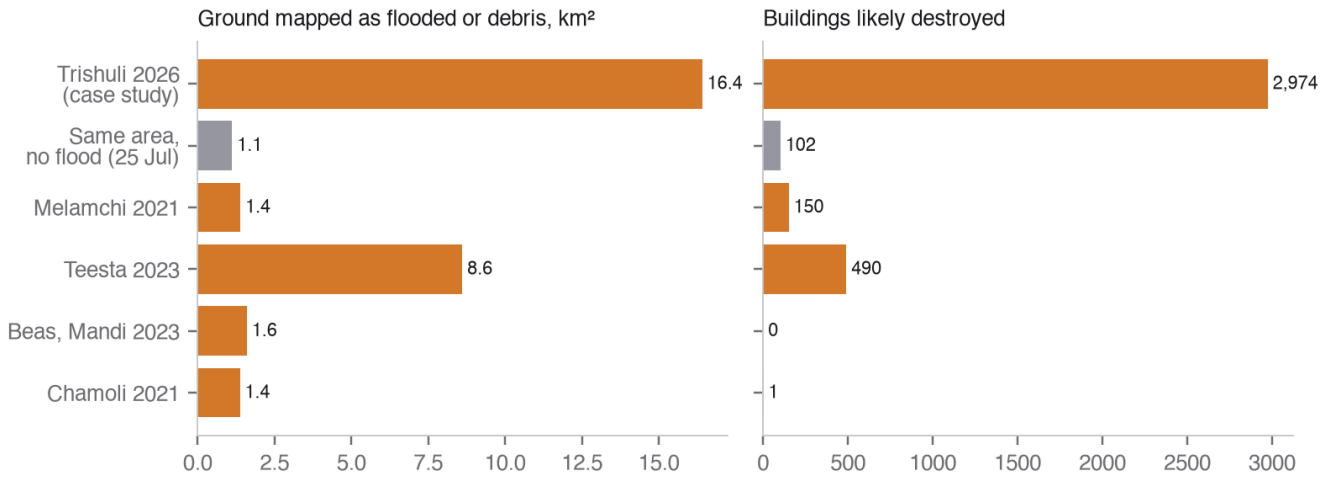
Figure 3. The same code and settings on the case study, on the same area on a date with no flood (radar only), and on four earlier floods it was never tuned on: Melamchi (Nepal, 2021), the Teesta glacial-lake outburst (Sikkim, 2023), the Beas at Mandi (Himachal, 2023) and Chamoli (Uttarakhand, 2021).

On the no-flood date (25 July 2026, mid-monsoon) Lifeline flags 1.1 km² across 3,037 km², 7% of the event figure. That run is radar-only, because any Sentinel-2 image in the 40 days after it would also show the 26 August flood; and it was one of the constraints when the radar settings were chosen, so it bounds false alarms rather than testing them

independently. Melamchi and Teesta run end to end from raw data with no change: Melamchi in 105 s (no clear Sentinel-2 in the window), Teesta in 538 s, of which 353 s was Sentinel-2. Both put damage along the rivers that were hit (Teesta: 8.6 km² and 490 buildings). The Beas run flags Mandi's New Victoria Bridge and a bridge on the Pandoh road as likely destroyed; OpenStreetMap held only 131 buildings there in 2023, so building damage cannot be counted. Chamoli in February is mostly steep snow-covered ground, and 80 km² is marked not observed. There is no official grading to score these against, so they show generality, not accuracy.
