Site #4344: AVONDALE #1B, Jefferson, Louisiana

23.6 MW

Entergy Louisiana

SITE CHANGE DETECTION & BASELINE MONITORING

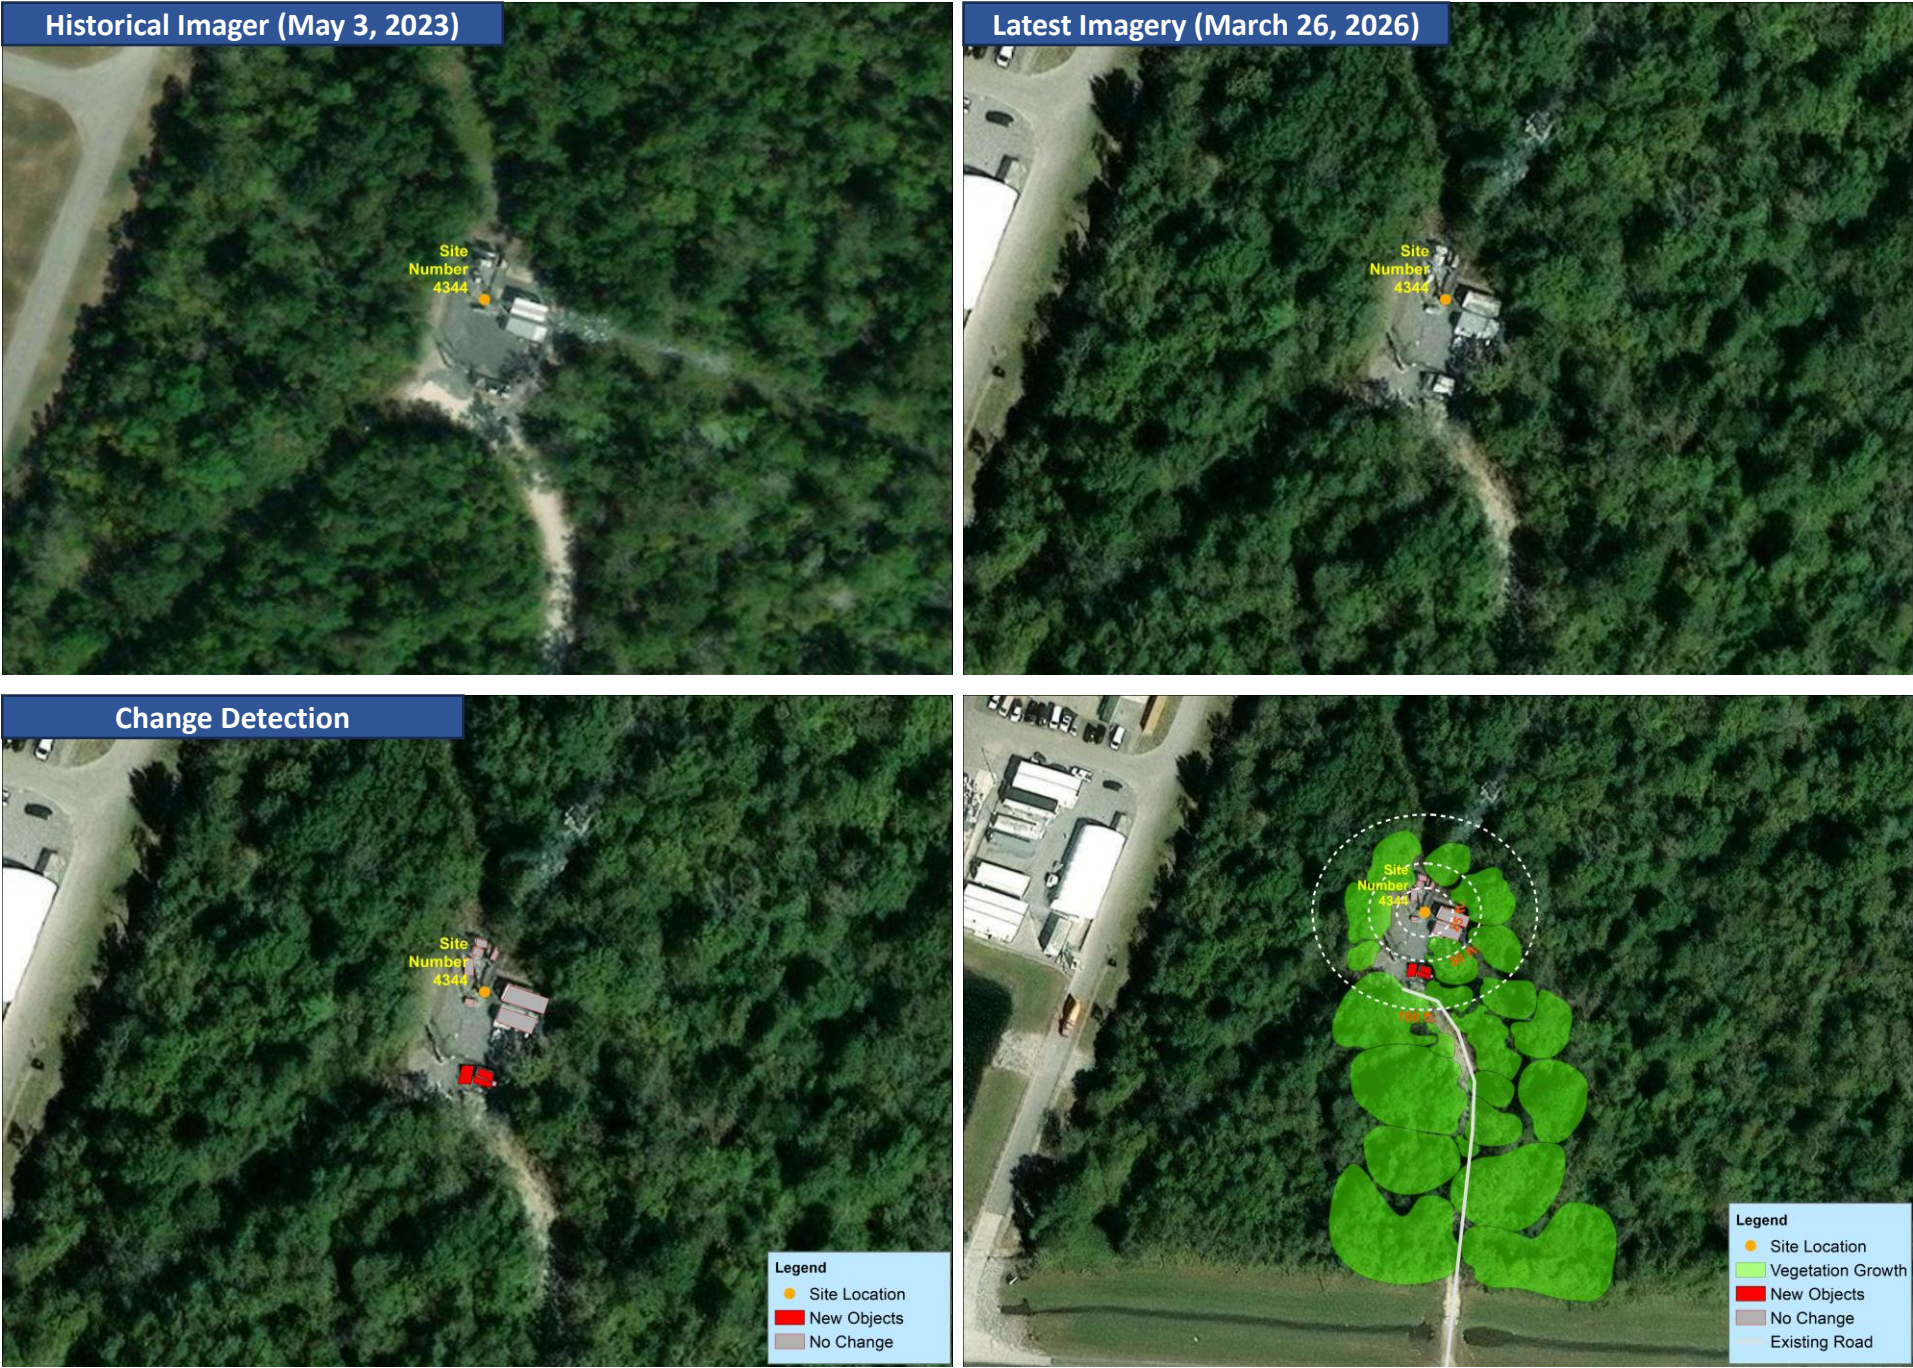
ACCESS ROUTE & SITE CONDITION ASSESSMENT		
Assessment Item	Status	Risk Level
Access Road Condition	Fair	●
Road Obstructions	Moderate	●
Post-Storm Accessibility	Partially Accessible	●
Gate Access Visibility	Clear	●
Parking / Staging Area	Available	●
Overall Access Status: LIMITED ACCESS

VEGETATION & ENCHROACHMENT MONITORING		
Monitoring Category	Observation	Risk Level
Vegetation Growth (25 ft)	Clear (0%)	●
Vegetation Growth (50 ft)	High (40.4%)	●
Vegetation Growth (100 ft)	High (46.3%)	●
Fence Line Encroachment	None	●
Access Road Overgrowth	Critical	●
Tree Canopy Expansion	High	●
Fire Fuel Accumulation	High	●
Vegetation Risk Level: High

- SITE CHANGE HIGHLIGHTS
- No significant changes to the primary site infrastructure were observed between the baseline and current imagery.
 - No visible missing or damaged antenna-related assets were identified from the available imagery.
 - Additional unidentified objects were observed within the site compound compared to the baseline imagery.
 - Vegetation encroachment is present within the 50-ft assessment area and may require routine maintenance.

Overall Monitoring Result: Limited Access with High Vegetation Risk

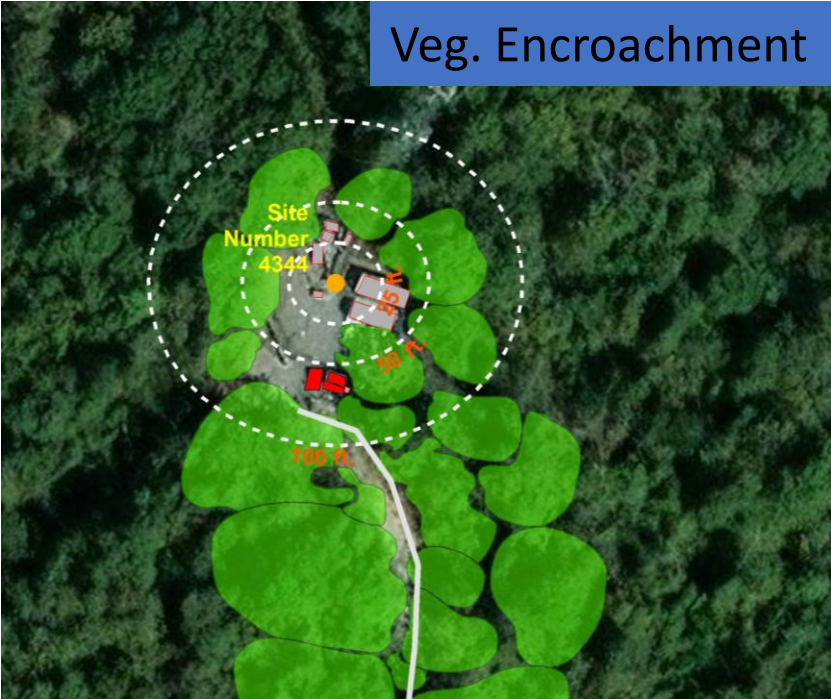
Veg. Encroachment

Gate Accessibility
