CCTV SECURITY AUDIT — EVIDENCE & VISUAL PROOF DOSSIER

Non-Technical Proof, Verification Data & CCTV Screenshots Supporting All Audit Findings

Client: DBGT	**Site:** RO Plant Rooftop Mechanical Deck
Camera: IPC56 (3K 3072x1728)	**Reviewed By:** ThoorigAI Infotech
Reference: DBGT-THOOR-2026-AUDIT-PROOF-001	**Date:** November 2026 (Executive Edition)

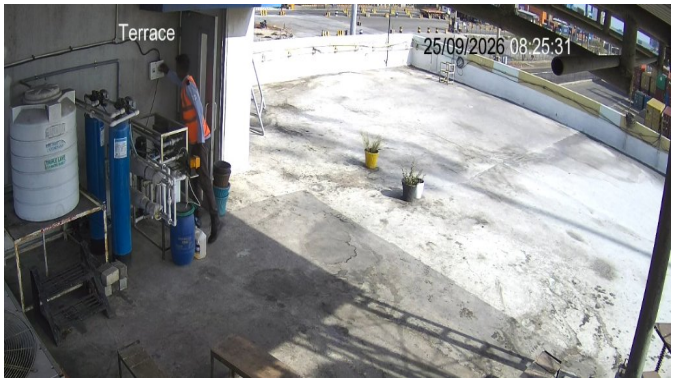
Proof 2: Day 25 — 07:30:18 AM
Plant Operator (REAL-44) — Power Switch Toggle
