MANUFACTURING QUALITY ASSURANCE REPORT

INSPECTION DATE	2026-02-27 10:19:37
VIDEO SOURCE	stream_258a9ddc_2026-02-27T10-17-50.301034Z_st_1.267_end_22.667_clip_1.mp4, stream_258a9ddc_2026-02-27T10-17-50.301034Z_st_33.367_end_58.400_clip_2.mp4, stream_258a9ddc_2026-02-27T10-17-50.301034Z_st_89.167_end_102.433_clip_3.mp4
OVERALL VERDICT	FAIL

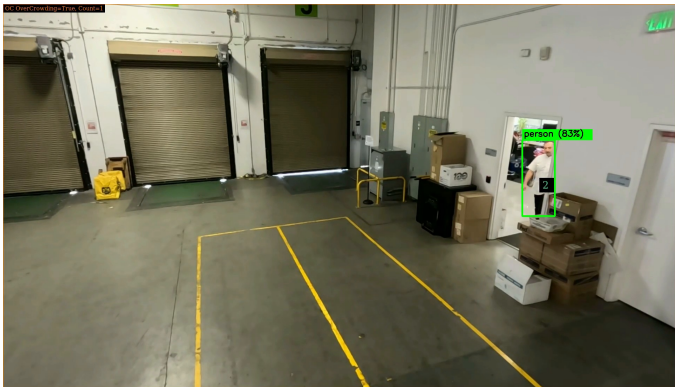
Finding 3: Inspection Finding

TIMESTAMP 10:19:30
SOP SECTION PPE & Safety Protocols
COMPLIANCE SCORE 0%

No high-visibility safety vests are observed being worn by any individuals in the scene.

No safety helmets are visibly worn by any individuals in the scene.

There is no visible forklift or other mobile equipment in motion within the scene; therefore, proximity to a moving forklift cannot be assessed.

- **High-Visibility Safety Vests:** No one in the scene is wearing high-visibility safety vests; both individuals are dressed casually.
- **Safety Helmets:** Neither individual is wearing any head protection such as hard hats.

[8.0s - 13.0s]: No PPE detected on the individual; no interaction with machinery or forklifts observed.
