MANUFACTURING QUALITY ASSURANCE REPORT

INSPECTION DATE	2026-02-27 10:39:21
VIDEO SOURCE	stream_8850268e_2026-02-27T10-37-38.747258Z_st_1.267_end_22.667_clip_1.mp4, stream_8850268e_2026-02-27T10-37-38.747258Z_st_33.367_end_58.400_clip_2.mp4, stream_8850268e_2026-02-27T10-37-38.747258Z_st_89.167_end_102.433_clip_3.mp4
OVERALL VERDICT	REVIEW

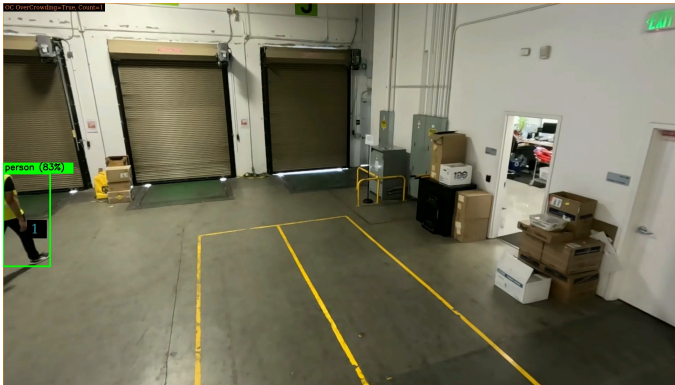
Finding 2: Inspection Finding

TIMESTAMP 10:39:05
SOP SECTION PPE & Safety Protocols
COMPLIANCE SCORE 95%

[8.0s - 13.0s]: Yes; both workers wear yellow safety vests and hard hats, meeting PPE requirements. No forklifts are present in the frames, so proximity assessment is not applicable. No violations or issues are evident.

[12.0s - 17.0s]: The worker is wearing a yellow safety vest and a white hard hat, and they remain closely positioned to the forklift while operating it.

[16.0s - 21.0s]: The worker operating the forklift is wearing a yellow safety vest and a white hard hat, complying with PPE requirements. The forklift operator maintains safe positioning while seated inside the vehicle, with no visible hazards nearby.

1. **High-Visibility Safety Vests:** Present. The individual is wearing a bright yellow safety vest, meeting standard requirements for visibility in industrial environments.
2. **Safety Helmets:** Not visible. Only the lower portion of the individual's body is shown, making it impossible to confirm helmet use.

- The forklift is stationary in the background, positioned away from the worker. No immediate risk

Yes, one person is wearing a high-visibility safety vest (yellow) and a safety helmet (white), both of which comply with standard PPE requirements. No forklift movement is observed,
