# Hydraulic System Inspection Summary

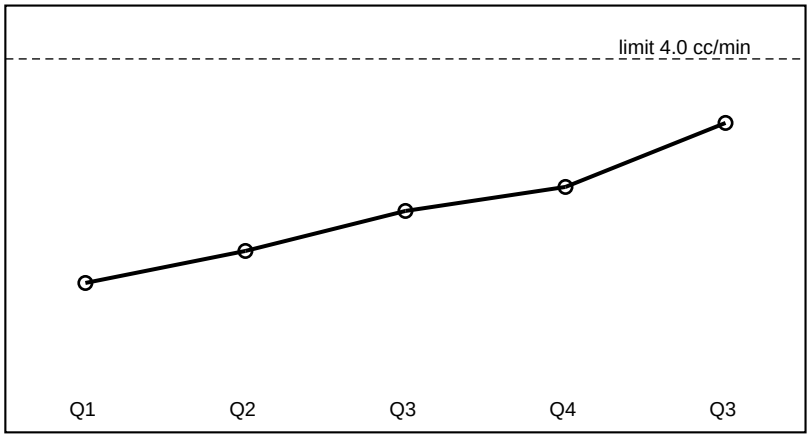
| Actuator | Part number | Leakage cc/min | Action |
|---|---|---|---|
| L/H MLG | 114A3200-5 | 3.2 | Replace |

Figure 1. L/H MLG actuator leakage trend over five inspections

Conclusion. The left main landing gear actuator (114A3200-5) has reached 80 percent of the allowable leakage and is scheduled for replacement before the next inspection interval. A functional test and leakage re-measurement follow the replacement.
