EV Battery Analysis Report

Generated On: 24-06-2026 17:03:16

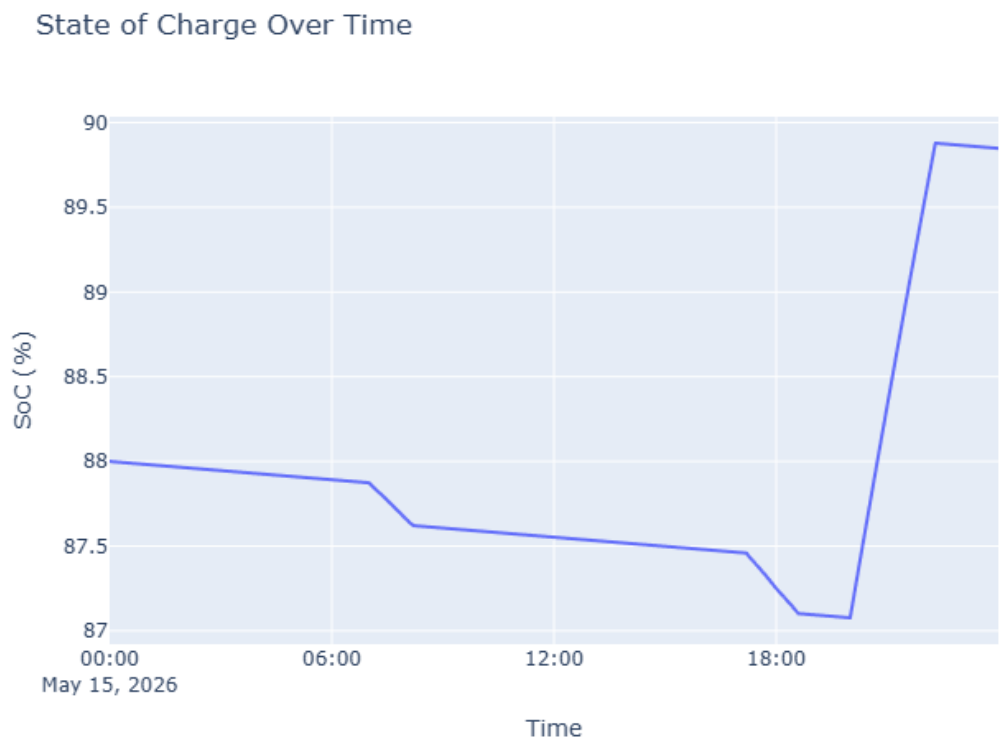
Figure 1: State of Charge variation over time.

Latest SoC: 89.85%

Minimum SoC: 87.08%

Maximum SoC: 89.88%

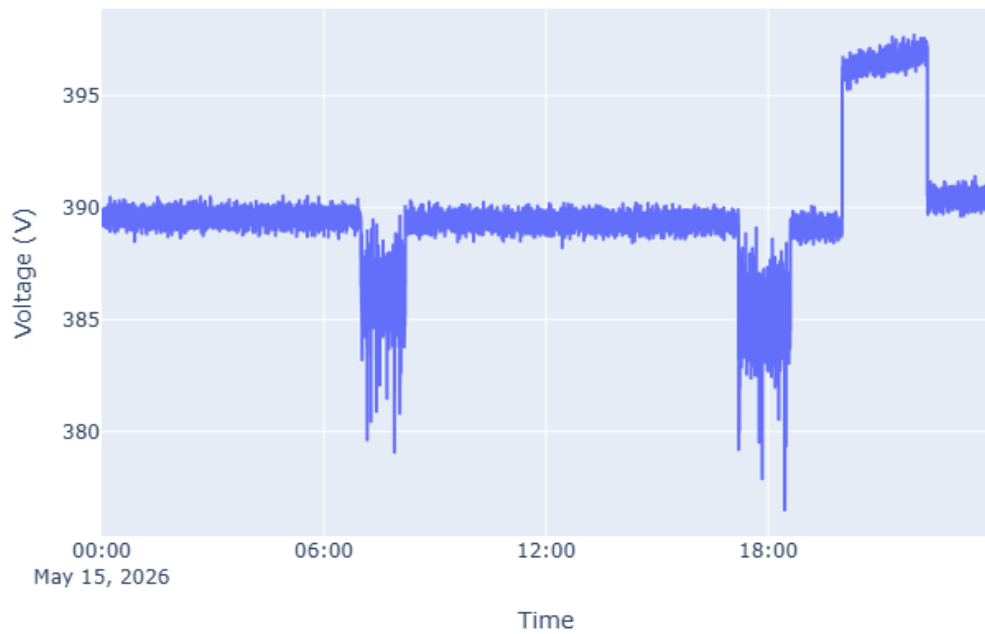
Figure 2: Battery pack voltage variation over time.

Voltage ranged from 376.52 V to 397.71 V.

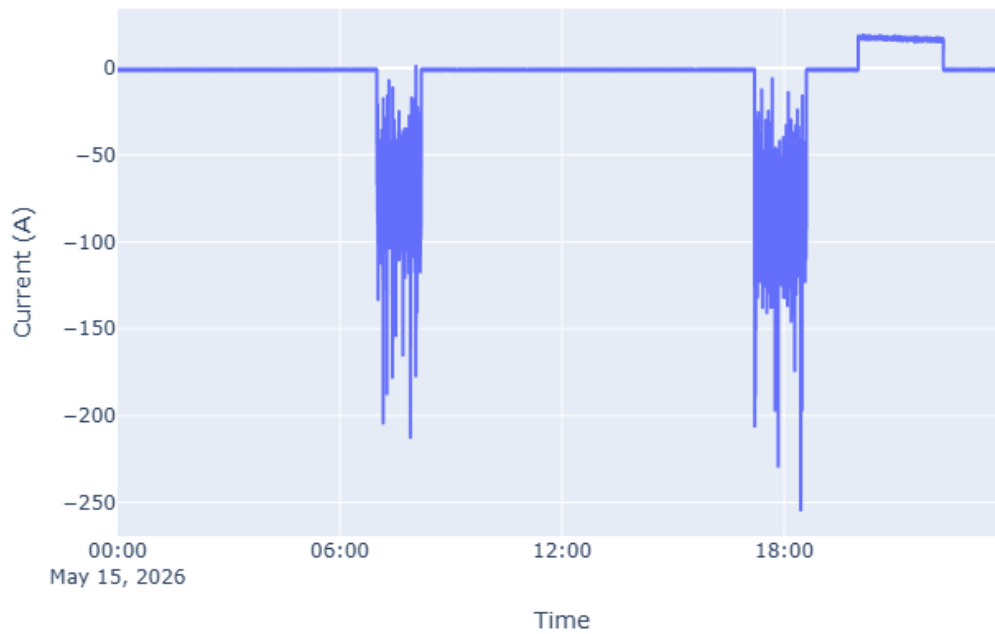
Figure 3: Battery pack current variation over time.

Maximum discharge current: 18.93 A

Maximum charging current: -254.19 A

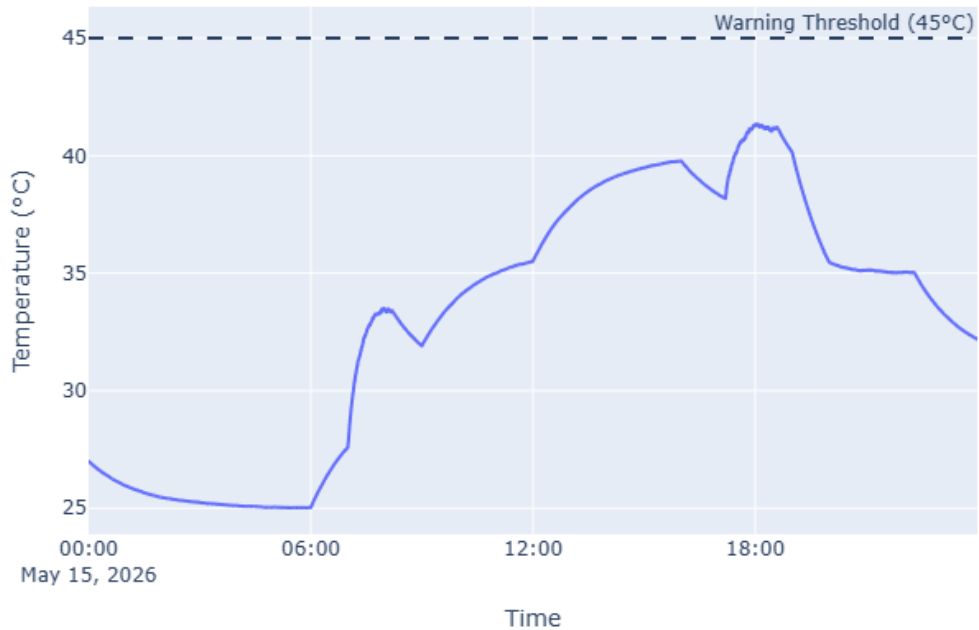
Figure 4: Battery pack temperature variation over time.

Maximum battery temperature recorded was 41.34 °C.

Temperature Status: Normal
