BOARD INSPECTION UPDATE

Krishna Lakkaraju
9/11/24

Physical Sciences Laboratory
University of Wisconsin-Madison

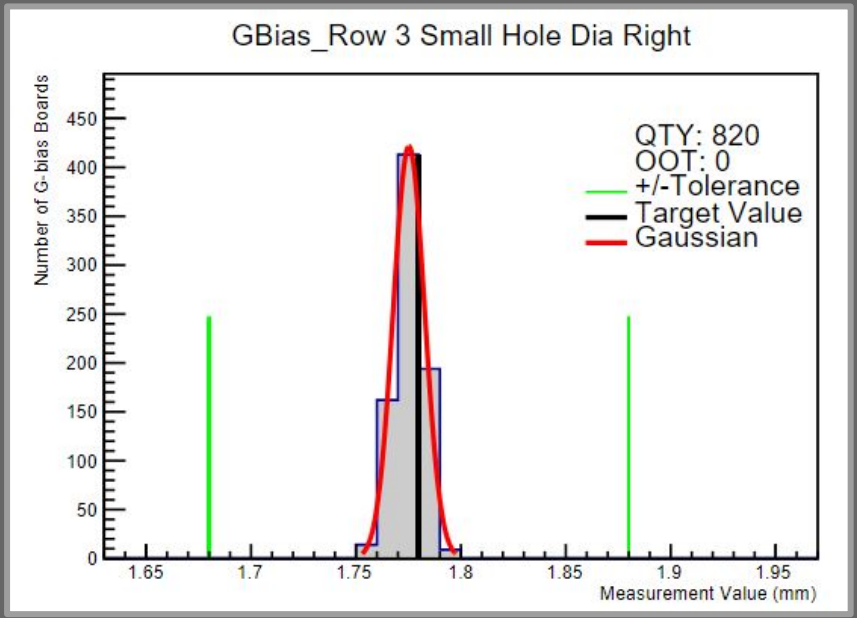
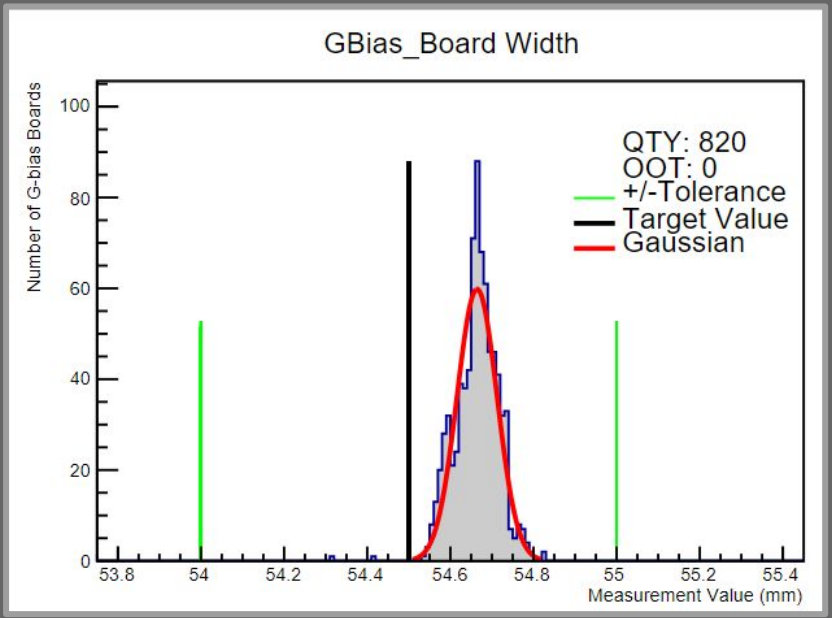
*Example Plots Illustrating Acceptable Distributions

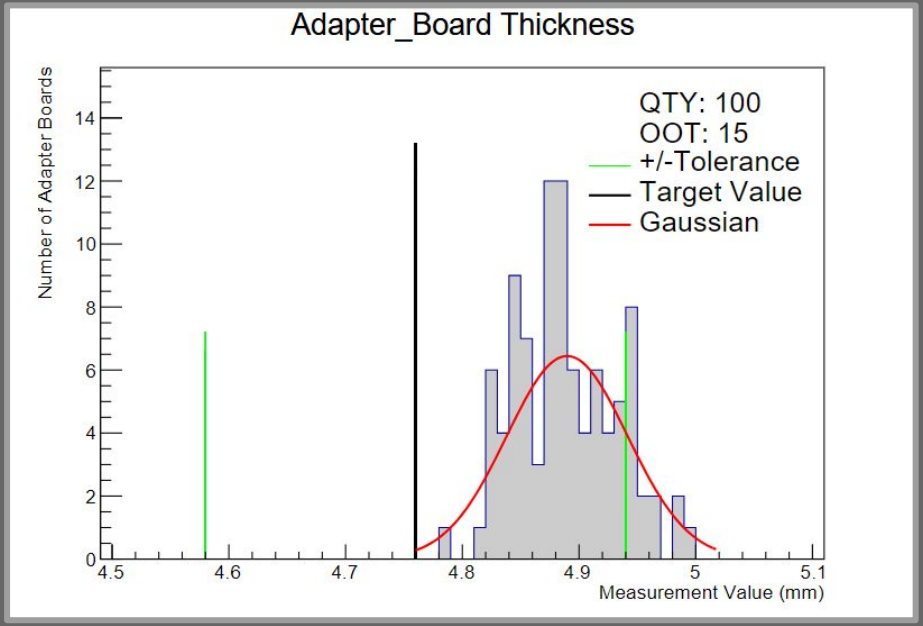
CE-ADAPTER THICKNESS

*Histogram Showing Out-Of-Tolerance (OOT) Measurement Values

- 15% Of Adapter Boards Inspected (100) in the Latest Shipment are too Thick
- Board Thickness May Influence Connector Clearance
  - Impacts Electrical/Physical Connection
- All Boards Were Accepted
  - Electrical/Physical Tests have been Conducted using IPC-6012 Guidelines
  - Four Boards have been Assembled

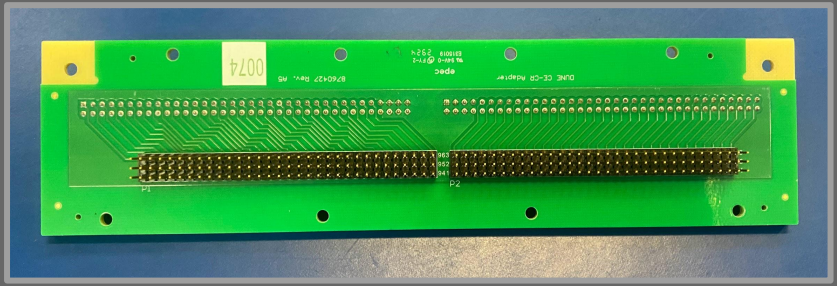
*Photo of A CE-Adapter Board and its Connectors
