NIST Technical Note 1870

Simulation of a Residential Wind Driven Basement Fire - Riverdale Heights, MD

February 2015

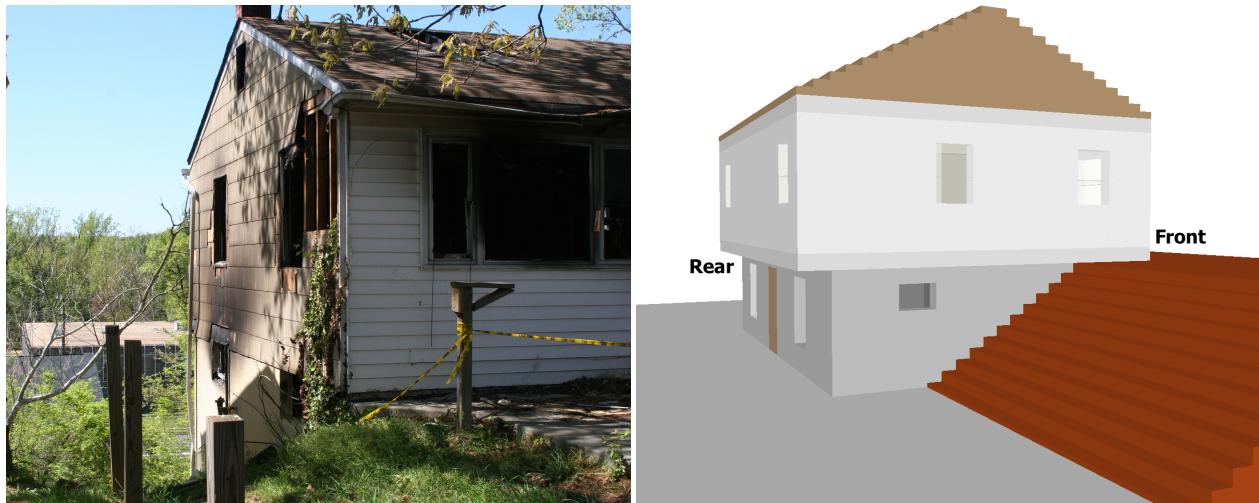
The structure was built on a sloped landscape such that on the front side of the structure the first floor was located at street level but the basement was below street level (Fig. 3.1). On the rear side of the structure, the slope allowed the basement to be a walkout. Therefore, access to the structure could be made on the front side to the first floor and on the rear side to the basement.

Figure 3.1: Photograph taken from front side street level showing the slope down to basement on the rear side of the structure (left) and Smokeview rendering of model representation of sloped landscape (right).

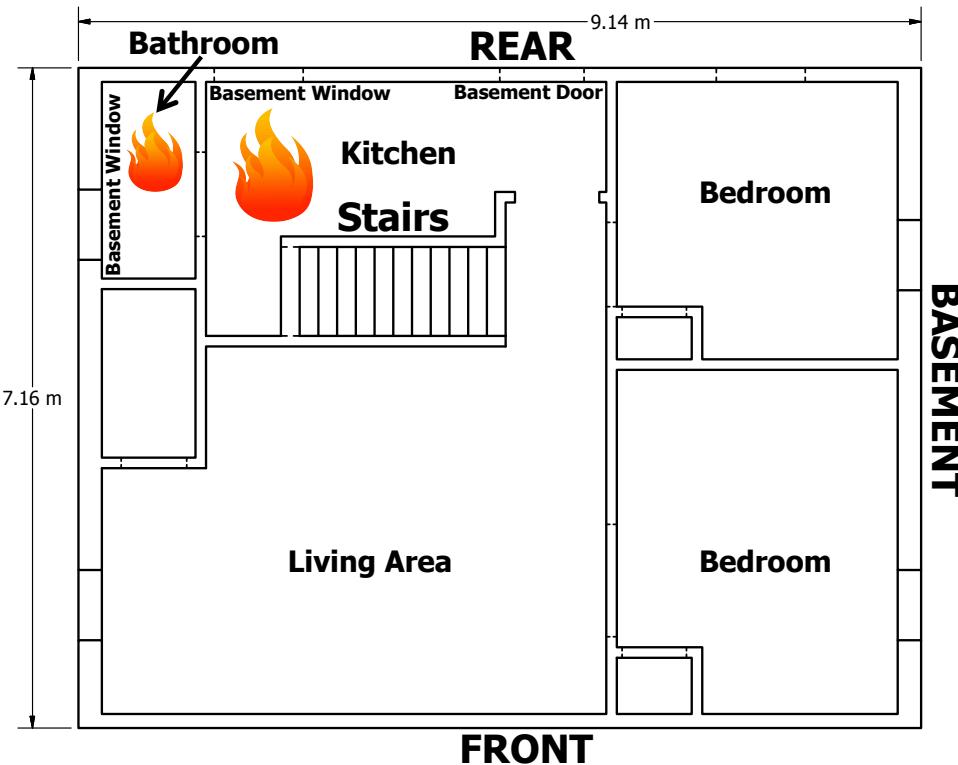
Figure 3.4: Plan view of the basement indicating the location of the two fires in the FDS model.

To calculate the total fire size, the appropriate burning area of the basement needed to be determined. Based on the floor plan of the structure and post-incident images, two distinct fires were considered: 1 source in the basement bathroom and 1 source in the basement kitchen. The bathroom fire was estimated to be comprised of wood paneling along the four walls (17.3 m² or 186 ft²) and wood subfloors and studs along the ceiling (2.9 m² or 31 ft²). This resulted in 20.2 m² (217 ft²) of wood burning surface area or a 1 MW fire using a 50 kW/m² HRRPUA. The remainder of the wood combustible load in the basement was lumped into the localized kitchen fire. The ceiling and wall areas included in the basement kitchen, stairway, and main living area totaled approximately 86 m² (926 ft²). This resulted in a 4.3 MW fire.

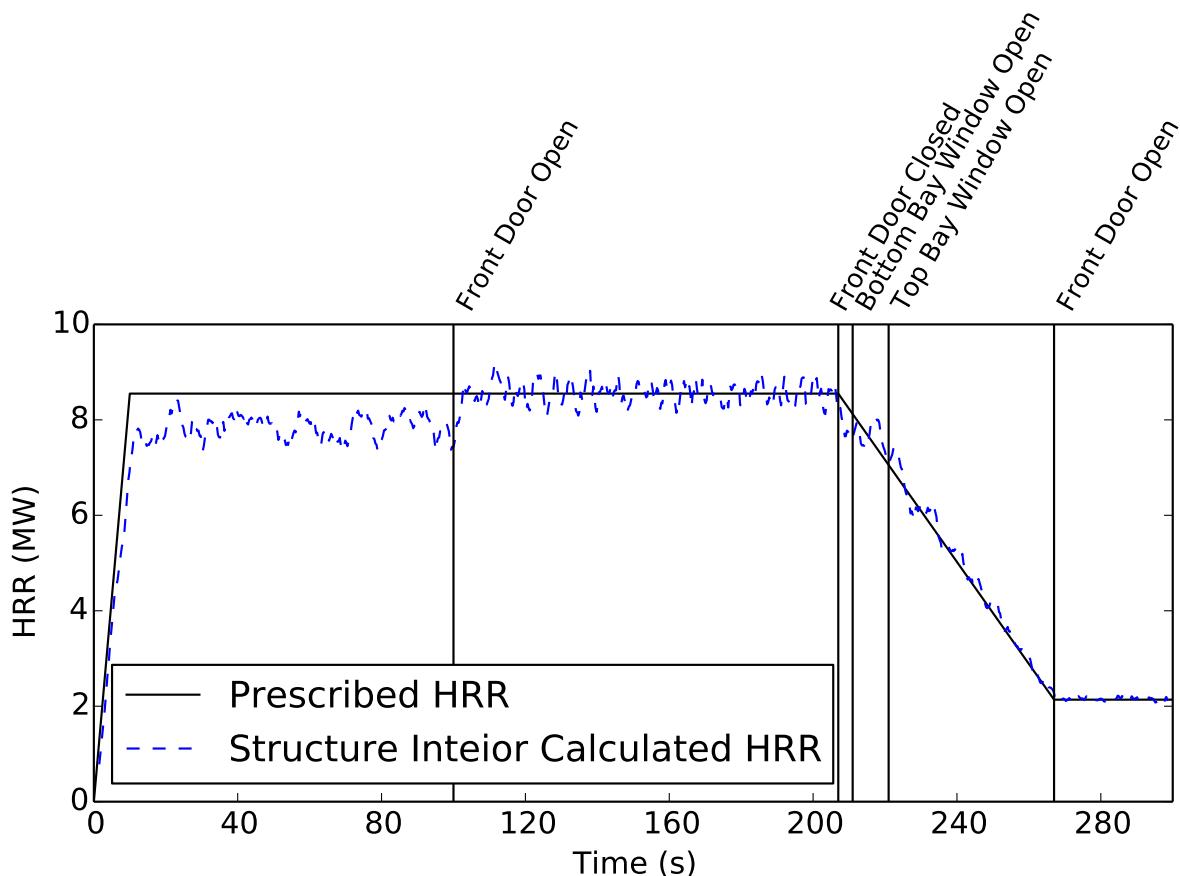
Figure 4.1: Comparison of prescribed and calculated interior HRRs from the FDS simulation. The vertical lines indicate the times when ventilation occurred.

In Fig. 4.1, the prescribed HRR that was input into the simulation is different than the HRR calculated by FDS based on the ventilation conditions. From 0 s to approximately 9 s, the calculated HRR was in approximate agreement with the prescribed HRR because there was an adequate amount of oxygen for all of the fuel to combust. The differences in prescribed versus predicted HRR is a result of either fuel accumulation within the structure not combusting because of a lack of oxygen or combustion occurring exterior to the structure where fuel and oxygen can mix and react. Fig. 4.2 shows the total calculated HRR within the computational domain (includes combustion occurring exterior to the structure) compared to the prescribed HRR curve.

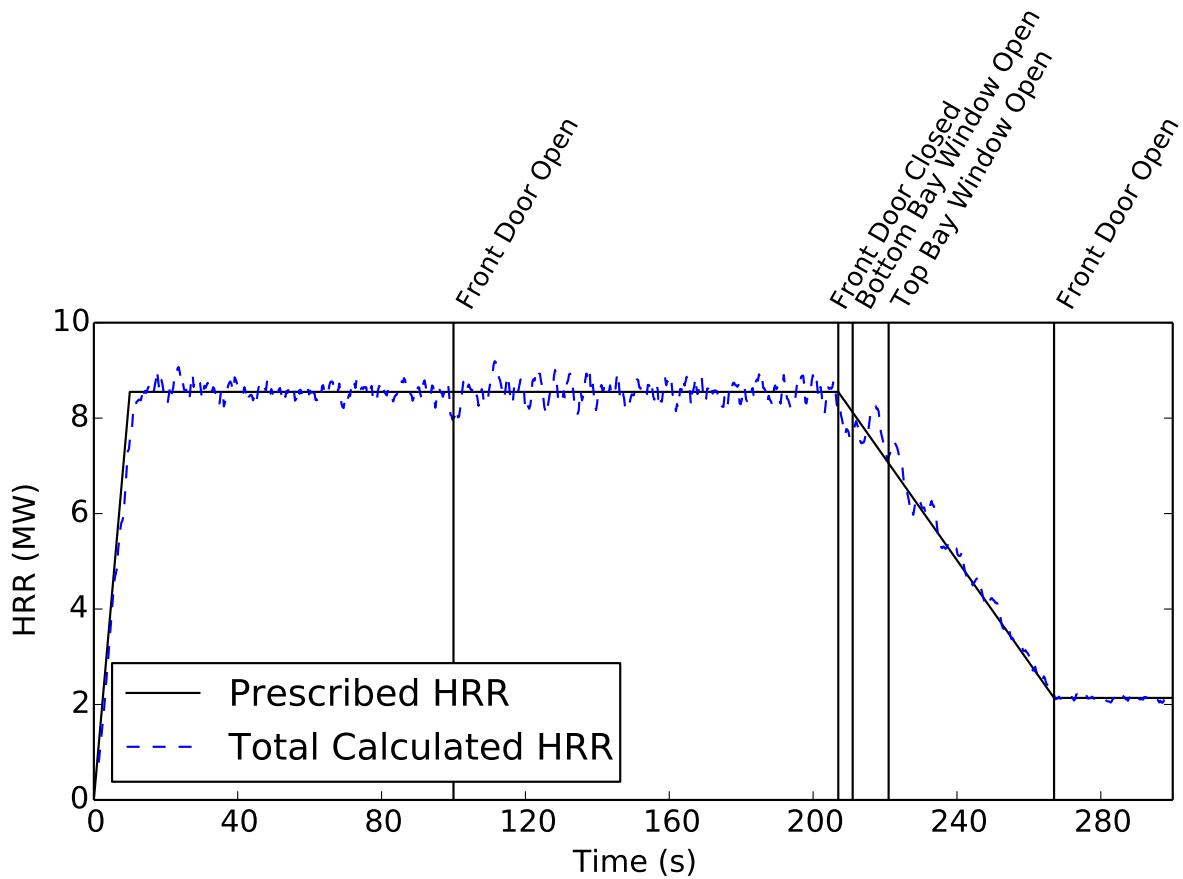
Figure 4.2: Comparison of total prescribed and calculated HRRs within the entire computational domain from the FDS simulation. The vertical lines indicate the times at which ventilation occurred.

A comparison of the differences between the HRR inside the structure (Fig. 4.1) and the total HRR (Fig. 4.2) over the first 100 s of the simulation indicated that on average there was the equivalent of an approximate 0.7 MW fire(s) occurring through open external vents (basement windows). This aligns with observed post-fire damage and post-incident report [10]. Fig. 4.3 shows a post-fire image of the back left corner of the structure as well as a Smokeview rendering of the fire from the FDS simulation prior to the front door being opened by firefighters.

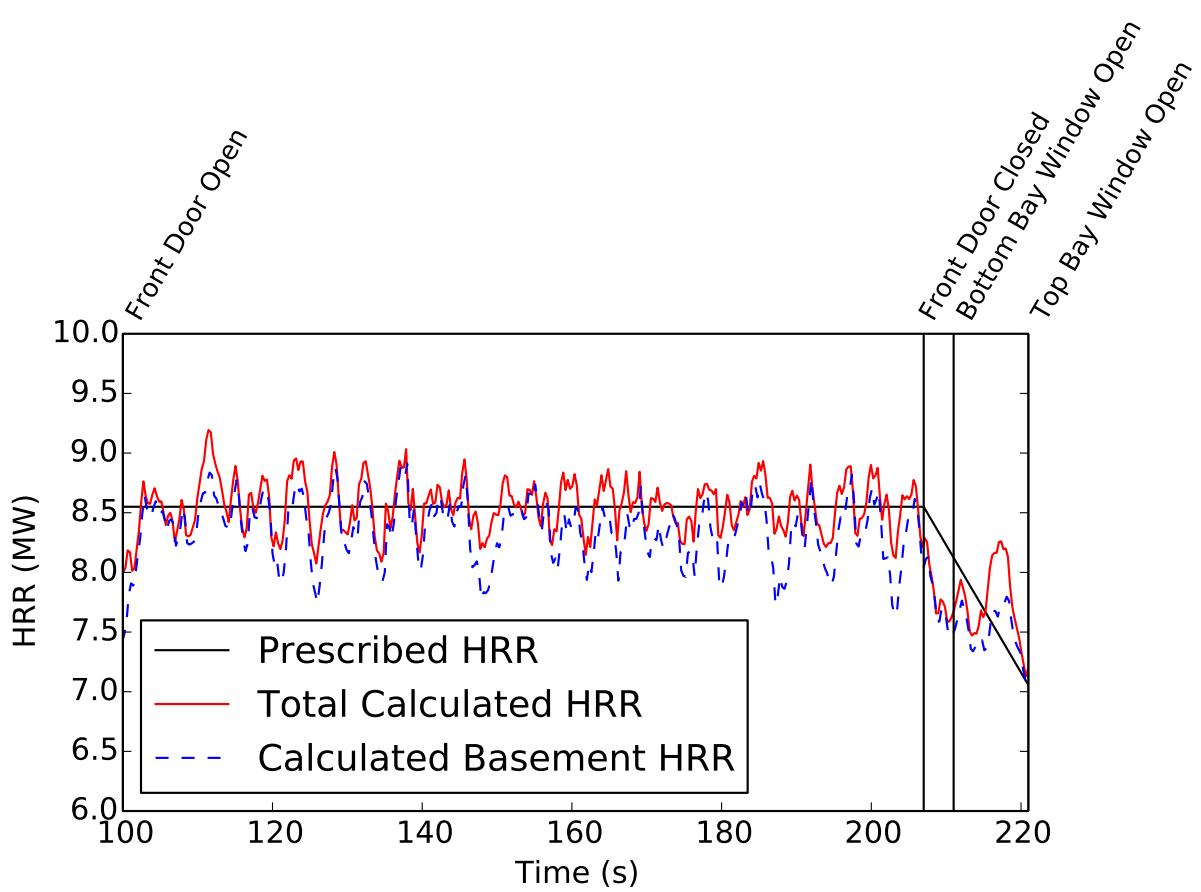
After 100 s of simulation time, 5.5 min after the first 911 call, firefighters open the front door to make entry to the first floor of the structure. The change in ventilation to the structure impacted the HRR. After the door was opened combustion no longer took place outside of the structure, as shown in Fig. 4.4, however the basement HRR was lower than the total HRR within the domain.

Figure 4.4: Comparison of prescribed, total calculated domain HRR and basement calculated HRRs from the simulation. The vertical lines indicate the times when ventilation changed.

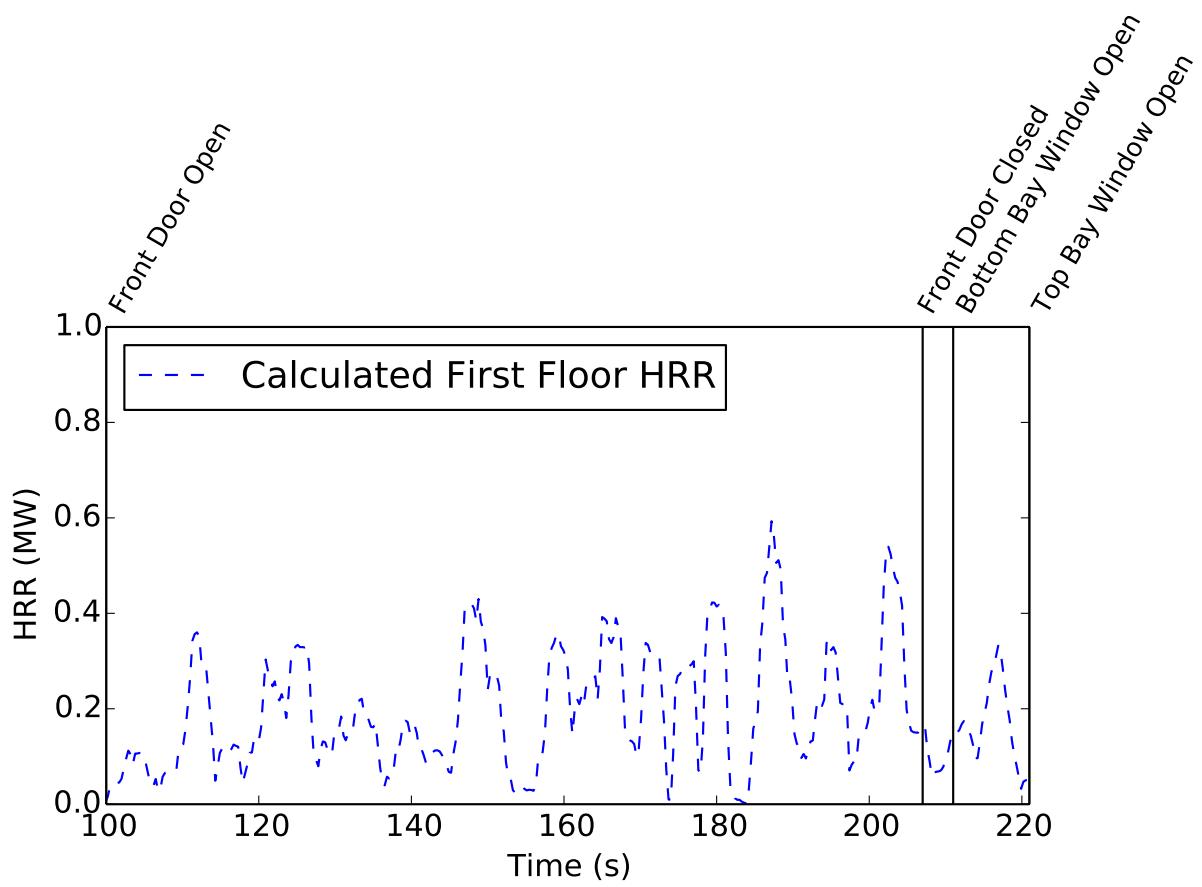
in combustion occurring on the first floor of the structure. Fuel that was combusting outside of the structure due to a lack of oxygen combusts on the first floor of the structure as the open front door allows flow to occur within the structure and fuel to mix with available oxygen and react (Fig. 4.5).

Figure 4.5: First floor calculated HRR from the simulation. The vertical lines indicate the times when ventilation changed.

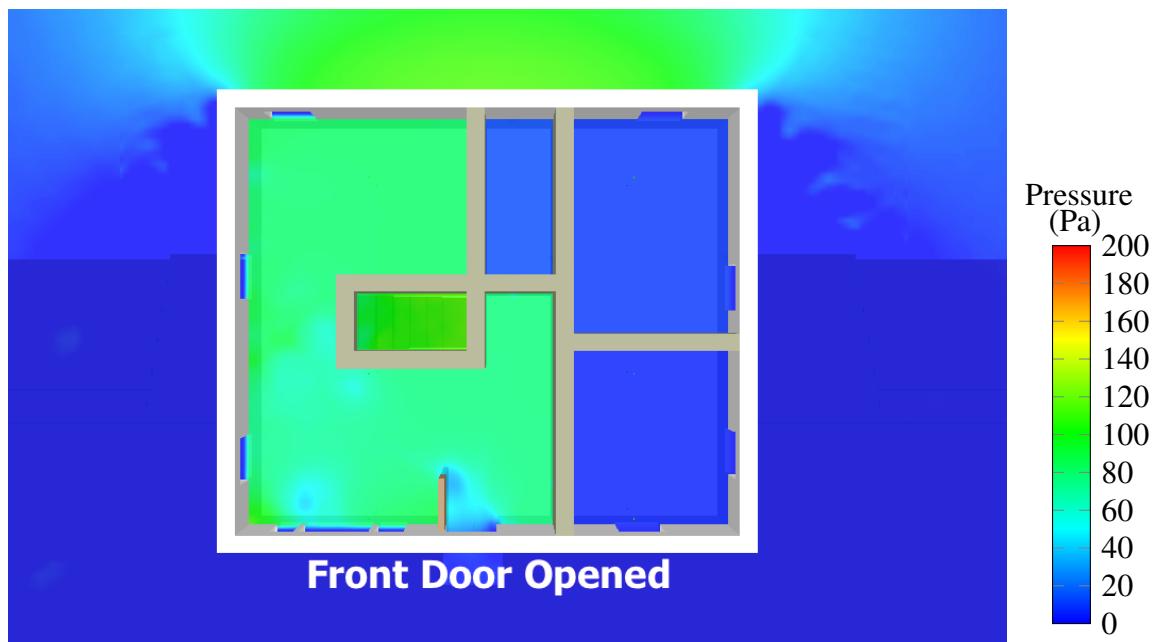
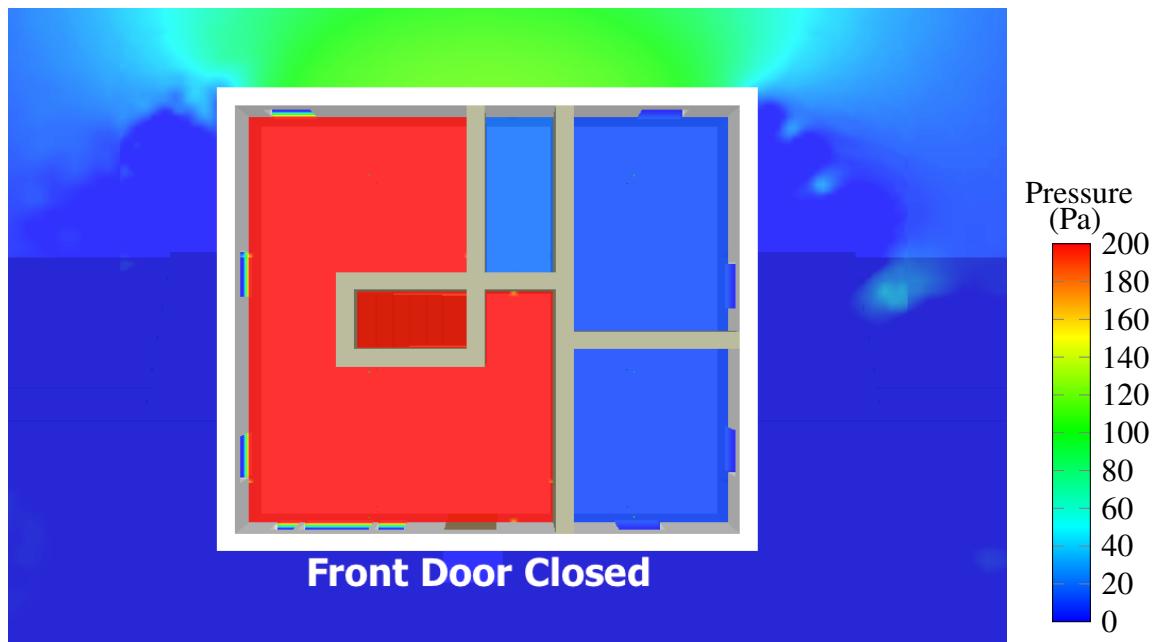
In the top snapshot in Fig. 4.6, the pressure profile shows an overpressure of approximately 200 Pa (2.9×10^{-2} psi), 1 s prior to the door being opened. This pressure may be on the conservative side (over-prediction) because of wind speed fluctuations, wind direction, and small amounts of structure leakage. One second after the door was opened (bottom snapshot in Fig. 4.6), the pressure on the first floor drops to between 75 Pa (1.1×10^{-2} psi) and 85 Pa (1.2×10^{-2} psi). Without the presence of wind, the pressure in the first floor prior to the door opening was approximately 18 Pa (2.6×10^{-3} psi) and after the door was opened the pressure drops to between 5 Pa (7.3×10^{-4} psi) and 10 Pa (1.4×10^{-3} psi).

Figure 4.6: Calculated pressure contours on the first floor of the structure 1 s prior to (top) and 1 s after (bottom) firefighter entry through the front door at 0.91 m (3 ft) above the floor.

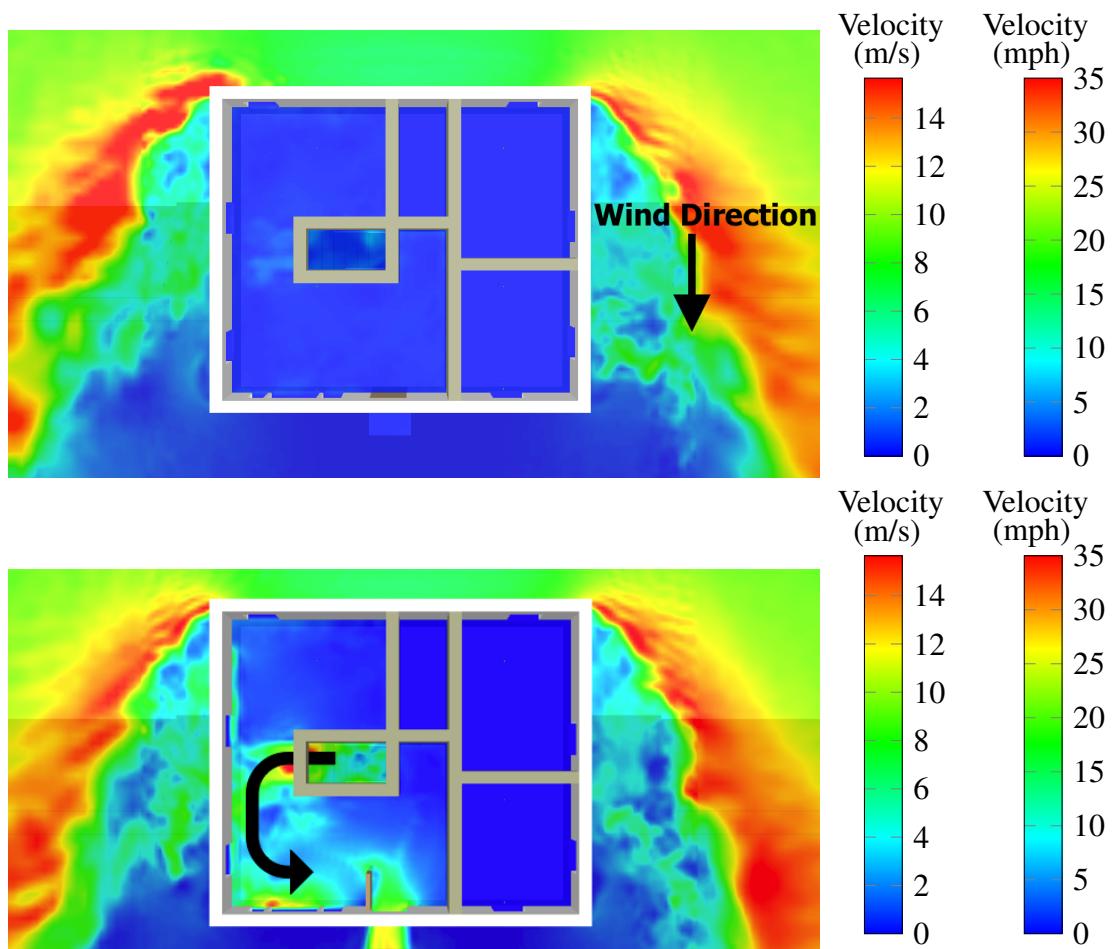
In Fig. 4.7, the velocity profile within the high-hazard area (first floor) is shown via two snapshots in time to illustrate the change in the interior conditions 0.91 m (3 ft) above the floor. The first snapshot is shown at a simulation time of 99 s, which is 1 s before the front door was opened, and the second snapshot is shown at a simulation time of 101 s, which is 1 s after the front door was opened. The velocity contours shown indicate that prior to the front door being opened, there was minimal flow on the first floor. However, after the front door was opened, a flow path was established forcing the combustion products from the basement fire to flow to the first floor through the interior stairwell. The simulation calculated the flow exiting the structure to be approximately 11 m/s (25 mph).

Figure 4.7: Calculated velocity contours on the first floor of the structure 1 s prior to (top) and 1 s after (bottom) firefighter entry through front door 0.91 m (3 ft) above the floor. Arrows indicate direction.

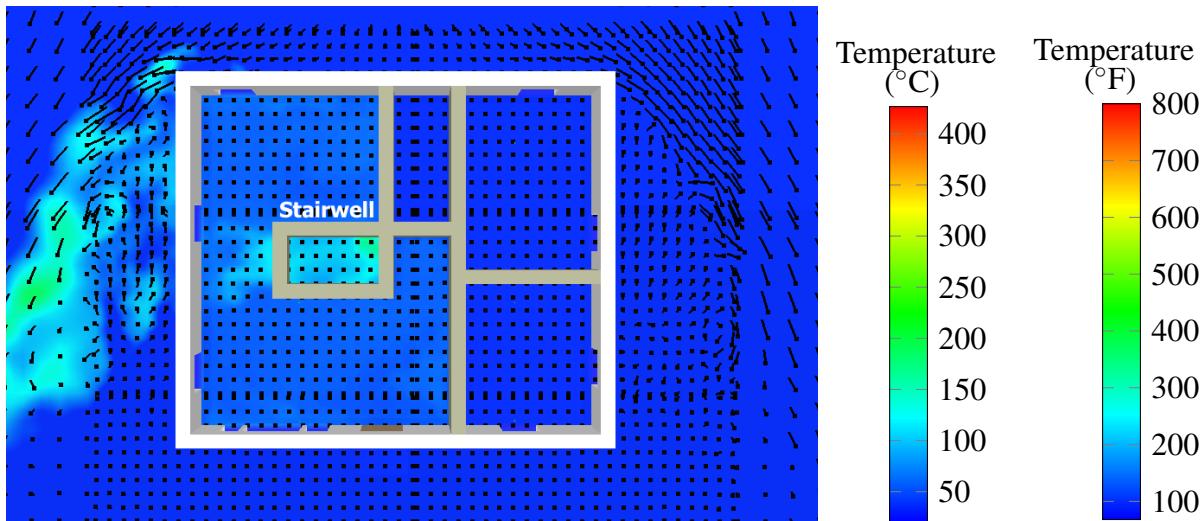
Analysis of the temperatures from the simulation focused on the high-hazard area of the structure: the first floor area between the front door and the top of the interior stairwell. The temperature contours shown in Fig. 4.8 indicate the gas temperatures within the structure 1 s before the front door was opened 0.91 m (3 ft) above the floor. The overlaid arrows represent the gas flow: the length of the lines represents the magnitude of the speed and the direction of the arrow represents the flow direction. Prior to the door opening, the open living area and kitchen on the first floor were approximately 60 °C (140 °F), while the peak temperatures were concentrated near the interior stairwell, 105 °C (220 °F). Note that there was very minimal flow throughout the first floor. Figures 4.9 and 4.10 show gas temperature contours at 0.91 m (3 ft) above the floor, 1 s and 5 s after the front door was opened.

Figure 4.8: Calculated temperature contours on the first floor of the structure 1 s prior to firefighter entry through front door 0.91 m (3 ft) above the floor.

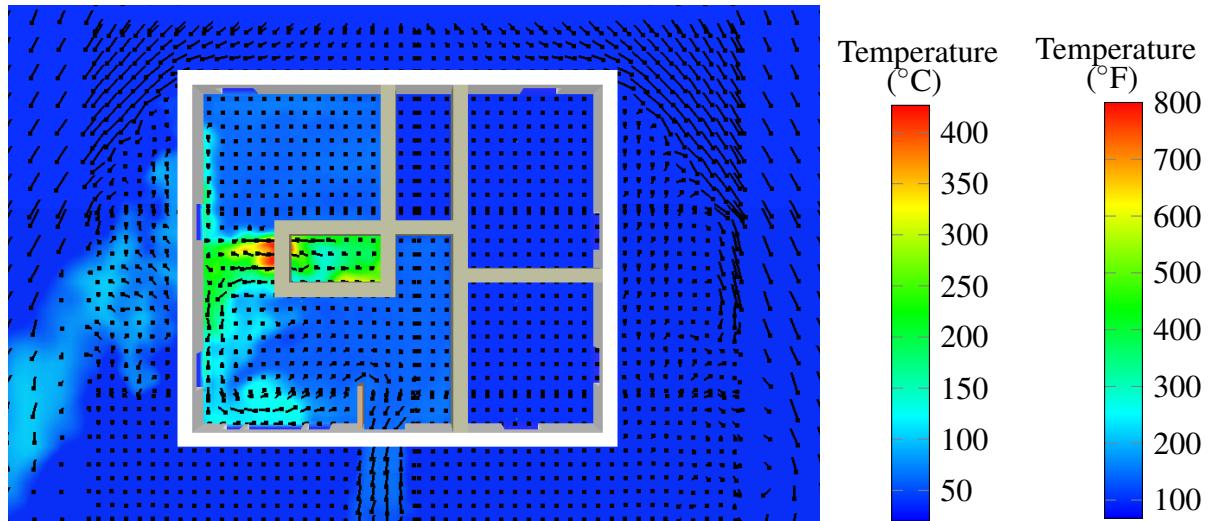
After the front door is opened, hot fire gases from the basement begin to flow through the interior stairwell into the first floor. Figure 4.9, 1 s after the front door was opened, shows that the temperature contours at the top of the stairwell have increased to approximately 200 °C (392 °F) with a hot spot that approached 425 °C (800 °F). Figure 4.10, 5 s after the front door was opened, shows more significant increases in temperature. The area at the top of the stairs is between 375 °C (700 °F) and 425 °C (800 °F). The gas temperatures 0.91 m (3 ft) above the floor at the front door have also increased to approximately 230 °C (450 °F) and show increased flow velocities.

Figure 4.9: Calculated temperature contours on the first floor of the structure 1 s after firefighter entry through front door 0.91 m (3 ft) above the floor.

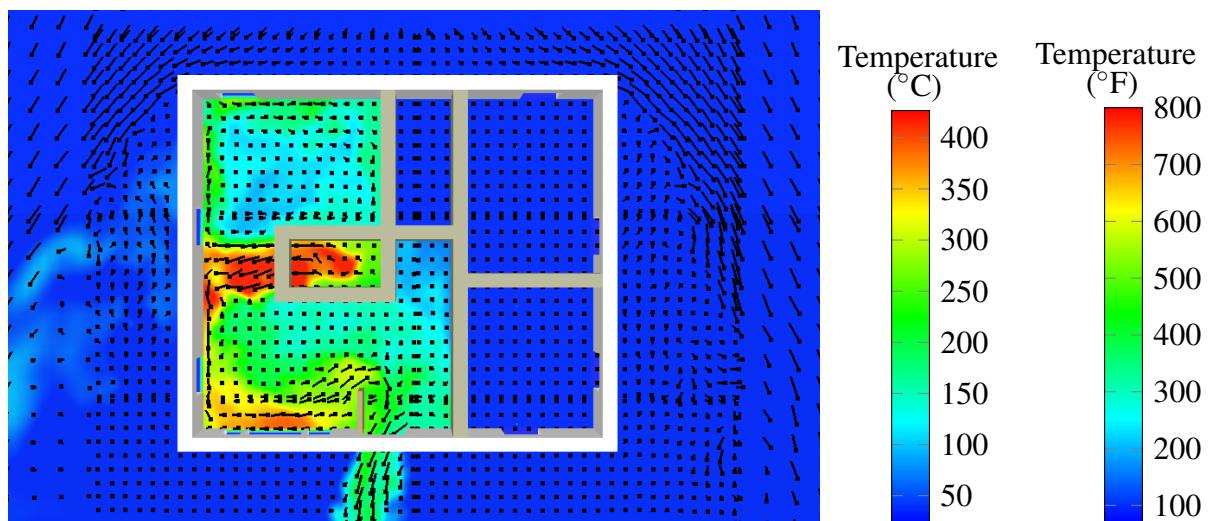
Figure 4.10: Calculated temperature contours on first floor of the structure 5 s after firefighter entry through front door 0.91 m (3 ft) above the floor.

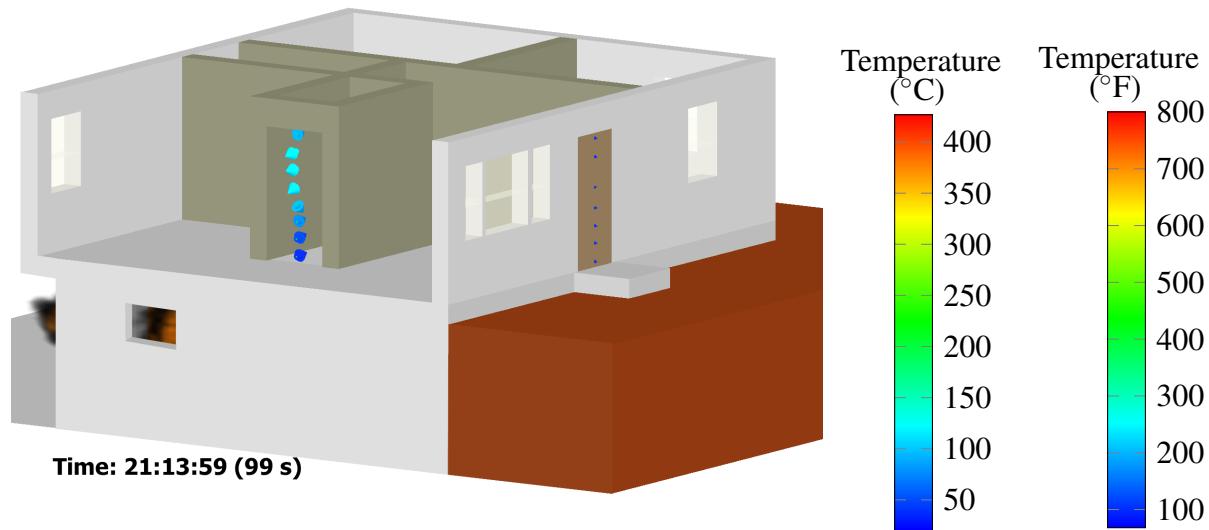
values from the included temperature scales. Therefore, a short blue arrow represents slow moving, cool gas while a long red arrow represents fast moving, high temperature gas. Prior to the door opening, there was minimal flow through the first floor stairwell door and the temperature peak was approximately 125 °C (257 °F) as shown in Figure 5.1. One second after the door opened, Figure 5.2, there was noticeable flow through both the stairwell doorway and through the front door. Simulated temperatures at the stairwell increased to approximately 200 °C (392 °F) and temperatures through the doorway were approximately 100 °C (212 °F). These values are also shown in planar contours 1 m above the floor in Figs. 4.7 and 4.9 for velocity and temperature, respectively.

Figure 5.1: Flow path vectors at front door and top of stairwell 1 s before the front door was opened.

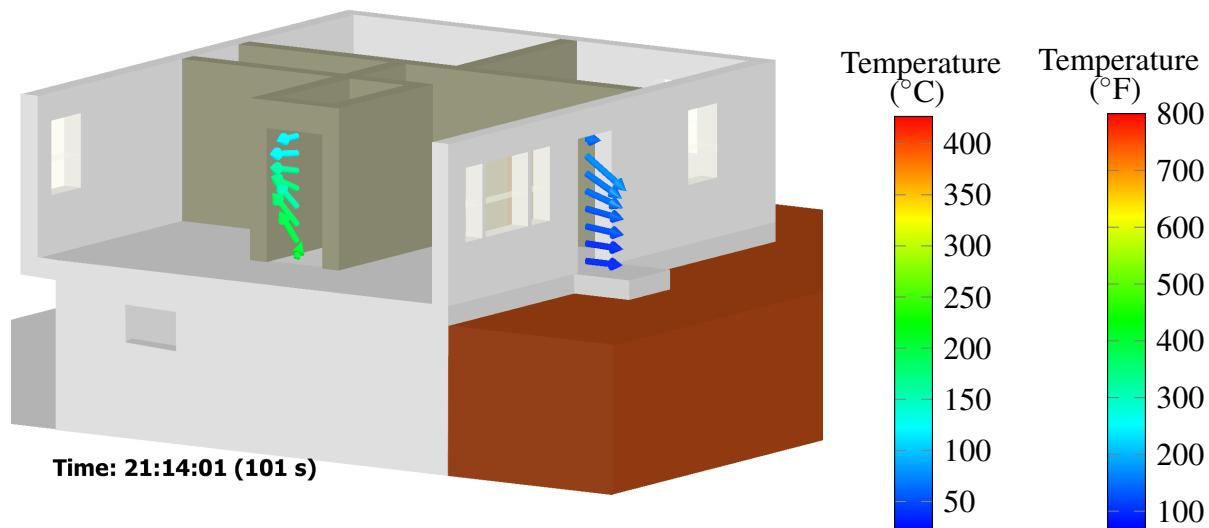
Figure 5.2: Flow path vectors at front door and top of stairwell 1 s after the front door was opened.

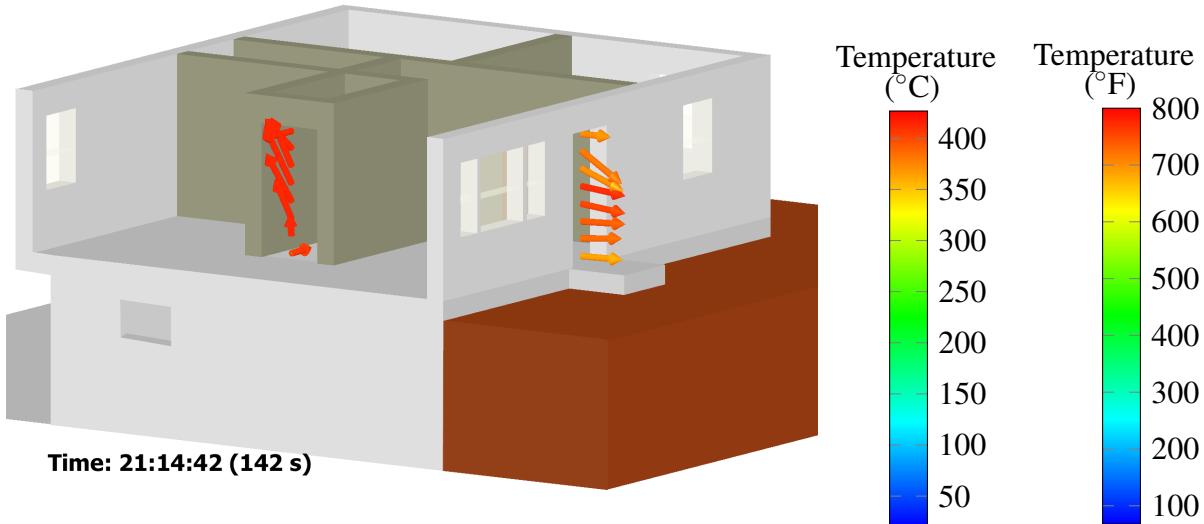
At the estimated time of firefighter entry to the first floor (142 s into the simulation at 21:14:42; see Table 4.1), the simulated flow magnitudes through the first floor (stairwell and front doors) remained similar to the conditions just after opening the front door. Velocities through both the doorway at the top of the stairs and the front door were approximately 13 m/s (29 mph), which was faster than the imposed wind speed (9 m/s or 20 mph) because of the addition of the buoyancy of the fire plume. The model temperatures increased through the stairwell doorway to between 400 °C and 425 °C (750 °F to 800 °F) and through the front door to approximately 375 °C (700 °F). From the approximate timeline (Table 4.1), the front door was forced closed due to airflow pushing against it, 207 s into the simulation. Figures 5.4 and 5.5 show the conditions 1 s prior to and after the front door closed. The figures show that while the closed door stopped significant flow through the stairwell door and onto the first floor, the temperature hazard for the firefighters (temperatures at or above 400 °C or 750 °F) remained.

Figure 5.3: Flow path vectors at the front door and the top of the stairwell 42 s after the front door was opened, at the estimated time of first floor entry.

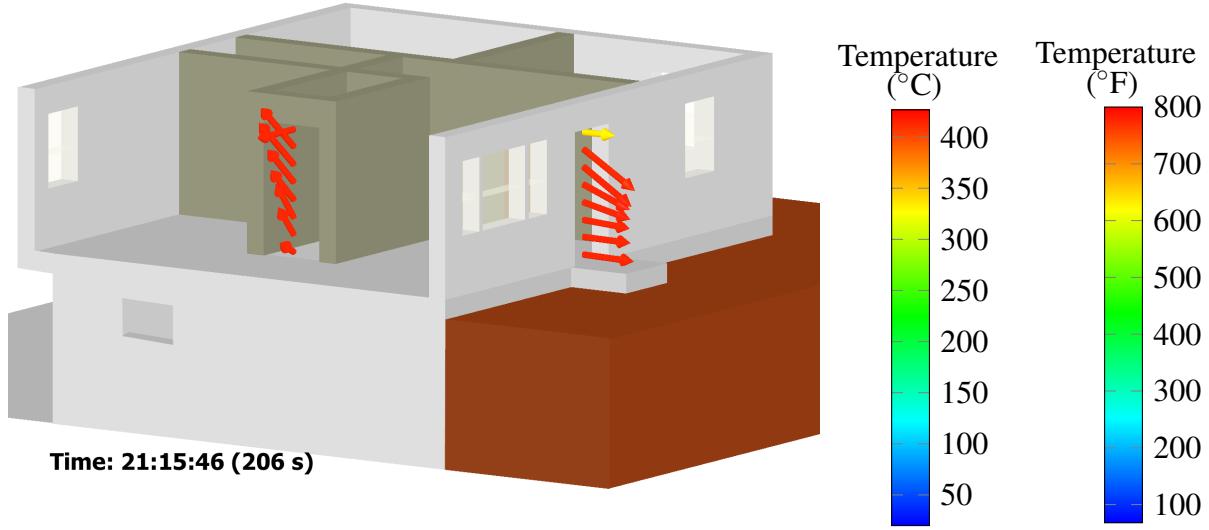
Figure 5.4: Flow path vectors at the front door and the top of stairwell 1 s before the front door was closed.

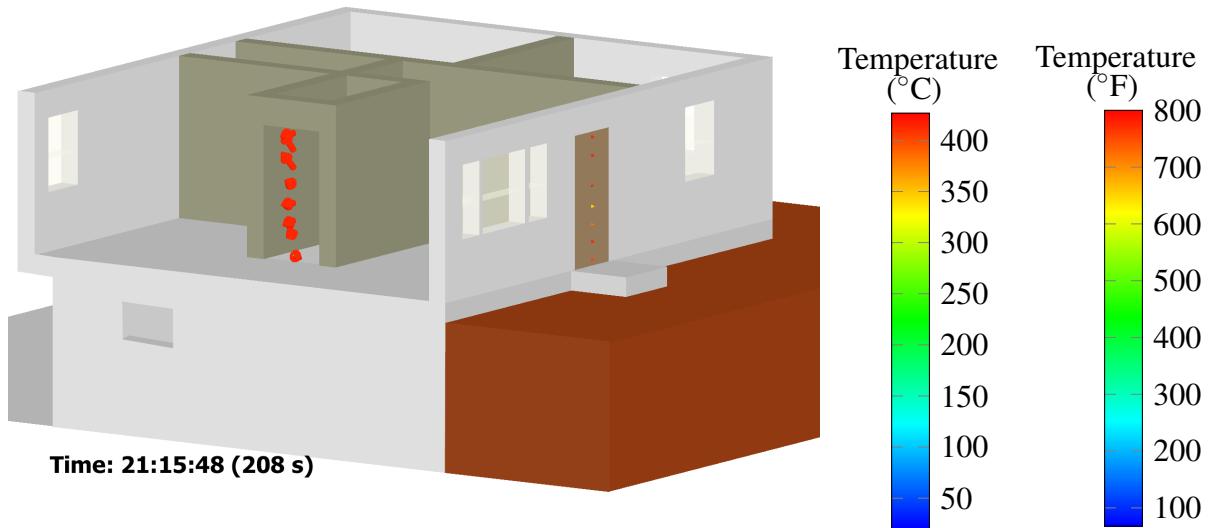
Figure 5.5: Flow path vectors at the front door and the top of stairwell 1 s after the front door was closed.

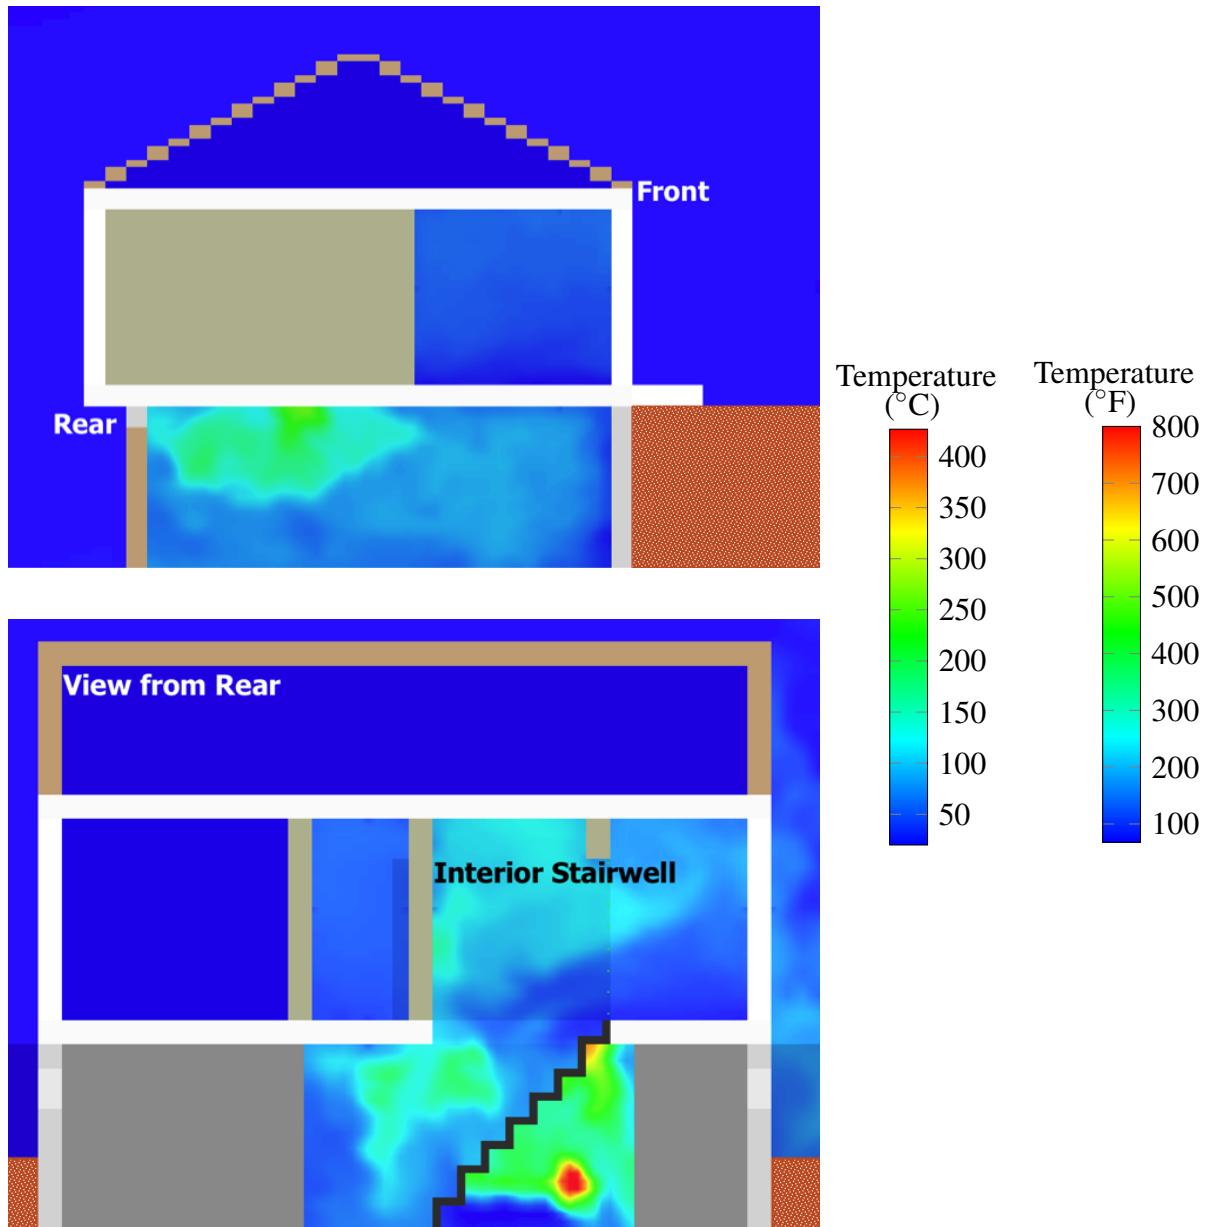
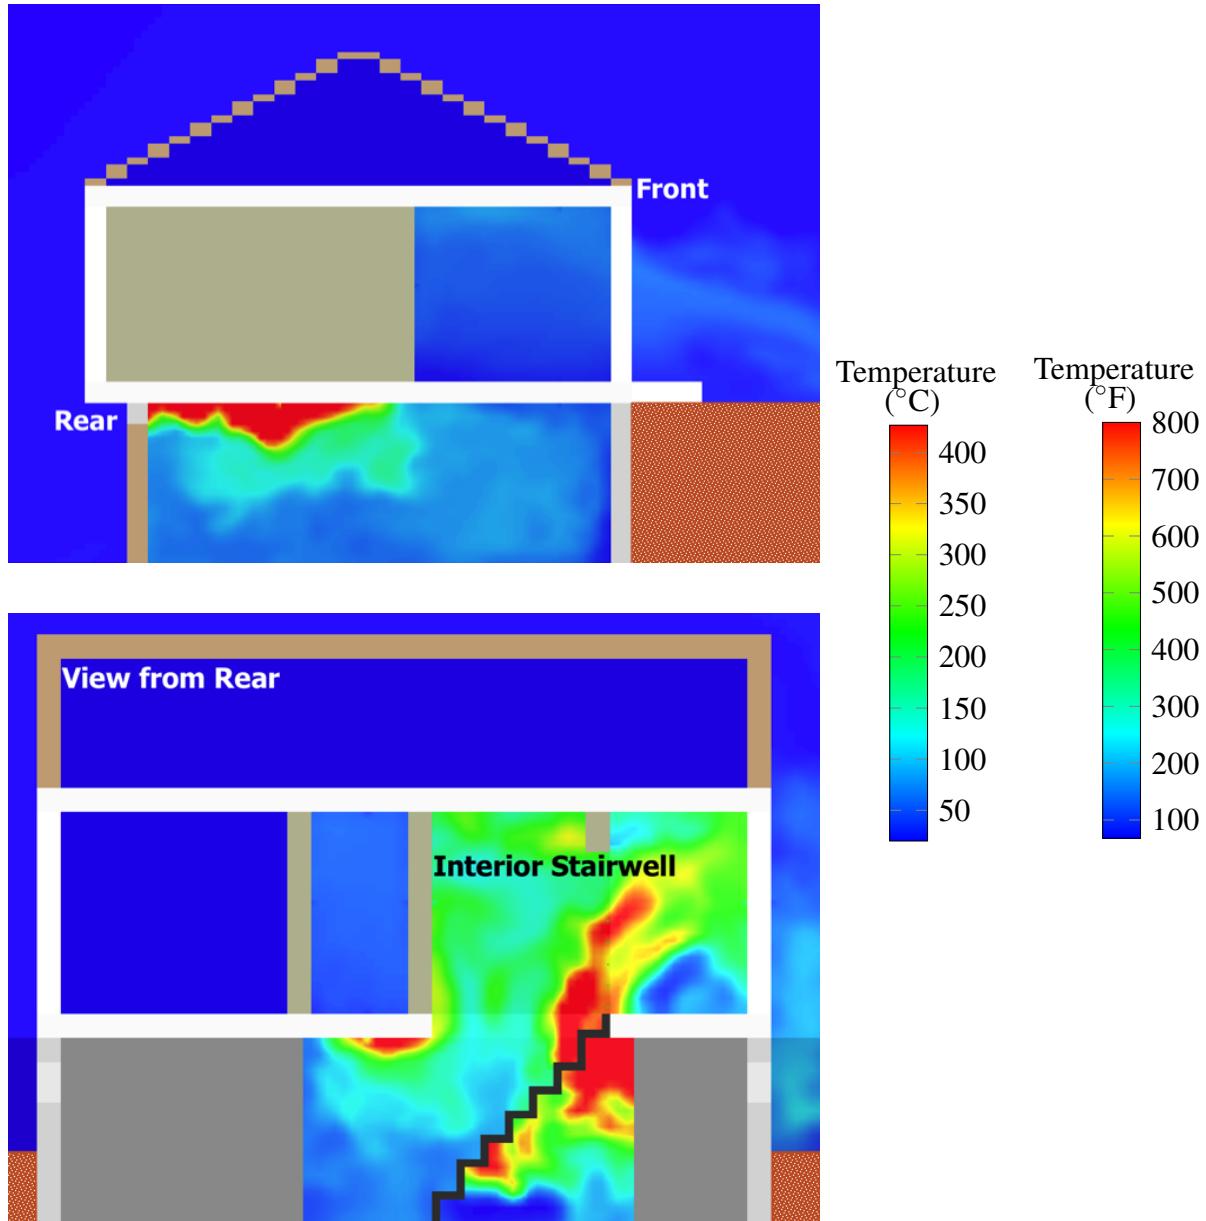
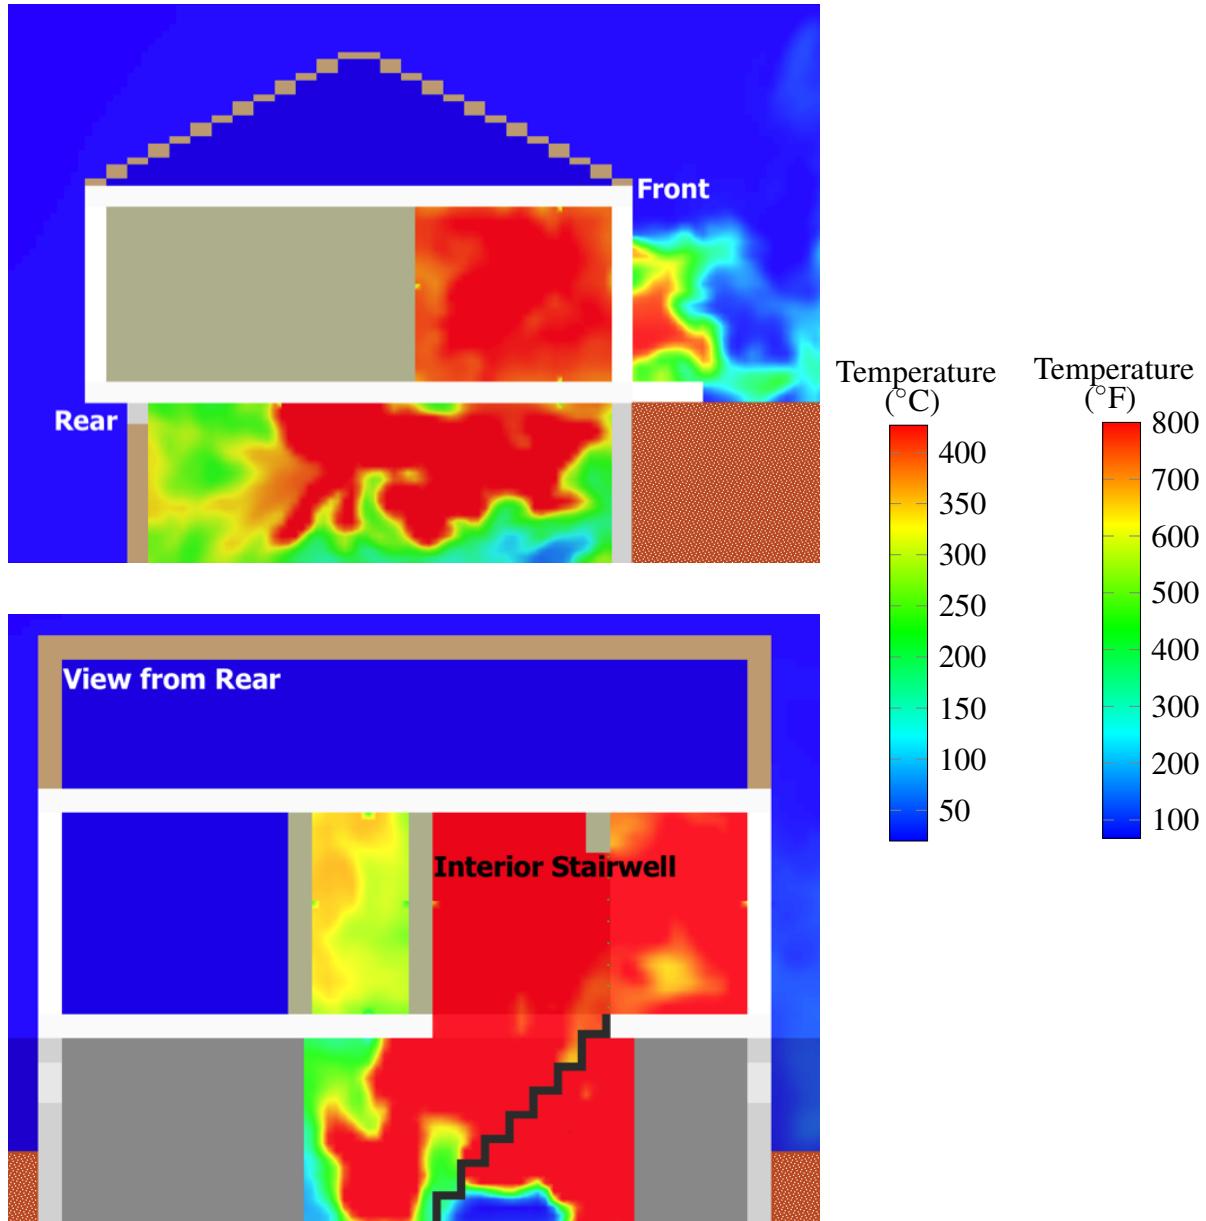
Figures 5.6 to 5.8 show two simulated interior views of temperature contours at particular snapshots in time. The top image is a planar view through the middle of the front door (from the front to the back of the house), which shows the conditions in the living area on the first floor and the conditions in the basement just past the bottom of the stairs. The bottom image shows temperature contours through the middle of the interior stairwell which connected the basement to the first floor of the structure (looking from the rear of the structure towards the front). Prior to the front door being opened, (Fig. 5.6) shows that temperatures in excess of 200 °C (400 °F) were confined to the basement of the structure: specifically the rear of the structure and under the stairwell. One second after the door was opened, hazard in the structure increased with the most drastic change occurring at the top of the stairwell as peak simulated temperatures exceeded 400 °C (750 °F). At the approximate time firefighters made entry to the first floor, Fig. 5.8, the conditions within the flowpath (interior stairwell through front door) had become more severe with simulated temperatures in excess of 400 °C (750 °F), for which a fully protected firefighter would be susceptible to burn injuries. These high-hazard conditions within the flowpath remained until the HRR was reduced by the simulated action of applying water on the fire.

Based on these results and the simulation results shown in Sections 4.3 and 4.4, after the front door was opened, the simulated flow path temperatures in the interior stairwell were in excess of 400 °C (750 °F) and the flow velocities were in excess of 9 m/s (20 mph). The conditions in the interior stairwell changed from tenable to high-hazard very rapidly following the opening of the front door. Within the structure, the hot gases and smoke were moving along the flow path from the basement towards the door located on the front side of the structure via the interior stairwell. The simulated temperatures are consistent with the post-incident conditions that were documented in the interior stairwell.

The interior stairwell acted as a chimney for hot gases in the basement to flow towards regions of lower pressure and vent openings located on the front side of the structure. Firefighters should avoid placing themselves within a flow path where elevated temperatures and flow velocities can present hazardous conditions and increase the rate of heat transfer to the firefighter via convection. A 360° scene size-up by arriving firefighters can help determine the location of the fire and identify potential flow paths within a structure. Door control can also be used to avoid creating inlet and outlet vents that could result in the establishment of a flow path.

First suppression efforts should take place at the same level as the fire (i.e. fight basement fires from the basement level) with the wind at the back of firefighters. Ongoing research by NIST, Underwriters Laboratories (UL), and others has demonstrated that applying water from the exterior into the fire area of a structure (prior to the start of interior operations) can significantly improve the safety of firefighters by reducing the thermal hazard from the fire and reducing the potential for developing high velocity hot gas flows within the structure [17, 18].
