Technogym MyRun – lower kit hardware notes (Gefran GIRT S6T30)

Reverse-engineering notes for the lower kit ("GIRT") of a used Technogym MyRun, collected while repairing one unit. There is **no schematic** for this board. Everything below is either measured on this unit, observed (photos, videos, BLE logs), taken from service manuals of related Technogym drives, or marked as inference.

Unit documented: MyRun serial `DCKA2B021008231`, console firmware `WFW0699_BA30.35167`, lower kit Gefran GIRT S6T30, part `0WR01179AG`, board `ECS2458-6` / `ESE6114`, GIRT firmware release 10.05, HW release AG. Name plate: *Gefran Drives and Motion S.r.l., Gerenzano (VA)* (the drives division is now WEG Automation Europe), main power out 0–370 V DC, 1.5 kW **[O]**.

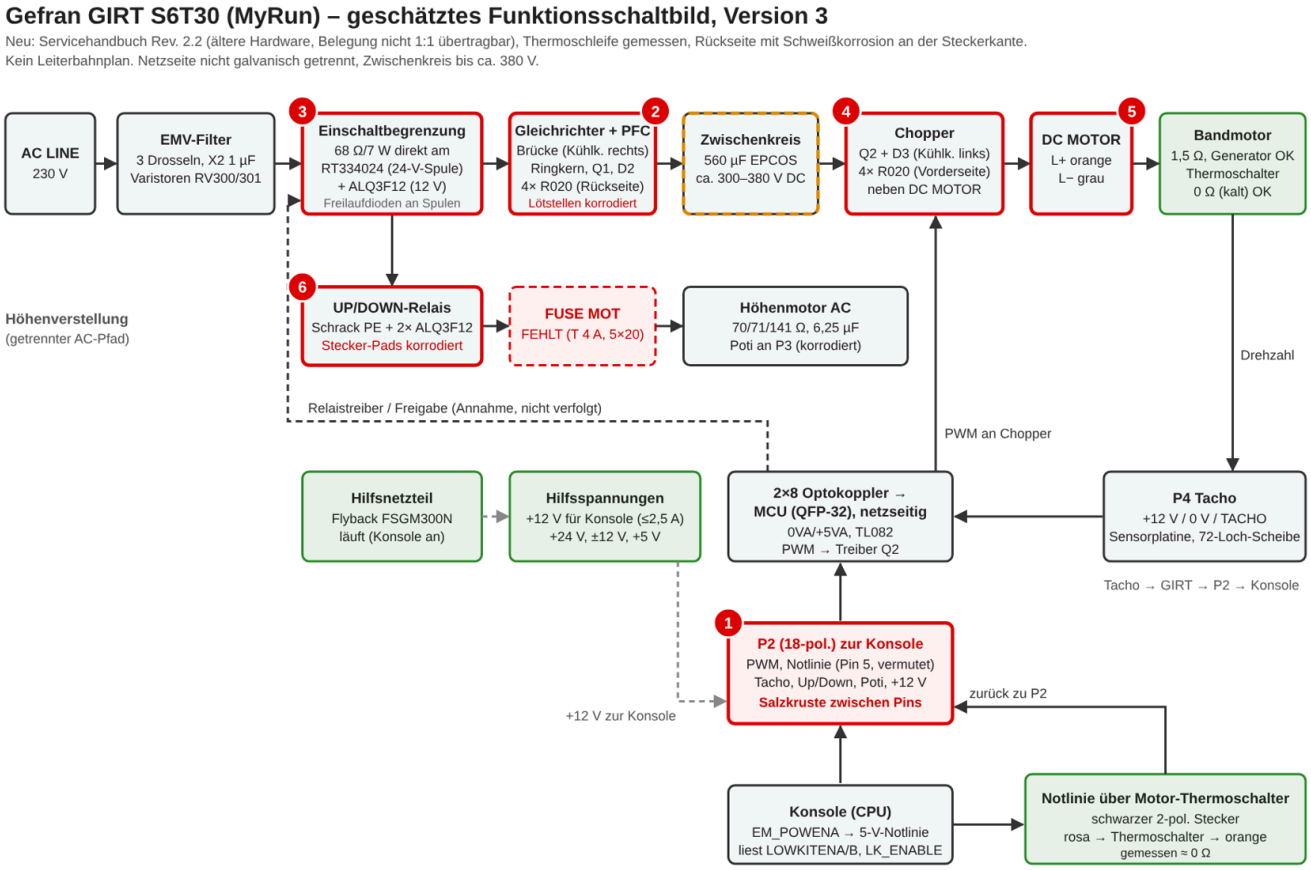
The block diagram is an estimate built from photos of both board sides (German labels); numbers mark the suspicion ranking at the time of drawing, not a verified fault location.

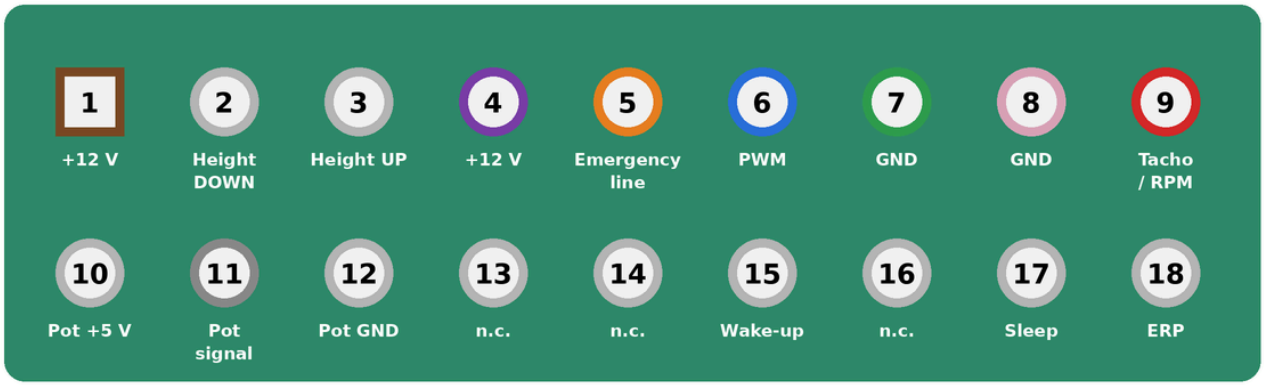
GIRT P2 – 18-pin console connector (2 × 9)

Pin 1 top left. Matches the back-probing photo. Wire colours as seen on the cable.

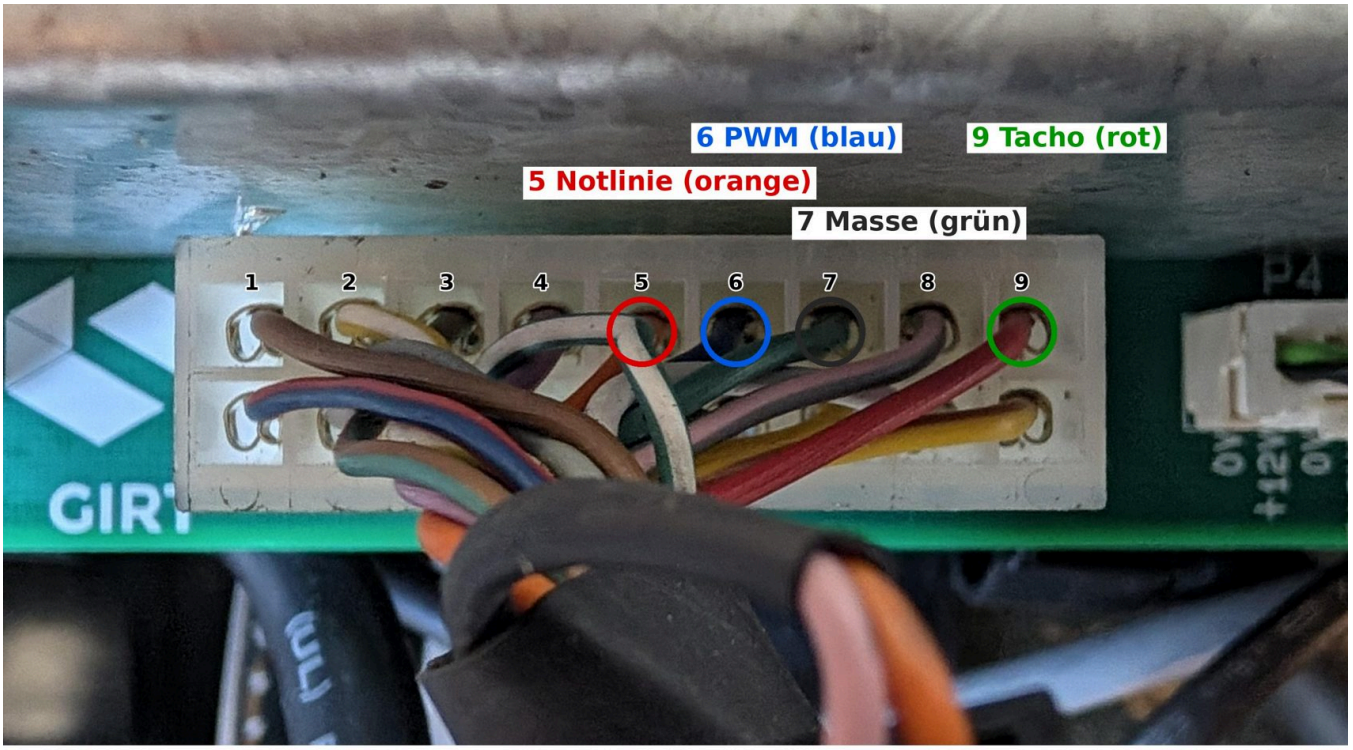
Orientation. View A of the figure is the plug seen from the cable side (as in the photo below): pin 1 top left, 1–9 on the top row, 10–18 on the bottom row. View B is the board seen from the solder side, rotated the way it usually lies on the bench: pin 1 (square pad) bottom left, pins 1–9 on the inner row, pins 10–18 on the row at the PCB edge (top).

Obere Reihe = Pins 1–9 (Pin 1 links, braun). Schwarz (COM) fest an Pin 7, rot nacheinander:

Pin 5: ca. 5 V solange Freigabe aktiv · Pin 6: einige 100 mV bis wenige V beim Laufen

Pin 9: schwankender Mittelwert beim Laufen, fest 0 V oder ~5 V im Stand · Kontrolle: Pin 1 gegen 7 ≈ 12 V

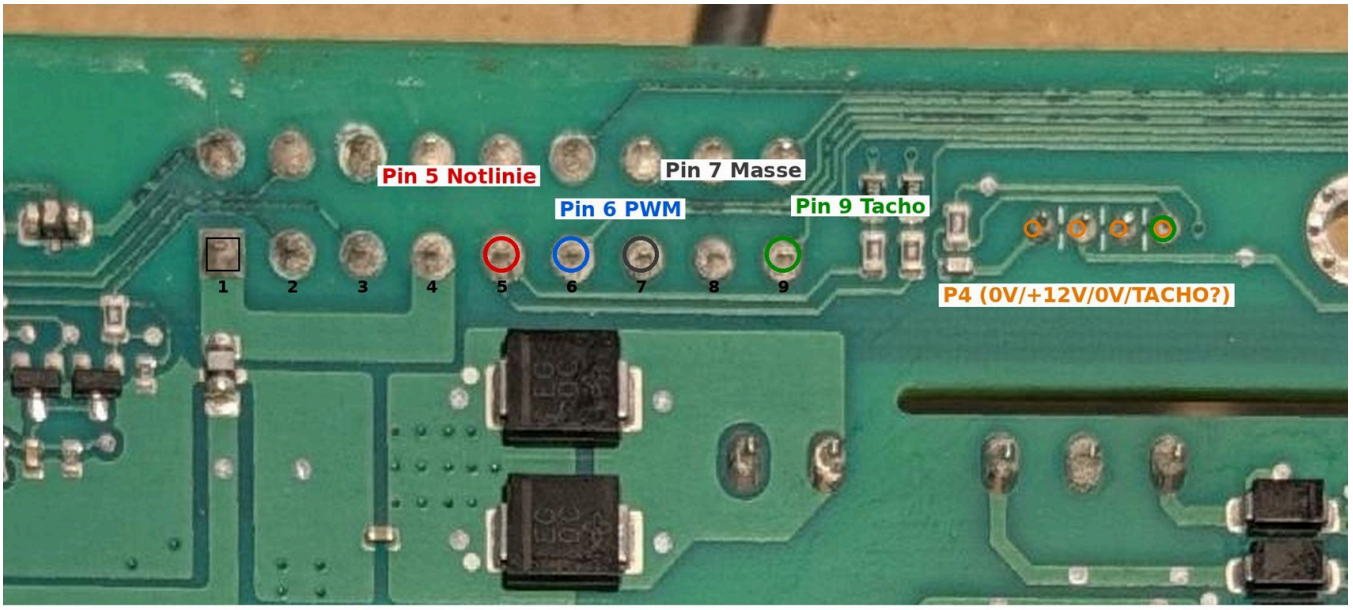
P2 plug from the cable side with the measurement pins marked (German labels).

P2 innere Reihe (näher zur Mitte), Pin 1 = eckiges Pad links. Messung: Multimeter V DC,

schwarz an Pin 7, rot an Pin 6 (PWM) bzw. Pin 5 (Notlinie) bzw. Pin 9 (Tacho), während des Starts.

P4: Lage aus Fotos abgeleitet. TACHO vermutlich rechts außen (grün) – vorher prüfen:

die beiden 0V-Pins von P4 müssen 0 Ω zu P2 Pin 7 haben.

Solder side of the board, same orientation as view B: P2 inner row (pins 1–9, pin 1 = square pad at the left) and the four P4 pads on the right.

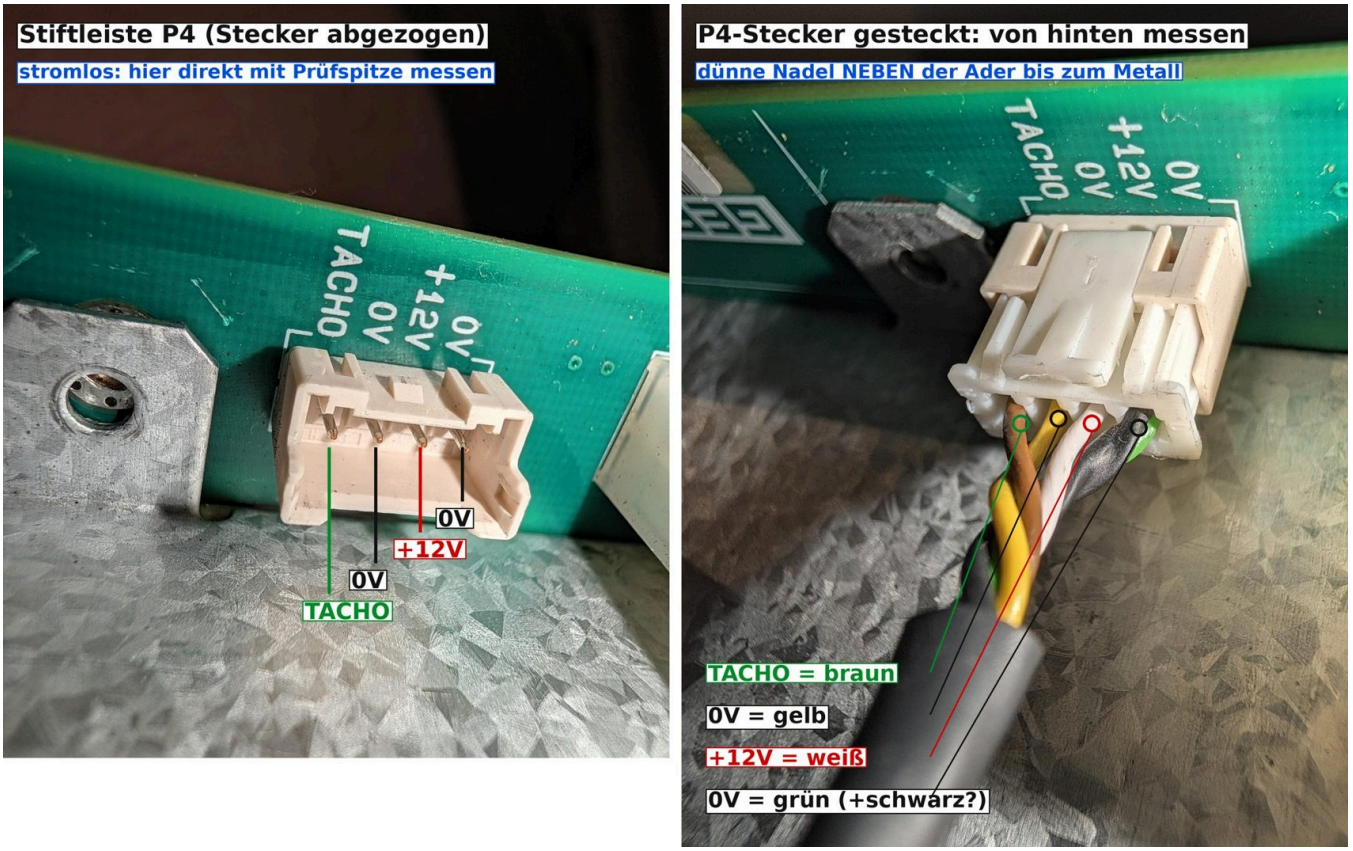
GIRT P4 – 4-pin speed-sensor connector

Wire colours derived from photos; the second 0V wire may be black/shield.

Left: header with the plug removed. Right: plug from behind with the wire colours. German labels.

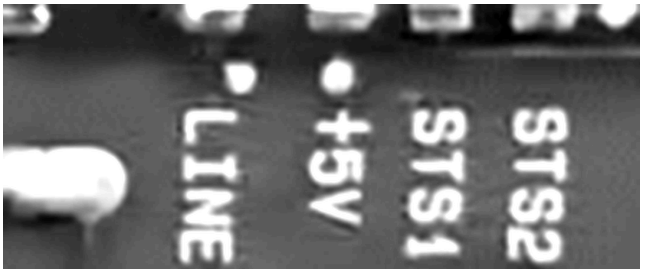
Silkscreen: `LINE`, `+5V`, `STS1`, `STS2`.

State	LINE	+5V	STS1	STS2
Boot	on at t0	on at +0.9 s	dark until +7.6 s, then 1 Hz	one 0.2 s flash at +8.3 s
Ready	on	on	1 Hz (0.5 s on / 0.47 s off)	off
Running	on	on	steady on	off
Fault (locked)	on	on	1 Hz	N pulses (≈0.27 s on, 0.5 s period), ≈1.4 s pause, then repeat; N = 8 or 4 so far, see below

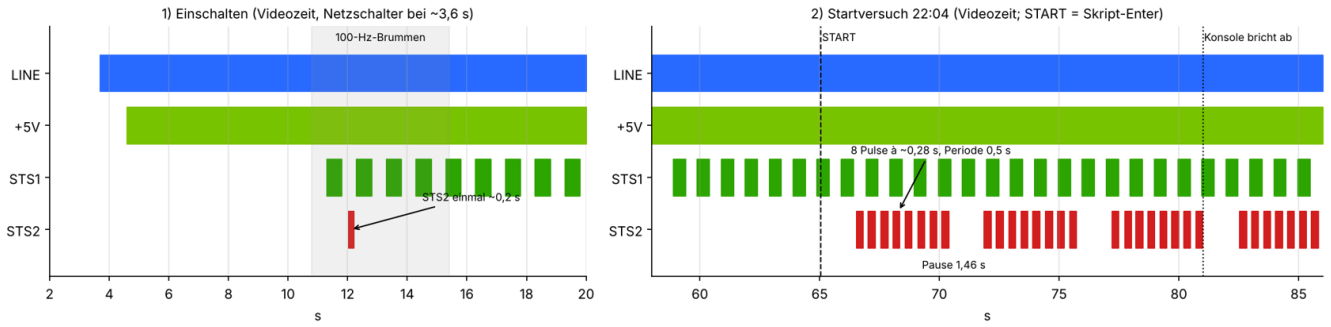
Two data points only. A possible reading **[I]**: the pulse count is the drive's error number. With the Technogym numbering shared by four drive generations, 08 is *belt-motor encoder error* and 04 is *DC-bus over-voltage (OU)*. In both cases the motor output stayed at 0 V, so the GIRT may be switching its output off for different reasons (or reporting different consequences of one root cause). Noting pulse count and HF number at every failed start will show whether the mapping holds. If OU is real, the voltage measuring chains (four 475 kΩ resistors with UJ12 diodes, assumed to sense the DC link) become the first suspects.

Frame-by-frame timing from phone video **[O]**:

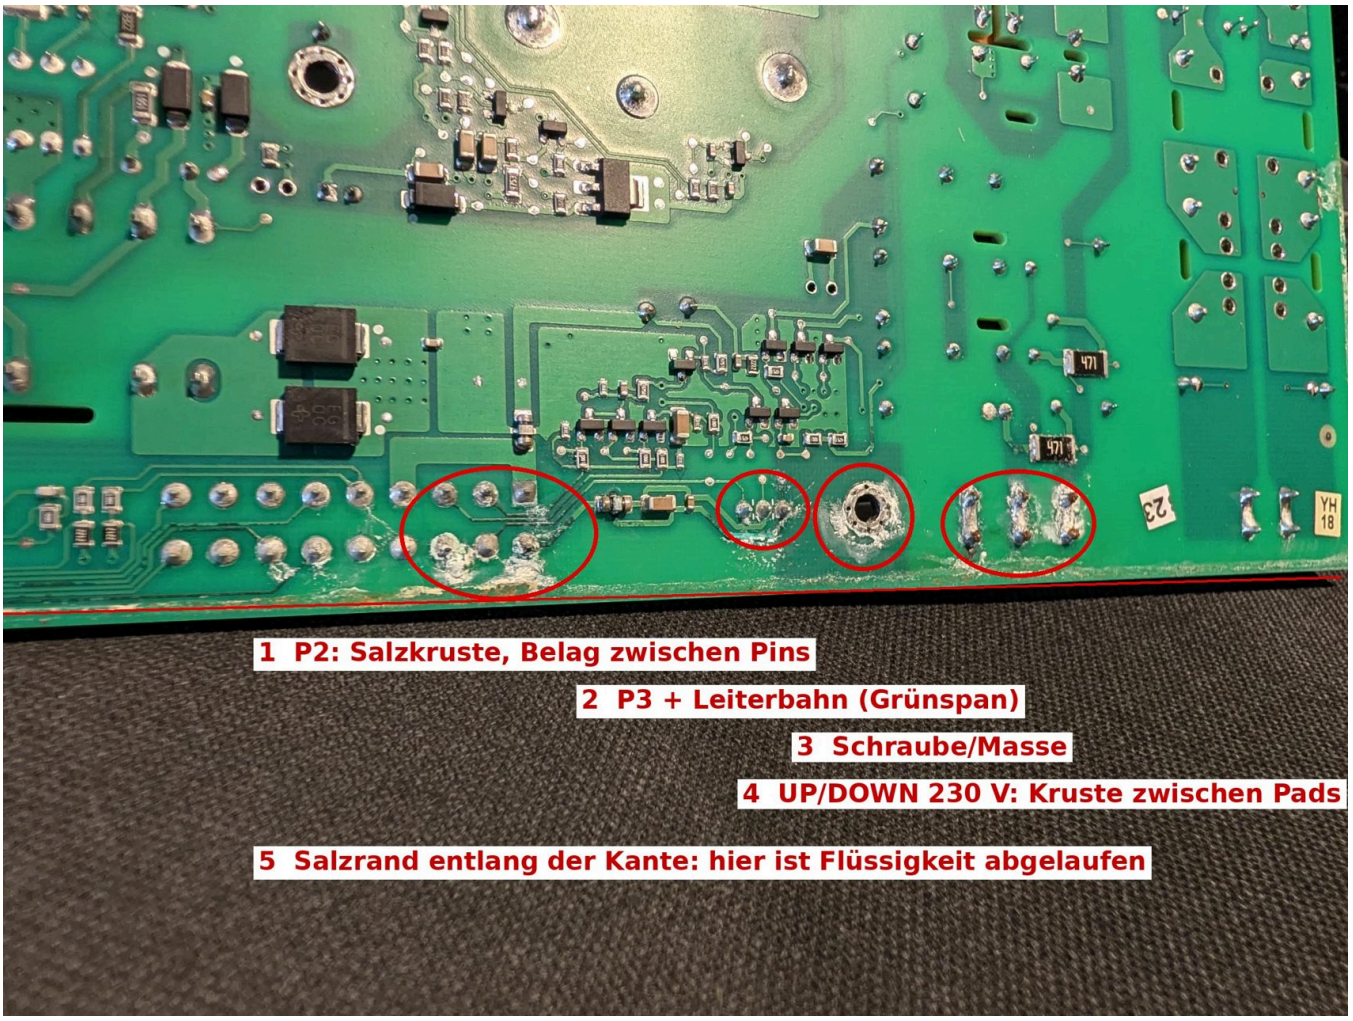
Salt crust between the P2 pins, on P3, at the earth screw and between the UP/DOWN pads; a salt line runs along the whole edge (German labels).

The P2/P4 signals run as a bundle of about 8 traces along the top board edge towards the driver/logic area (100 Ω resistors, "2F" transistors, 4.75 kΩ, 22 Ω). Under the solder mask there are dark spots (corroded copper), rust dots at the edge and a dark deposit on one upper-row P2 pad **[O]**. **Measured 11/08 (13:40):** all P2 and P4 pads on the solder side show 0.3–0.5 Ω

Repair idea if a trace is bad: 30 AWG wire-wrap bridge pad to pad, then seal with UV solder mask or protective lacquer.

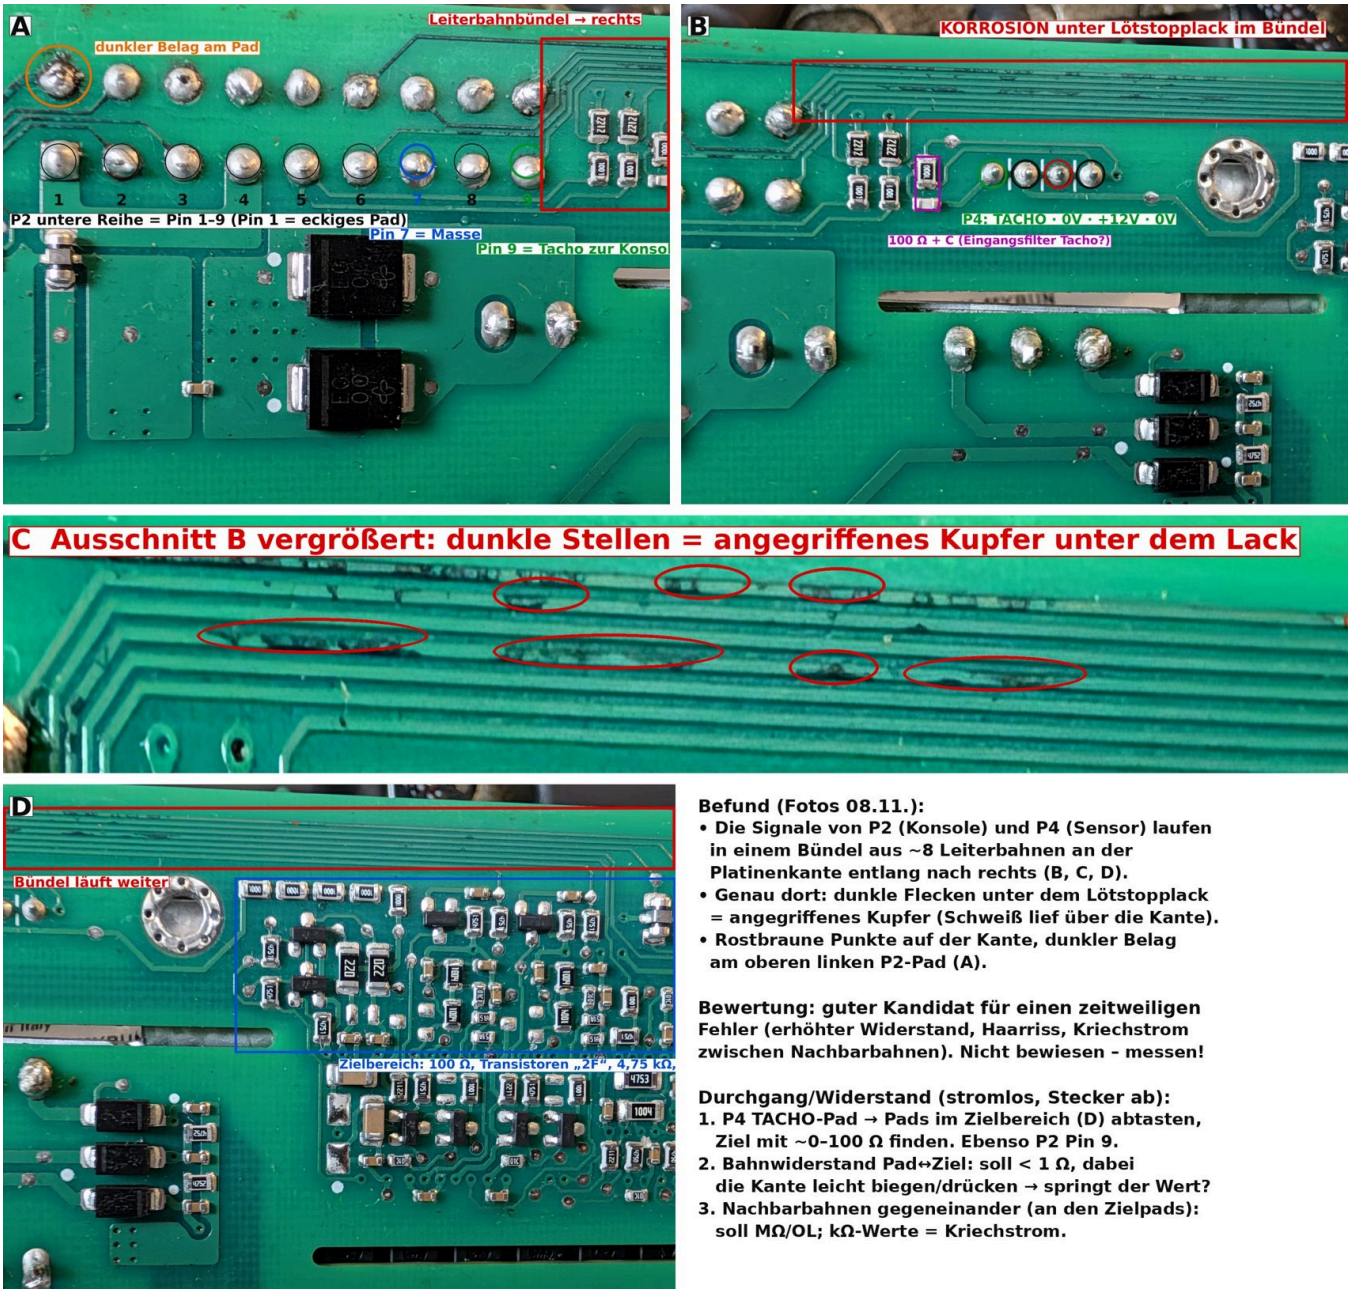
to the next contact, with 0.2–0.4 Ω for the probe tips touching each other, so each trace is continuous to its first component pad (at most ≈0.1–0.2 Ω of trace resistance). That makes an *open* corroded trace unlikely; an intermittent contact under pressure, leakage between neighbouring traces and faults behind the first component are not excluded. Still open: whether the values stay stable when the edge is pressed or bent, and the neighbour-trace checks (OL / MΩ expected).
