Technogym MyRun – lower kit hardware notes (Gefran GIRT S6T30)

Reverse-engineering notes for the lower kit ("GIRT") of a used Technogym MyRun, collected while repairing one unit. There is **no schematic** for this board. Everything below is either measured on this unit, observed (photos, videos, BLE logs), taken from service manuals of related Technogym drives, or marked as inference.

Unit documented: MyRun serial `DCKA2B021008231`, console firmware `WFW0699_BA30.35167`, lower kit Gefran GIRT S6T30, part `0WR01179AG`, board `ECS2458-6` / `ESE6114`, GIRT firmware release 10.05, HW release AG. Name plate: *Gefran Drives and Motion S.r.l., Gerenzano (VA)* (the drives division is now WEG Automation Europe), main power out 0–370 V DC, 1.5 kW **[O]**.

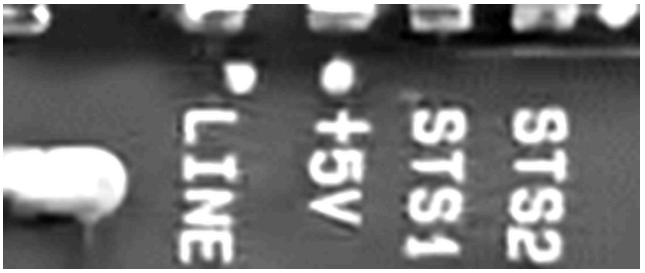
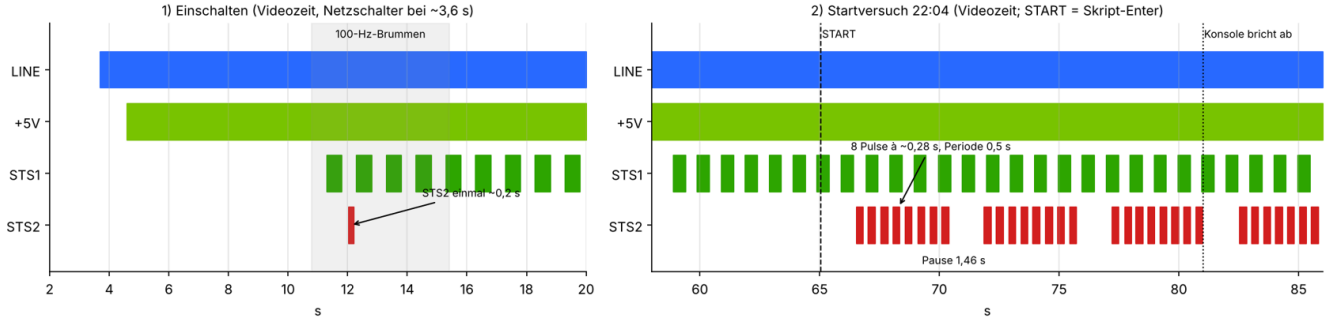
Technogym driver codes (same numbering in four drive generations **[Man]**): 01 OH, 02 OC, 03 UU, 04 OU, 05 ST (serial timeout), 06 PE (EEPROM), 07 EdC1 (incline-motor encoder), **08 belt-motor encoder error**, 09 OtM (motor thermal switch), 10 Oli, 11 OLm, 12 OLr. The mapping "STS2 blinks 8 times = code 08 = encoder" is the most likely reading **[I]** but unproven; no other documented board blinks codes on its STS LED.

Silkscreen: `LINE`, `+5V`, `STS1`, `STS2`.

State	LINE	+5V	STS1	STS2
Boot	on at t0	on at +0.9 s	dark until +7.6 s, then 1 Hz	one 0.2 s flash at +8.3 s
Ready	on	on	1 Hz (0.5 s on / 0.47 s off)	off
Running	on	on	steady on	off
Fault (locked)	on	on	1 Hz	8 pulses (≈0.26–0.31 s on, 0.5 s period), 1.46 s pause, group period 5.33 s

Frame-by-frame timing from phone video **[O]**:

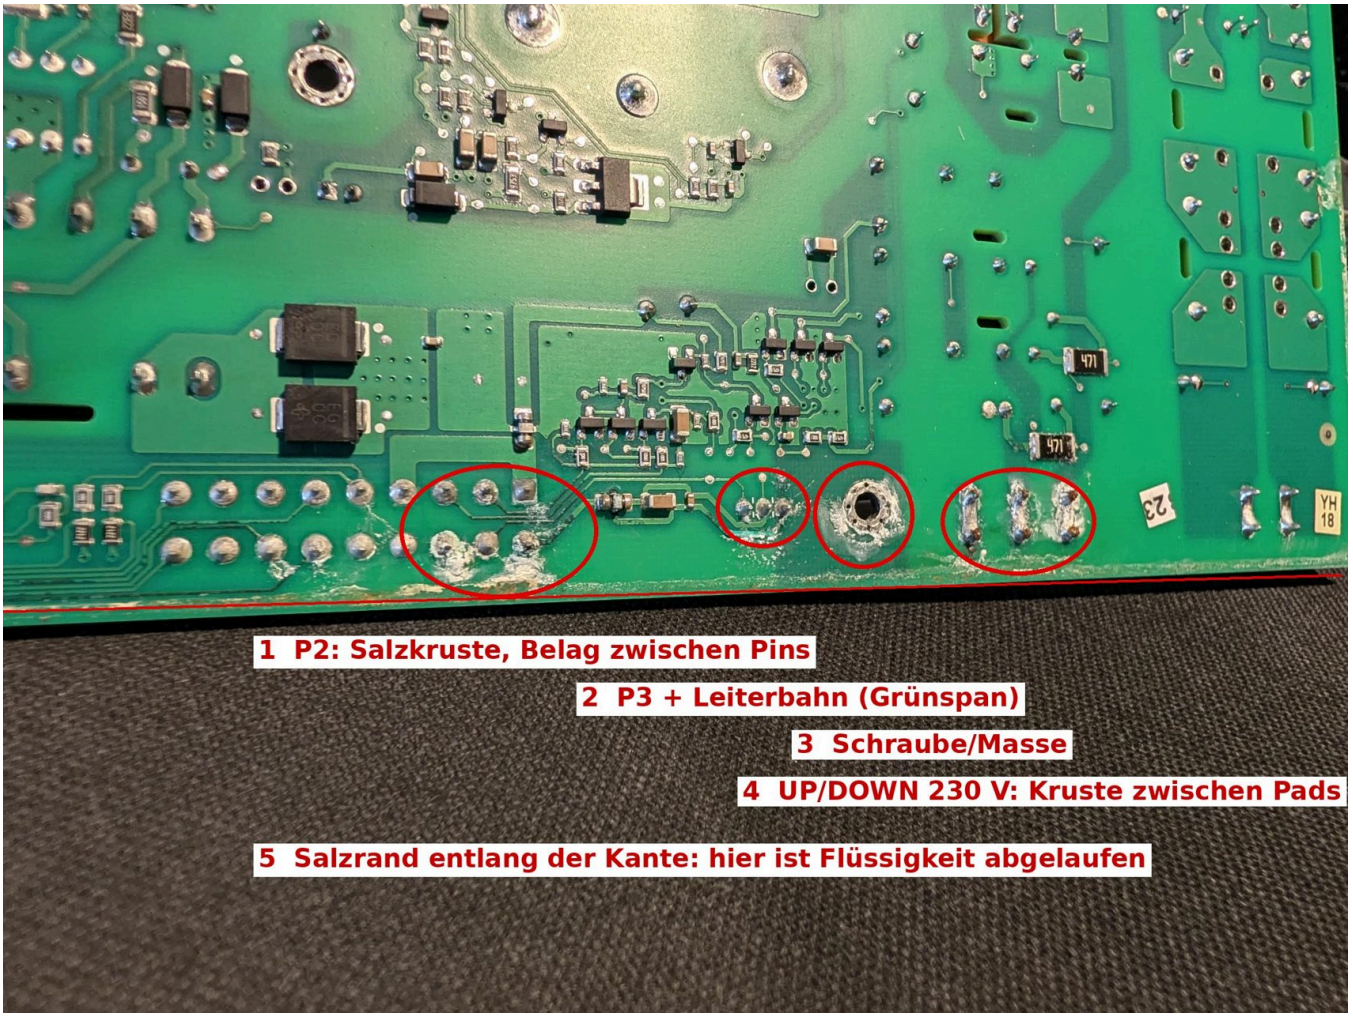
Salt crust between the P2 pins, on P3, at the earth screw and between the UP/DOWN pads; a salt line runs along the whole edge (German labels).

- Incline: missing FUSE MOT replaced (T4A/250 V ceramic, 5×20). Incline test 0 → 2 → 0 % passes.
- Cleaning of salt/sweat residue on the connector edge (isopropanol / water / isopropanol).
- Re-soldered: P2 (all 18 pins), DC MOTOR, UP/DOWN, RT334024 + 68 Ω resistor, bridge rectifier, heat-sink contacts of Q2/D2/D3, all four 4753 resistors with their UJ12 diodes and other suspicious joints. Afterwards the belt ran 95 s once without failing, but the fault came back, so it is not cured.

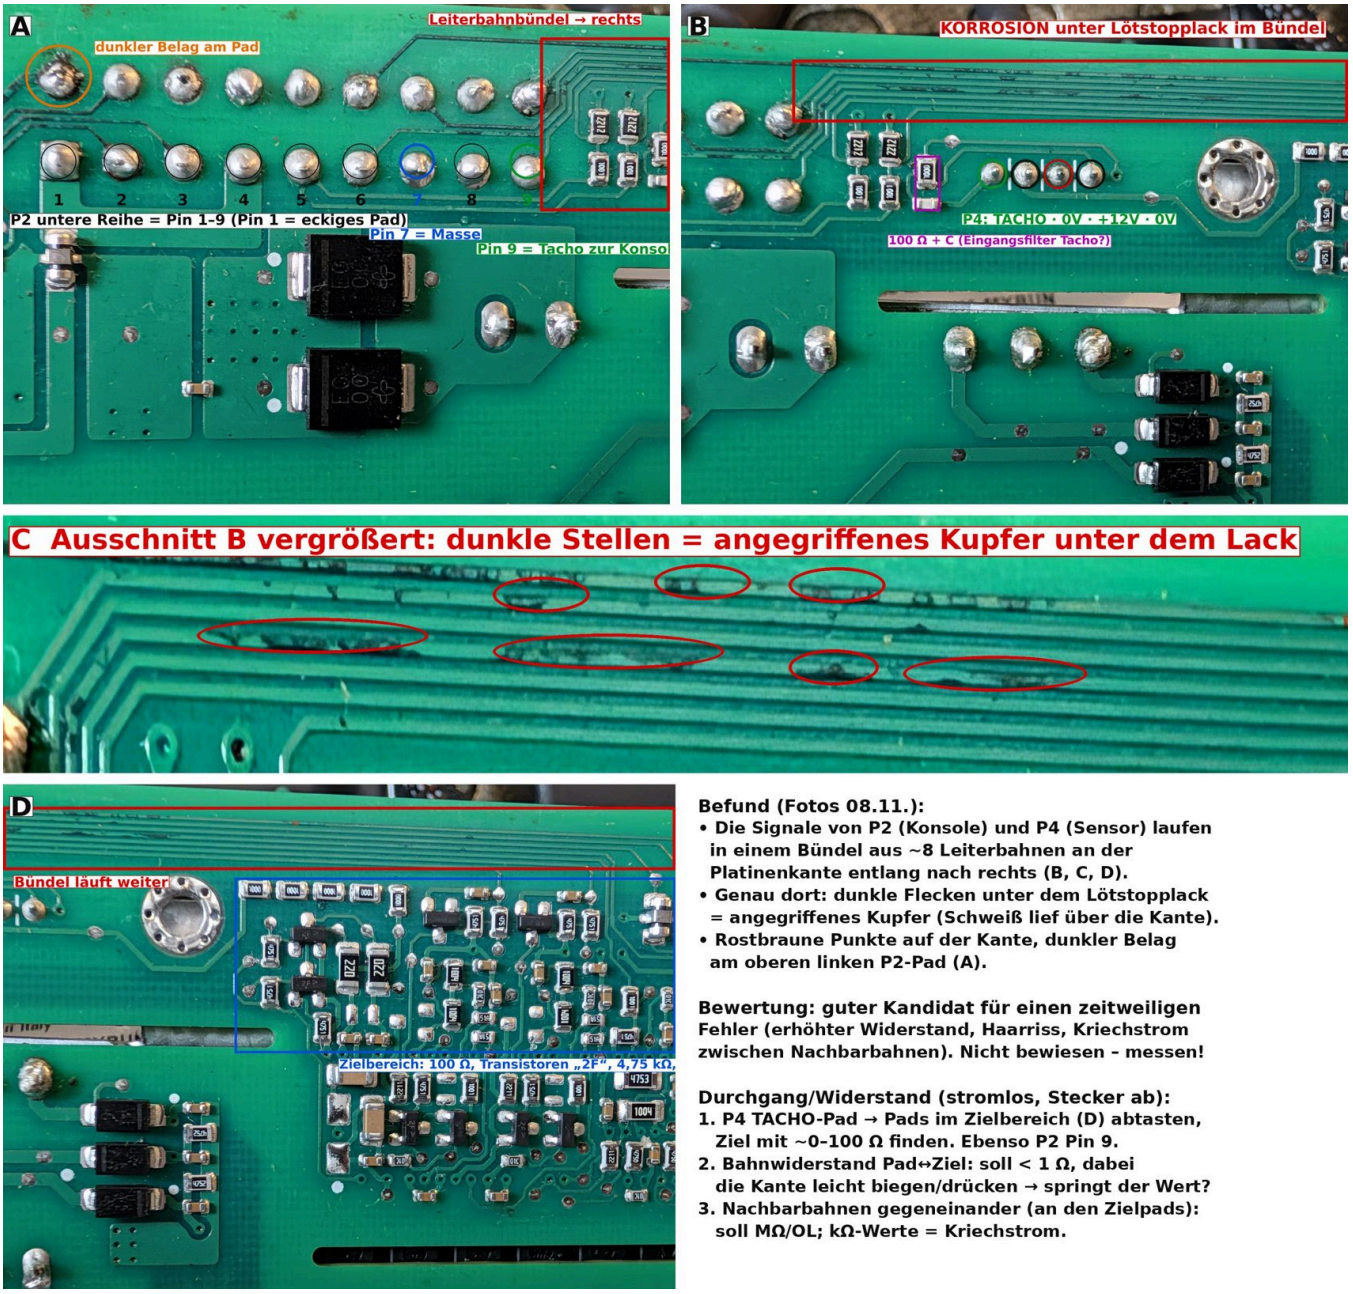
The P2/P4 signals run as a bundle of about 8 traces along the top board edge towards the driver/logic area (100 Ω resistors, "2F" transistors, 4.75 kΩ, 22 Ω). Under the solder mask there are dark spots (corroded copper), rust dots at the edge and a dark deposit on one upper-row P2 pad **[O]**. That these traces are interrupted or leaky is a **hypothesis**; it still needs pad-to-pad continuity (≈0 Ω and stable when the edge is pressed) and neighbour-trace checks (OL / MΩ).

Repair idea if a trace is bad: 30 AWG wire-wrap bridge pad to pad, then seal with UV solder mask or protective lacquer.
