DISTRESSES IN THE PAVEMENTS (BIOTECHNOLOGY COMPLEX TO MARRIED SCHOLAR HOSTEL)

K.MUKUNDA REDDY (194104520)

FOR COURSE CE585 – CREDIT SEMINAR

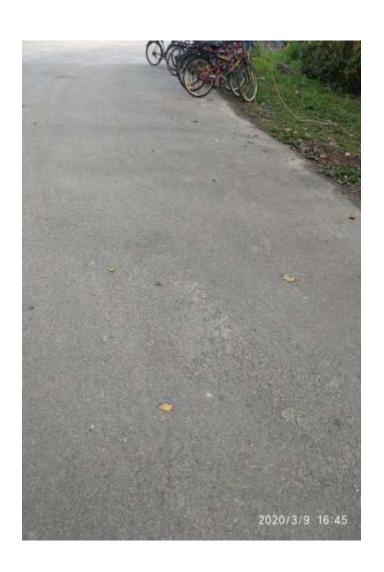
CORRUGATIONS

Cause :Due to lack of bond between asphalt & surface course mixes.

Due to braking and accelerating actions.

frost and heave of subgrade layer due to drainage problem.

Treatment: These have to be milled off and replaced with highly stable asphalt mix. And proper drainage facility
