Customer: RALEC KUNSHAN		Date: 26-May-16	Time: 14:30
Participant From Maruwa	Participant From Organizer	Report To	
1. Mr Ogawa MM MD	1. Mr Spring R&D Chief	1. Mr.Anthony,Mr.Ogawa	
2. Mr Takimoto Shanghai Sales	2. Ms Lee IQC SUPV	2. Mr.Seeni,Mr.Naga,Mr.Sinna	
3. Mr Matsumoto JM Sales	3. Mr Gao IQC Chief	3. Mr.Theva,Mr.Shahrudin,Mr.Fauzi	
4. Sivakumar MMSB QA	4	4 Mr. Matsumoto	
5. Ronny Fang Shanghai Sales	5.	5.

RALEC facing 2 technical problem

1. RA12-4

Slit line width unbalance

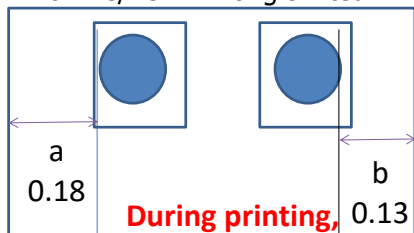
1st Slit & 2nd Slit shows the width imbalance. Potential Failure is

a. Slit's V Groove different size

1st Slit

Centre slit

=> Mould 1st slit repaired after pressing some qty

=> Noticed shedder mark on product

This causes need to be checked before concluding

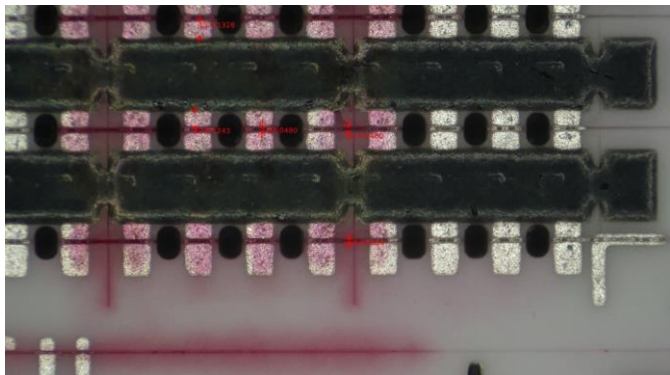
No	Complaint / Request	Product	Image	Details	MARUWA Comment	PIC	DATE
1	Slit width NG	RA12-4		Slit size different compare to the standard size. Standard: 40u Actual: 110u Failure % : 30%	Received NG Sample and will review the NG Suspected: a. Mould overshoot b. Slit unbalance - 1st slit repaired	Mr Izumo Mr Naga	ASAP
2	Lot No indication	All product			Maruwa will include small label on bundle from April 16 shipment onwards	Mr Peter (warehouse)	April 2016 shipment
3	Printing unbalance	MA02-2C MA02-4C		After printing, printing area no balance between the hole.	Need to confirm the thru hole shifted spec from 30u to 20u	Mr Muto Mr Naga	ASAP
4	Angle (+/-)	7910M		5K Sample evaluated => Result OK Request : 50kpcs	Result OK	Mr Nazli	June'16
