Customer Visit Report

MM-IN-RD-9100-P06-04
Rev: 1

Customer: Haemonetics Penang				Date: 22-Mar-23	Time: 9:15
Participant From Maruwa		Participant From Organizer		Report To	
1. Mr Siva	Maruwa Malaysia	1. Mr Allan	Plant Director	1. Datuk Anthony & Mr Sasaki	
2. Ms Adibah	QA	2. Mr Saw	Engineering Mgr	2. Mr Sinna & Mr Nazli	
3.		3. Mr Chun Seng	Engineering	3. Mr Okui & Mr Kitauji	
4		4 Ms Wen Chee	Purchaser	4 Mr Sathia & Ms Pang	
5.		5. Ms Sim	Material Planner	5. Mr Mori & Mr Ogawa

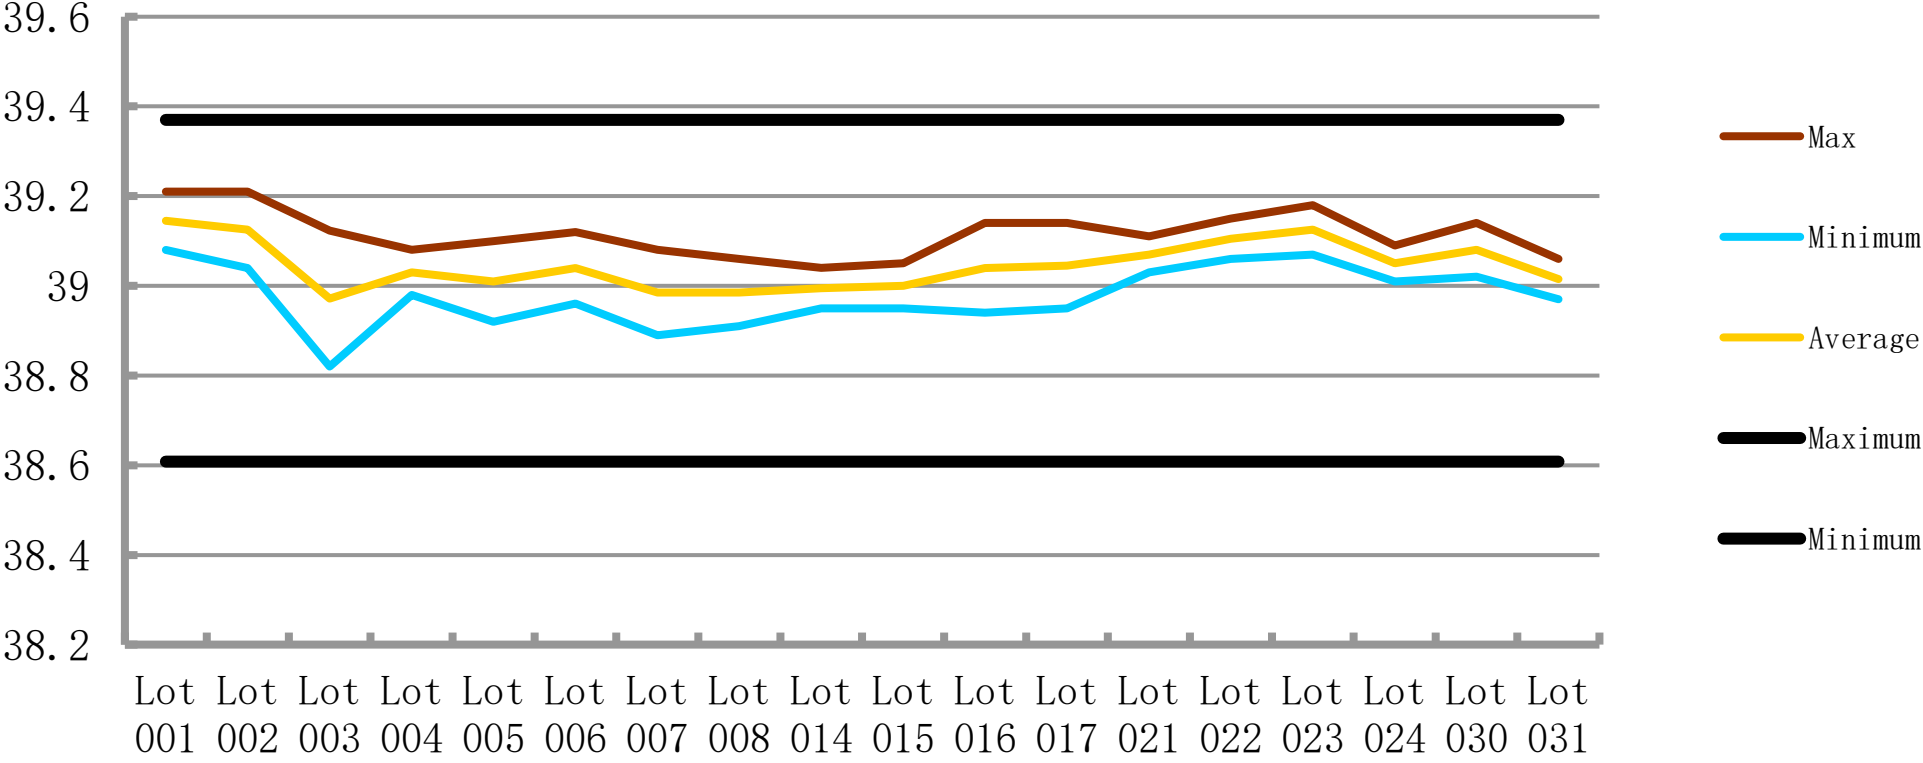
Mr Alln commented that Maruwa's product yield have improved from 90% => 96%. Maruwa need to further improve on the dimension & product angle.

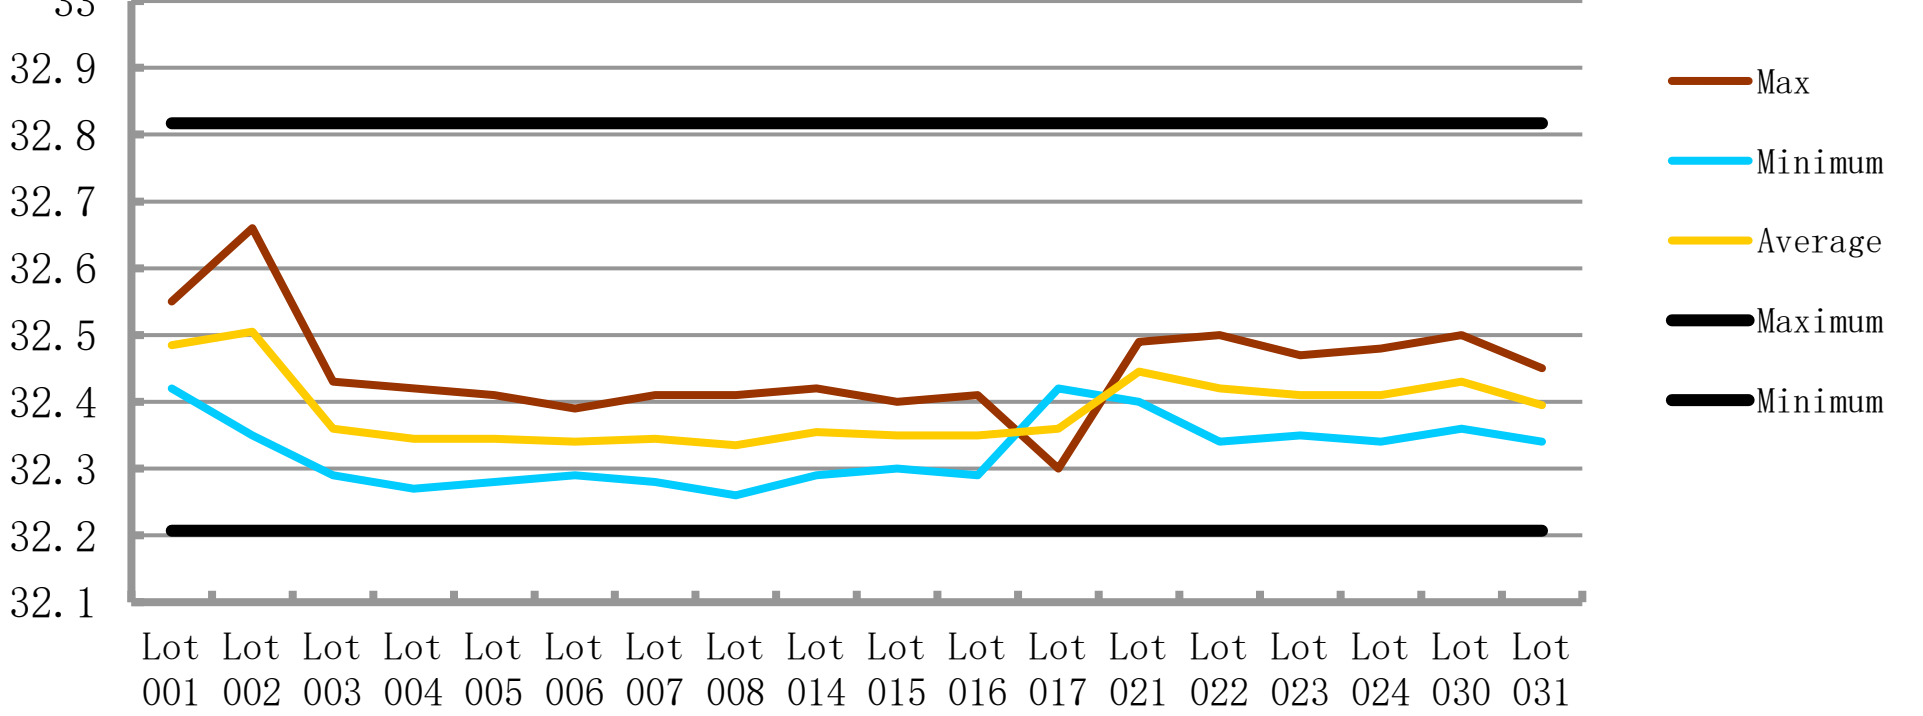
Outer Diameter 2 SPC Trend

OD 2 - Product placement on the seal crown is tilted due to Maruwa's dimension is at the min which need to be improved.
