Supplier Visit #2

CDCQ Press/Mould– Foshan

Date: 18/Feb

New 20ton (2U/2D) Press machine

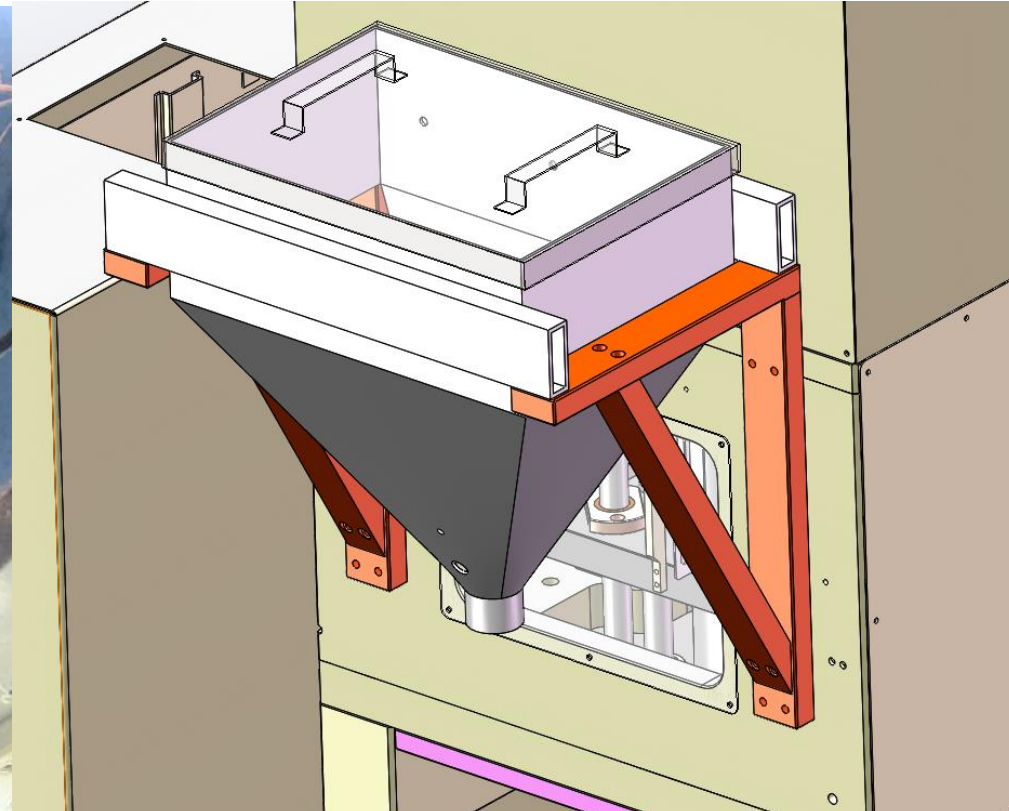
Powder rubbish hopper - Need to add in

Increase the hopper capacity to 80KG
将料斗容量增加到80公斤

回复: **80KG**太大没有位置放
料斗容量变更为**40KG**

Re: 80KG is too big and there is no place to put it
Hopper capacity change to 40kg

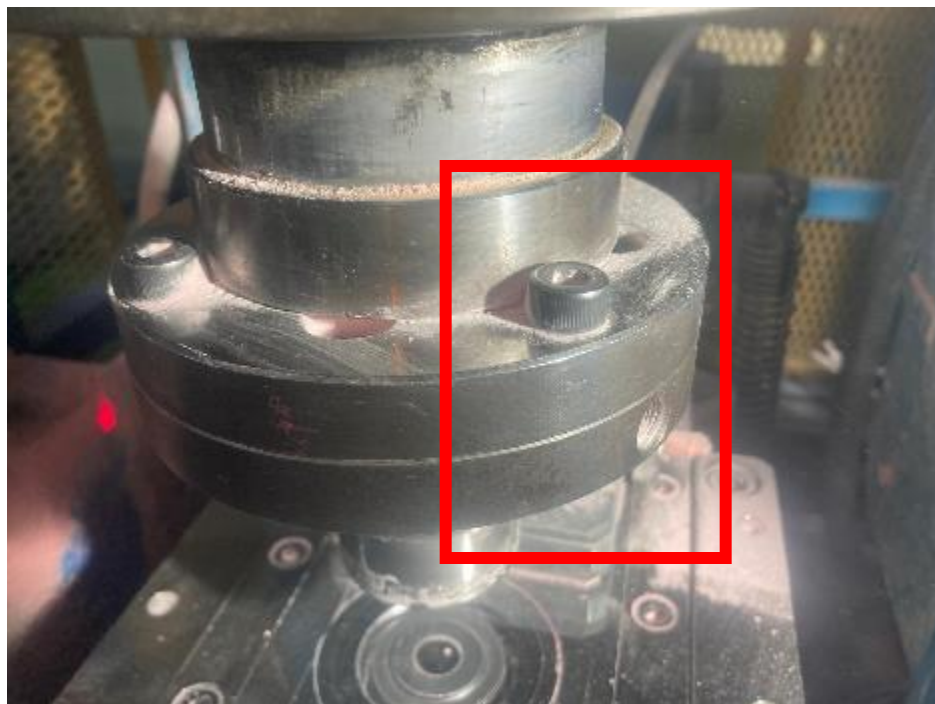
TAMAGAWA

- The alignment shifts during pressing or after exceeding the maximum load by double pressing. The screws come loose (M6 -> M8).
- When setting up the upper punch, it is difficult to align the screw by turning it downwards.

Require similar like Tamagawa

Re: Will comply as per
Maruwa request

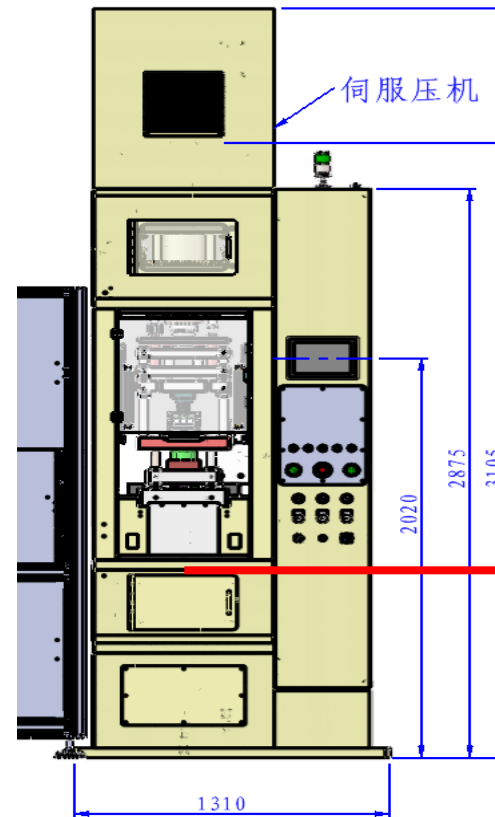
d. Equipment – panel position 回复: 取料机建议放到机台左侧, 方便换模具及操作机台
 Re: It is recommended to put the reclaimer on the left side of the machine to facilitate the change of mold and the operation of the machine

Max limit
 → No any gauge
 below this line

**Please provide the layout drawing*

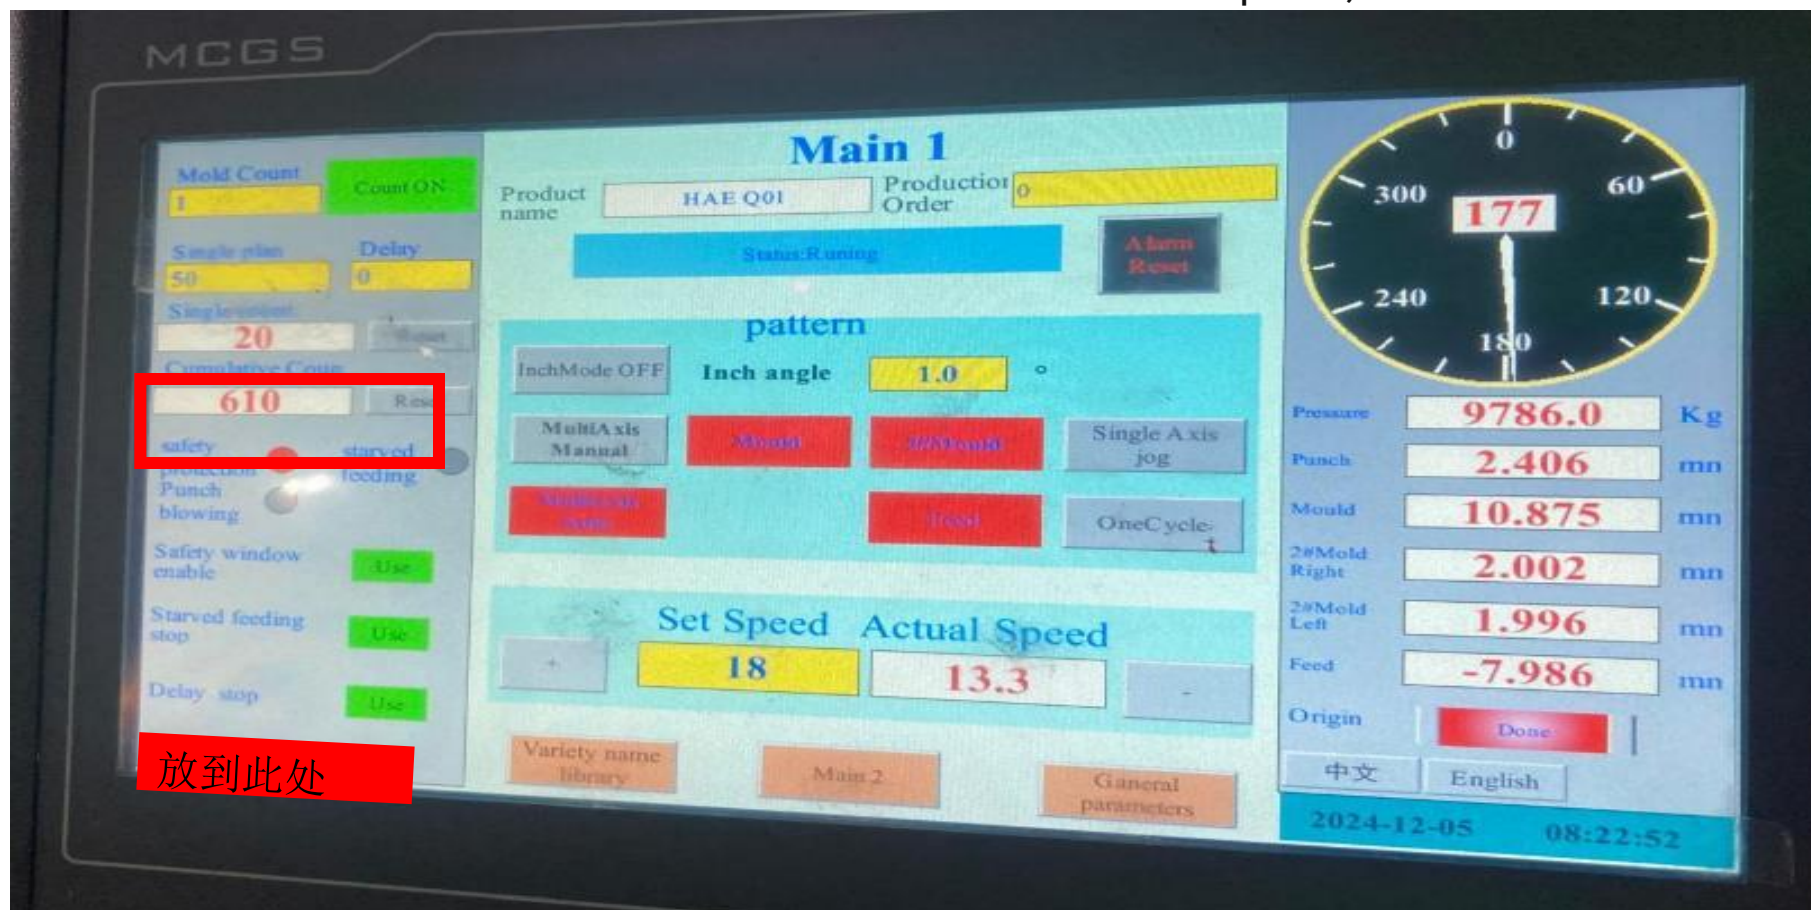
Maruwa requesting the die plate groove angle to be in the range of $6.6^{\circ} \sim 7.0^{\circ}$
=> Final angle will be 6.8°

The operator mistook it for the mold cleaning counter and reset it.

→ A confirmation screen is required for mould cleaning

→ Relocate – mould cleaning button separately : operator always mistake

Re: Location update, intent will be shown later

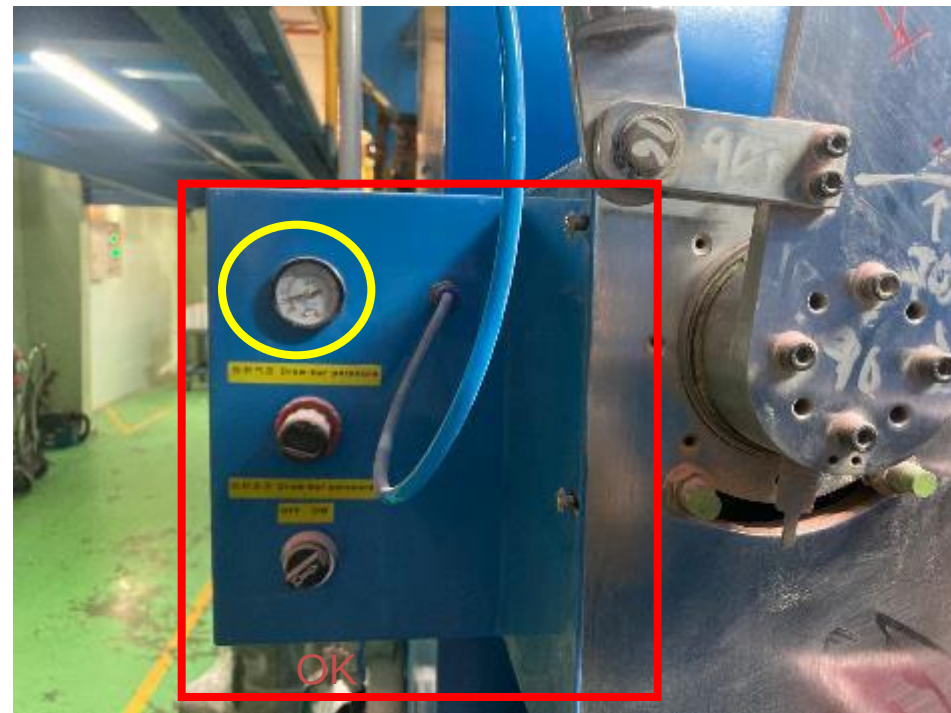
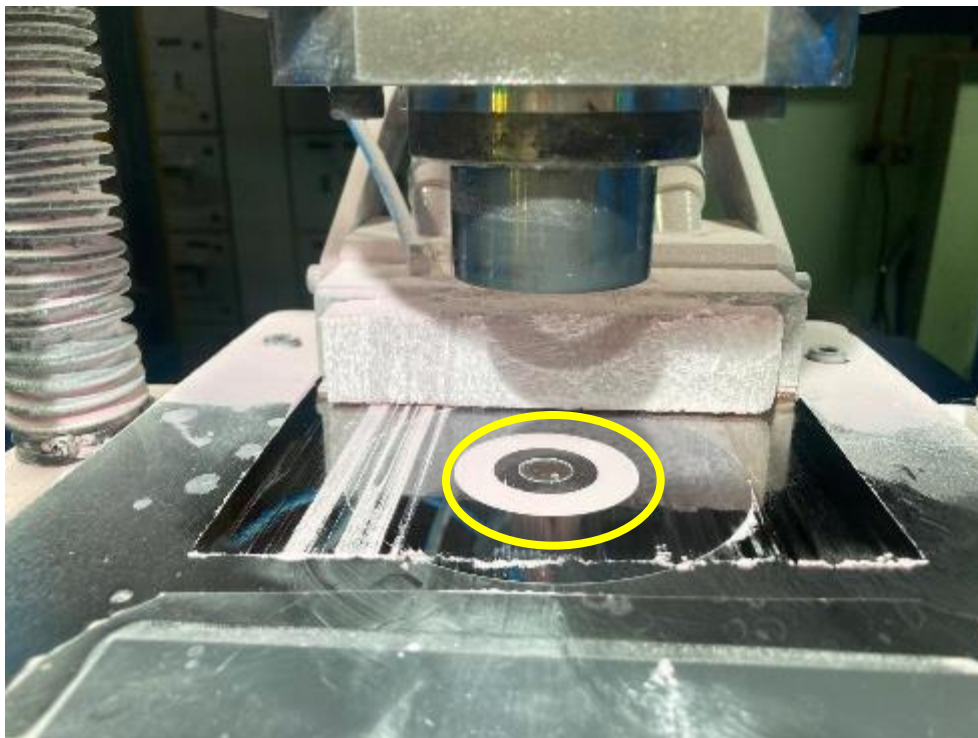
- powder filling unbalanced after increased machine speed
- Abnormal sound from feeder box when feeder go front (The time when pressure is high)

Re: It has something to do with the fluidity of the powder, and the powder cartridge of the new machine should be high

After-sales tracking, the new machine is processed before it is released

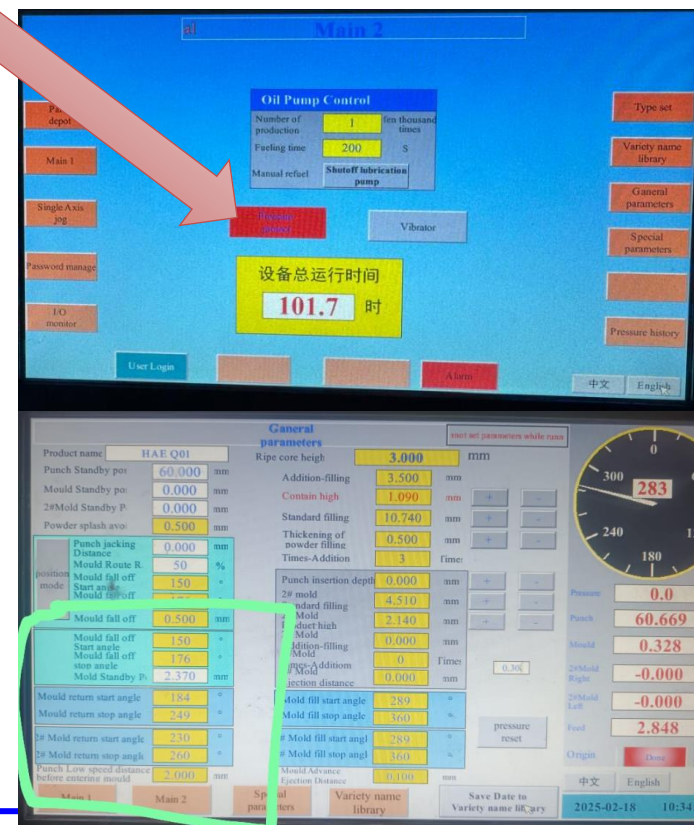
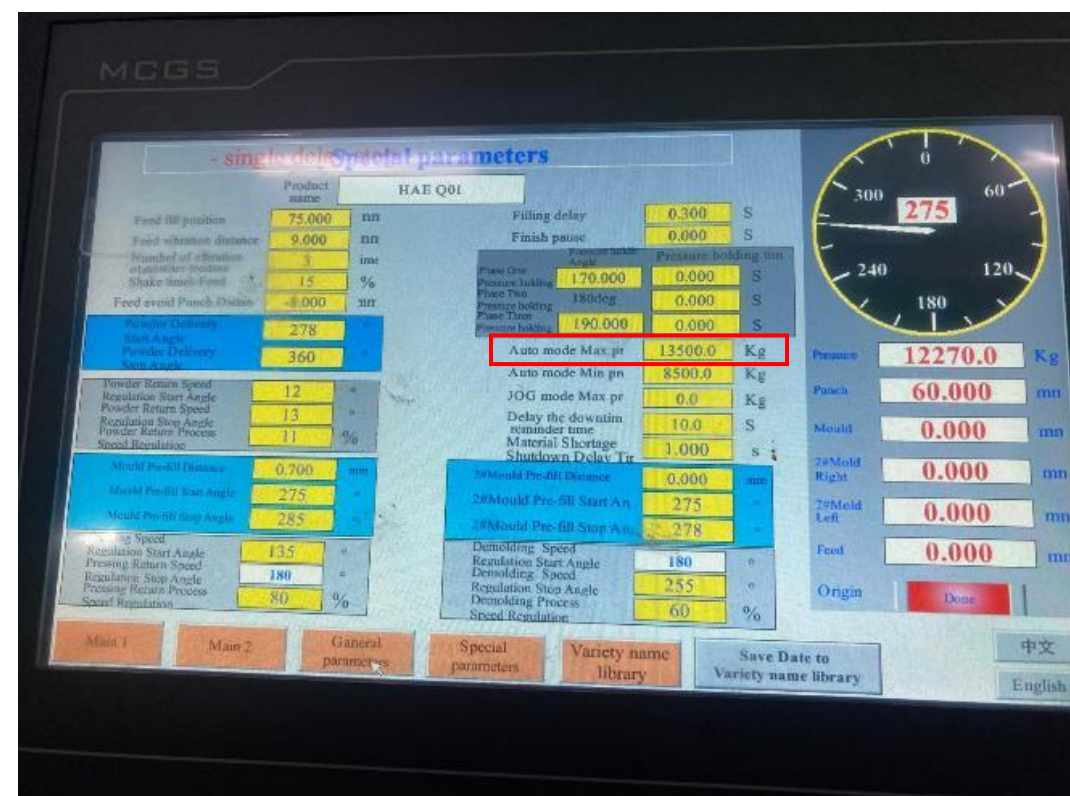
- It will be possible to control the pressure input.
- It will make an emergency stop the moment the pressure reaches this level or exceeds this level. The current function is slow to stop, and will only make an emergency stop once the pressure reaches 15 tons, 19 tons or more.

? **Need to add in auto stop when exceed setting spec**

Re: The pressure setting not activated → will update the software for to enable & disable

Similar software will be update for DP21

All parameter setting will be protected with password where the login will be recorded in the log

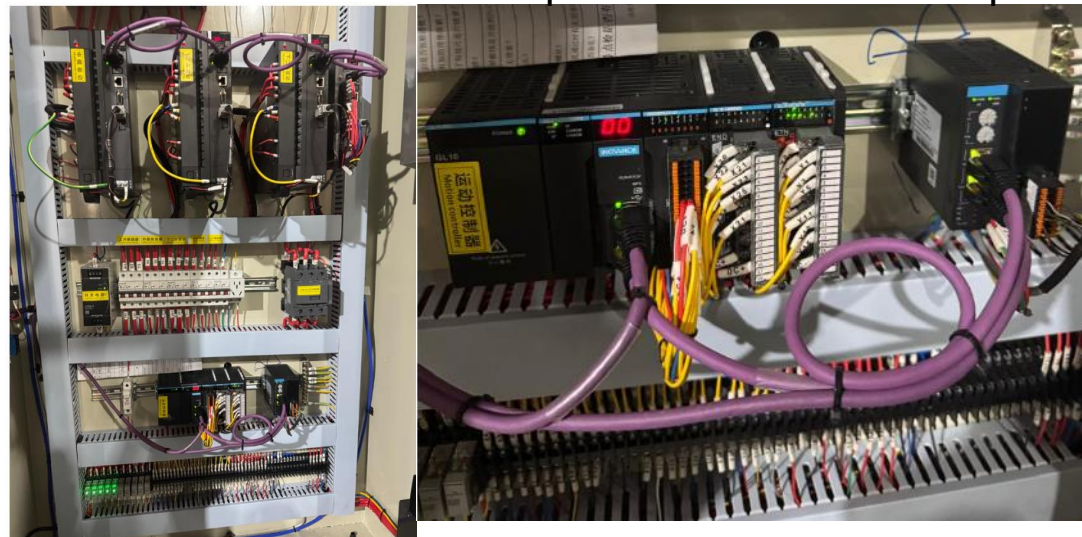
IoT – PLC Setting Parameter Info

IP address : 192.168.3.123
Subnet : 255.255.255.0
Gateway: 192.168.3.254
Port No : **Not available**
Tag No : **Not Available**

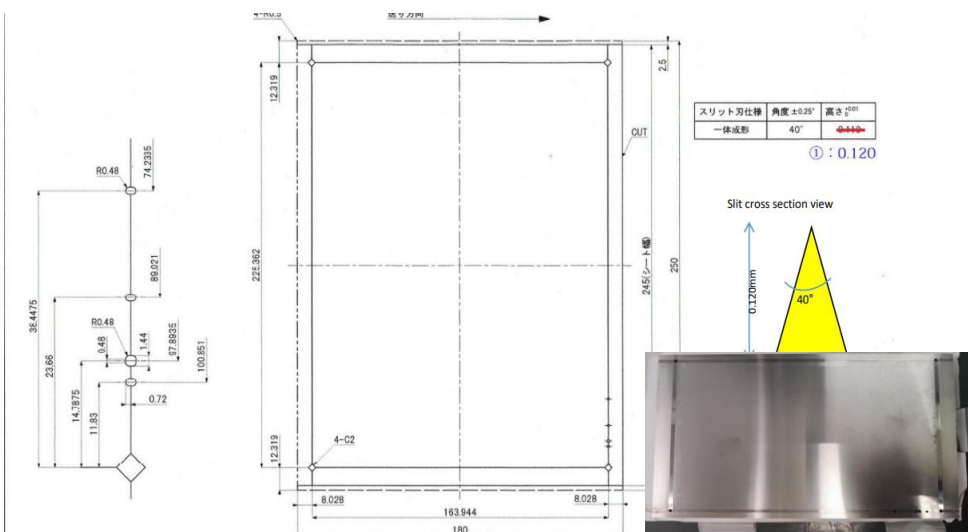
MPS276-D02 : MOEN Fix

⇒ No abnormal on dimension

⇒ Sharp edge on upper punch
