Supplier Visit #2

CDCQ Press/Mould– Foshan

Date: 18/Mar

New 20ton (2U/2D) Press machine

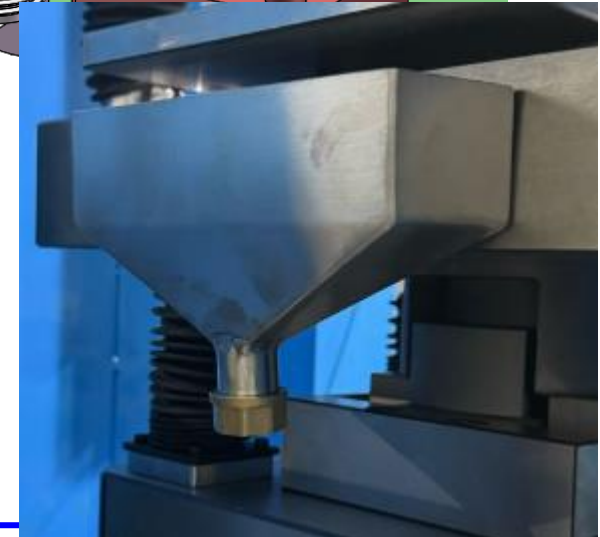
Powder rubbish hopper - Need to add in

回复: 20T-C06机型上追加

Re: Added on the 20T-C06 model

Fix as per
requested

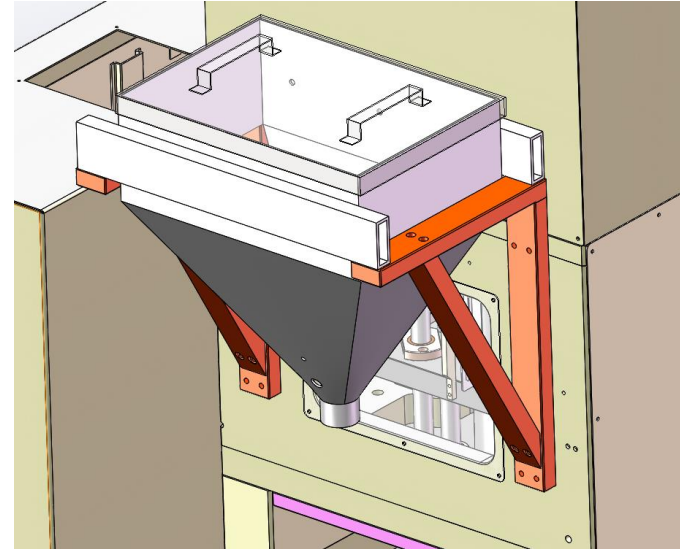
Increase the hopper capacity to 80KG
将料斗容量增加到80公斤

回复: **80KG**太大没有位置放
料斗容量变更为**40KG**

Re: 80KG is too big and there is no place to put it
Hopper capacity change to 40kg

**OK
Completed**

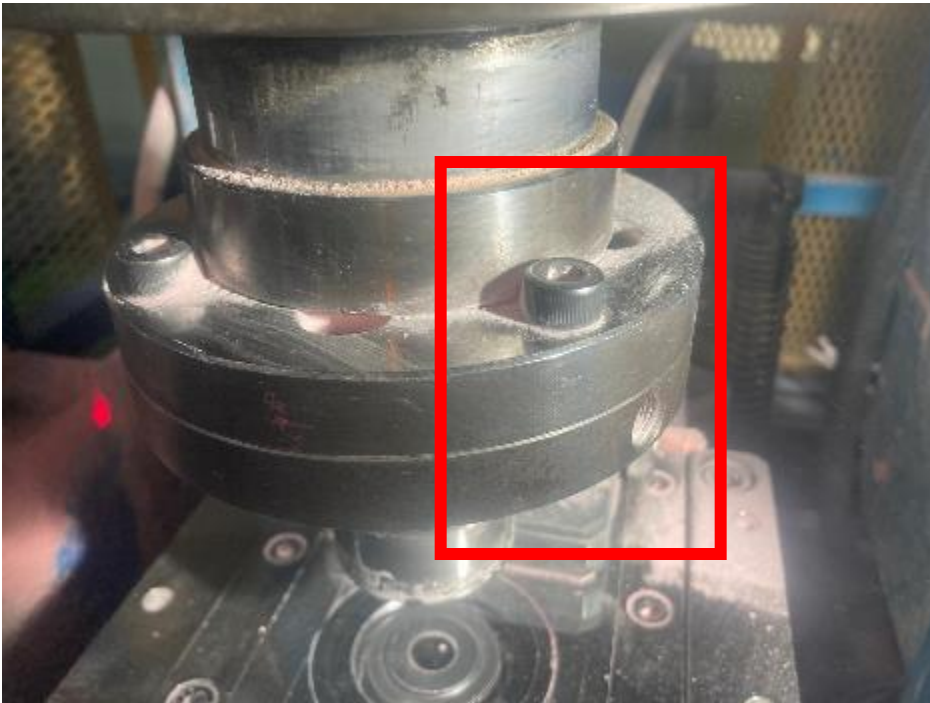
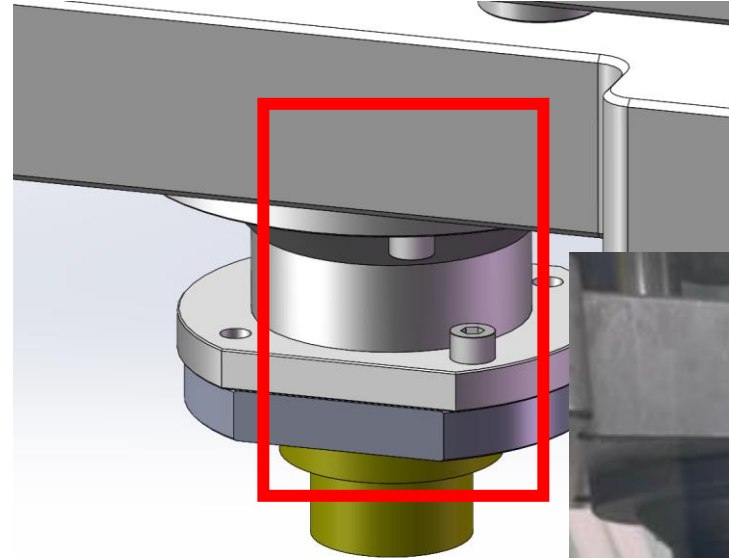
- The alignment shifts during pressing or after exceeding the maximum load by double pressing. The screws come loose (M6 -> M8).
- When setting up the upper punch, it is difficult to align the screw by turning it downwards.

Require similar like Tamagawa

Re: Will comply as per Maruwa request

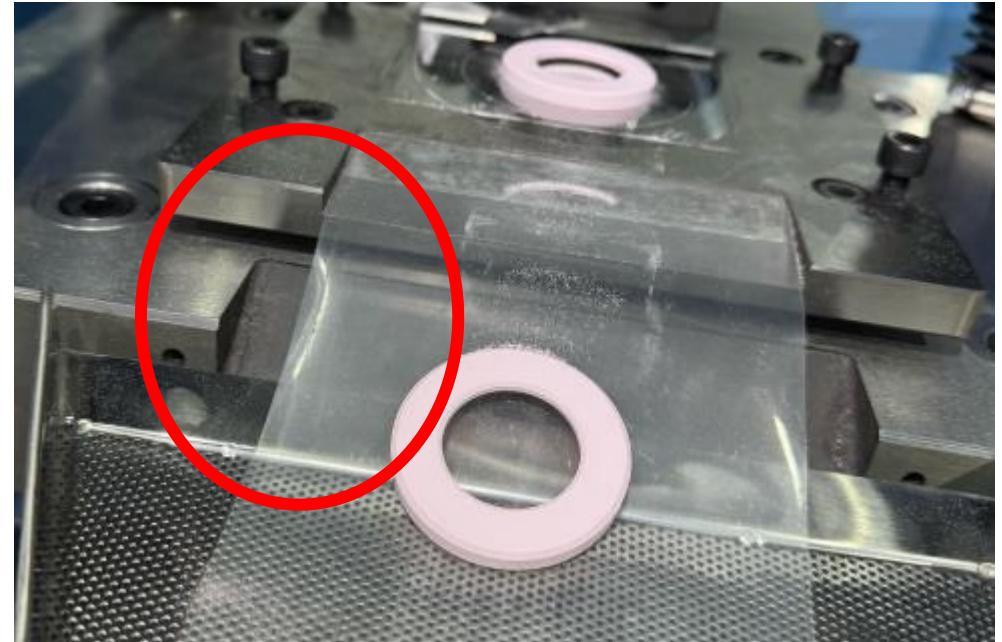
Max limit
 → No any gauge below this line

Maruwa requesting the die plate groove angle to be in the range of $6.6^{\circ} \sim 7.0^{\circ}$
=> Final angle will be 6.8°

OK

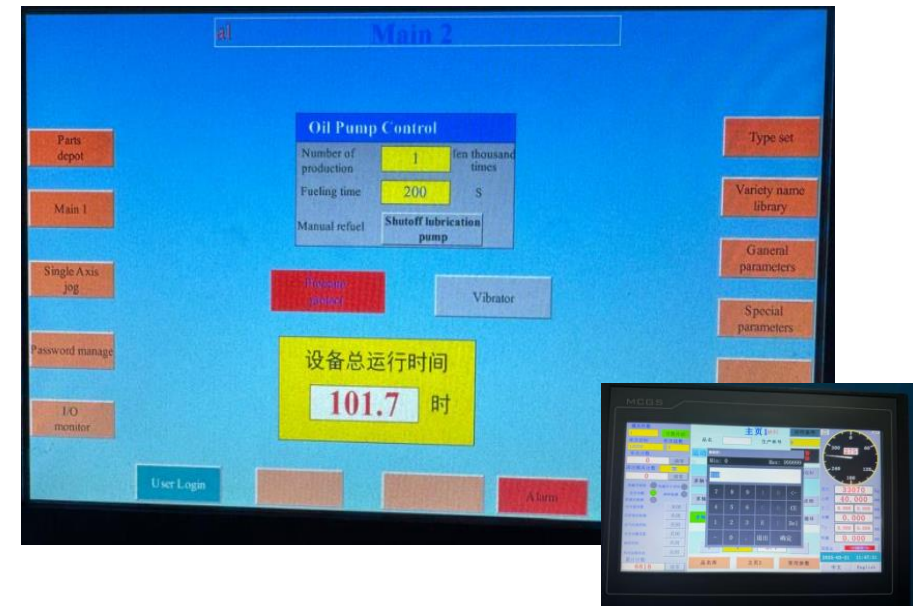
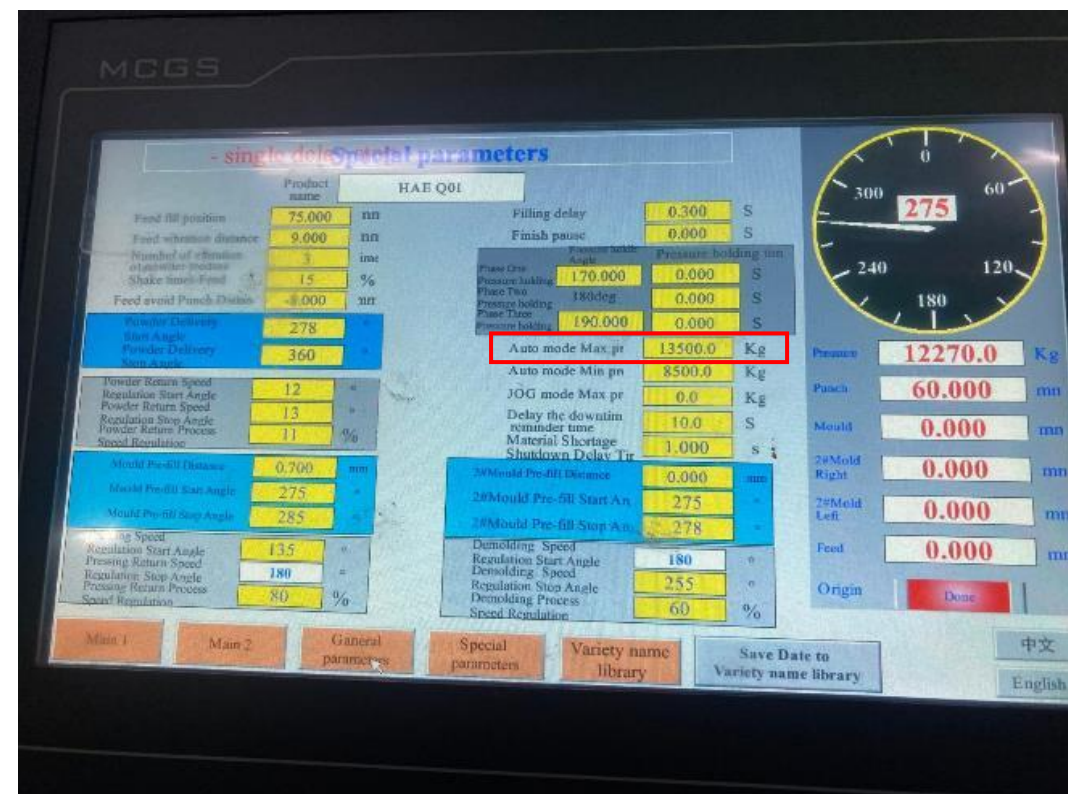
The operator mistook it for the mold cleaning counter and reset it.

- It will be possible to control the pressure input.
- It will make an emergency stop the moment the pressure reaches this level or exceeds this level. The current function is slow to stop, and will only make an emergency stop once the pressure reaches 15 tons, 19 tons or more.

Need to add in auto stop when exceed setting spec

→ A confirmation screen is required for mould cleaning

→ Relocate – mould cleaning button separately : operator always mistake

Mould cleaning reset button separate with quantity reset

Re: The pressure setting not activated → will update the software for to enable & disable

All parameter setting will be protected with password where the login will be recorded in the log

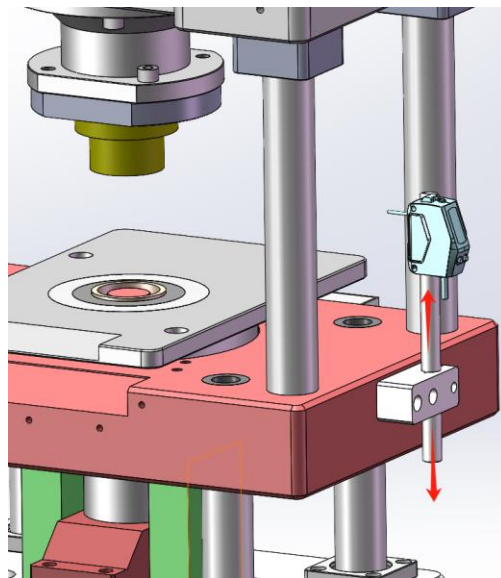
b. Barrier sensor – Custain sensor 回复: 新设备安装安全光栅 (OK)

Completed barrier sensor

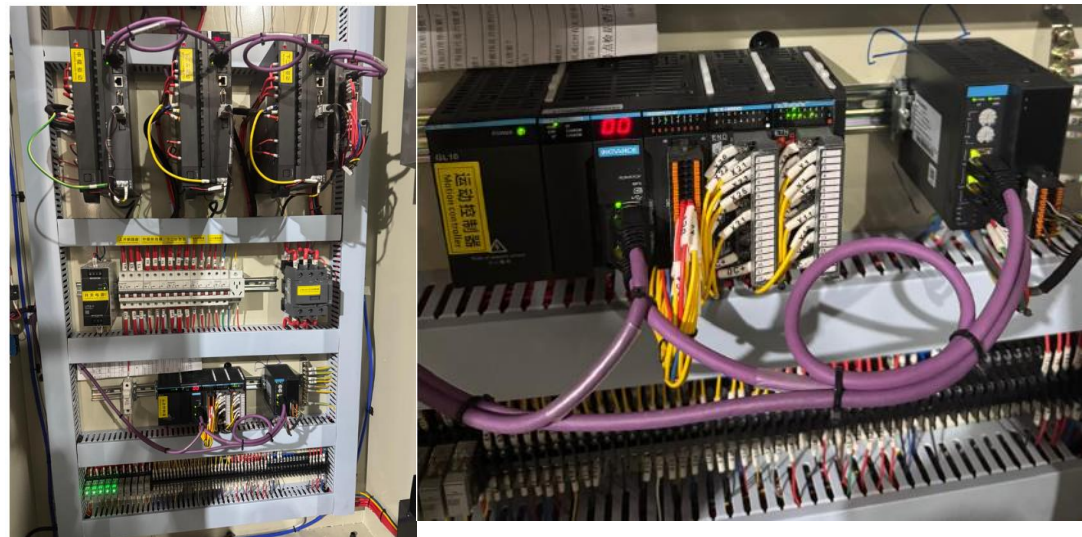
IoT – PLC Setting

Parameter Info

IP address : 192.168.3.124 & 125

Subnet : 255.255.255.0

Gateway: 192.168.3.254

Port No : **8005**

Tag No : **provide later**
