MONTHLY REPORT · OCTOBER 2026 · HUAWEI FUSIONSOLAR

Optimizer review: all 8 panels healthy

Module-level check of the 5.12 kWp health centre plant · Chiang Mai province · lifetime, 2026 and October 2026

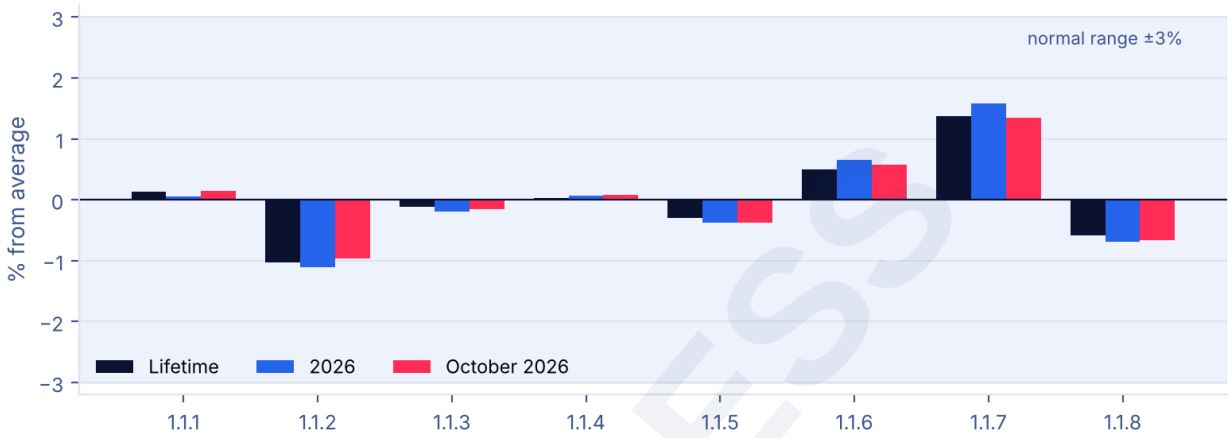
Each panel on the roof

Panels on the roof, with each optimizer's lifetime yield (blue = within ±1% of the average)

A failing panel or optimizer drifts further below the others over time. Here 1.1.7 always leads and 1.1.2 always trails by the same small margin, which is normal factory tolerance in panel power.

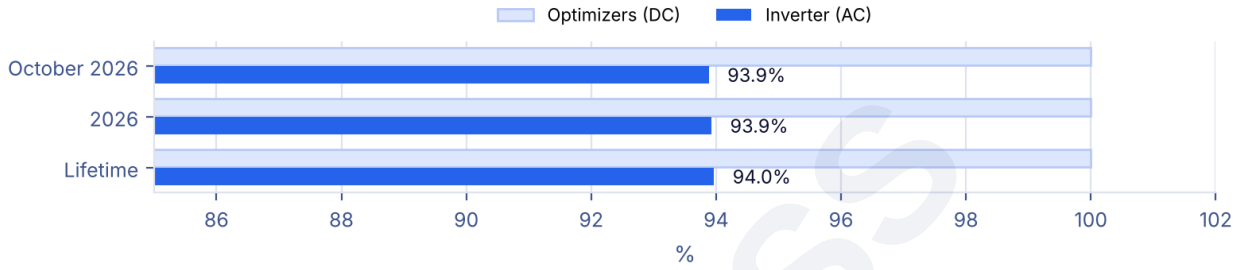
From the panels to the inverter

The inverter records about 94% of the energy the optimizers report, the same in every period. About 96–97% is typical, so roughly 3% is unaccounted for. It may be a difference between the two meters, but it is worth tightening the DC connectors and checking the cable run on the next visit.

2 · CHECK
DC connectors and cable
Look for the missing ~3%
