Home H4, Samut Songkhram

Very low yield – 0.7 kWh/kWp

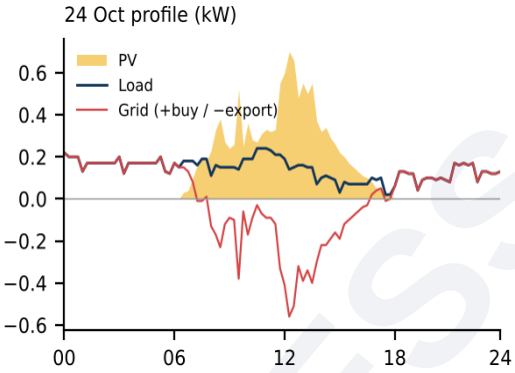
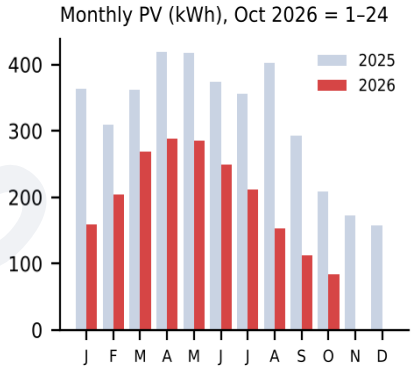
• It made only 83.7 kWh in 24 days, or 0.70 kWh per kWp per day. A healthy system makes about 4–5 (Home H6 made 5.1).

• At 10:00 on 25 October the inverter was putting out 0.26 kW from 4.995 kWp. Home H6 was putting out 2.5 kW from 5 kWp at the same time.

• The monthly yield is falling: 288 kWh in April and 285 in May, then 249, 211, 153 and 112 kWh, and now 84 kWh in October. Even its best month in 2025 (418 kWh) was low.

• There was a grid fault on 8 October (undervoltage, Grid Failed and a power meter fault). The meter and export data look normal now.

1. Site check: look for shading from trees or new buildings, heavy dirt, and burnt or loose MC4 connectors. Measure the open-circuit voltage of each string.

2. Compare the string voltage with the design. If one string is open-circuit, the inverter will be running on only part of the array.

3. Clean the panels and trim any trees, then check the yield again after 1 week.
