Laundromat, Songkhla

Offline since March 2026 – check if replaced

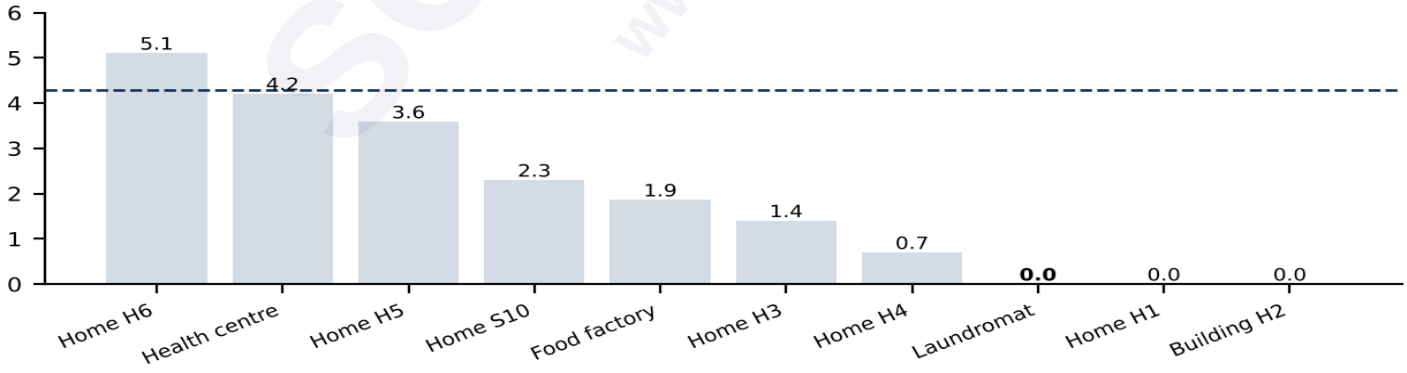
How this plant compares (kWh/kWp per day, 1–24 Oct)

Rank 8 of 10 Huawei plants. Dashed line = expected 4.3 kWh/kWp per day.
