SOLAR ESS MONTHLY REPORT · OCTOBER 2026 · SOLISCLOUD · PLANT REPORT

Restaurant A, Pathum Thani

24 kWp · 20 kW 3-phase hybrid inverter · no battery

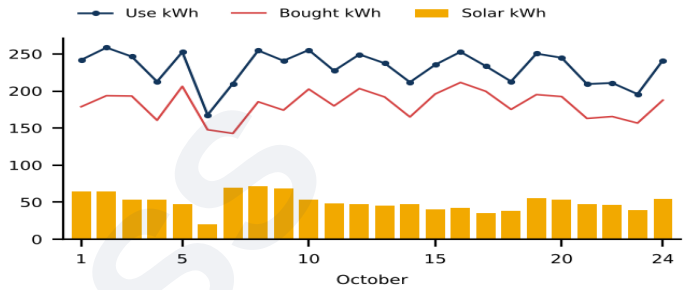
24 October, 5-minute data

About ⅔ of panels not producing

• 24 kWp but only 8.3 kW peak on 24 Oct (0.35 kW per kWp) while the restaurant was importing 15–18 kW – nothing should be limiting the panels.
• Yield 2.1 kWh/kWp/day against 3.8–4.0 at similar central/northern sites.
• Solar covers only 21% of a very large load (231 kWh/day).

• Site check of every string: DC isolators, fuses, MC4 connectors and MPPT input currents; one or two strings are probably disconnected or tripped.
• Expected gain once fixed: about 1,300–1,500 kWh/month.
