Monthly Report: an AC-Coupled Inverter That Stopped and How the Hybrid's Data Showed It

Rev01 · 10 November 2026 · Monthly Report · 14.19 kWp solar with battery, zero export · a shop in Surat Thani province · Data: SolisCloud, April – 10 November 2026

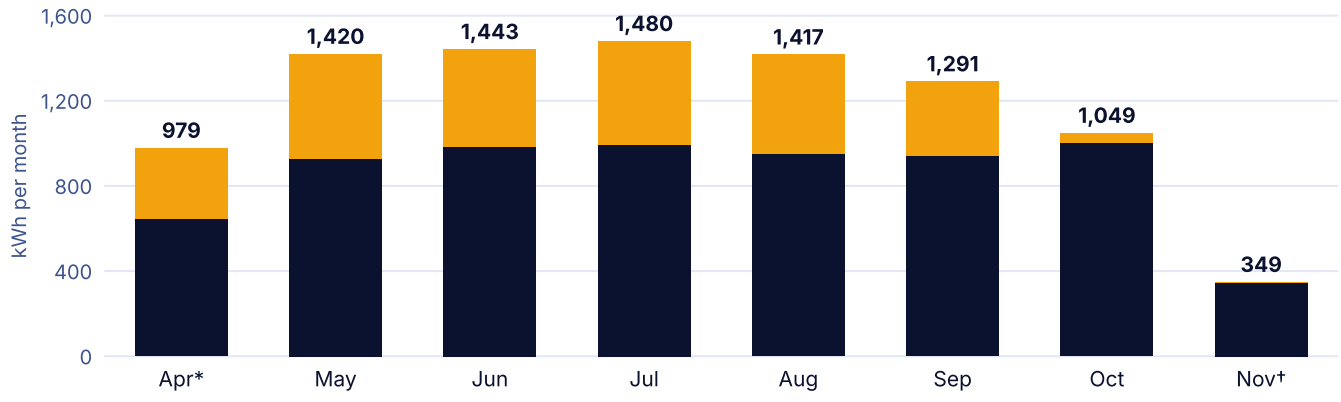
i What is an AC-coupled inverter?

AC coupling adds solar to a hybrid system without changing the hybrid itself. The catch: the second inverter often has no app of its own, so if it stops, nobody is told. The hybrid's "AC Coupled" reading is the only way to see it.
