MONTHLY REPORT · OCTOBER 2026 · HUAWEI FUSIONSOLAR

Optimizer review: all 8 panels healthy

Module-level check of the 5.12 kWp health centre plant · Chiang Mai province · lifetime, 2026 and October 2026

8 × 640 W · 8 optimizers

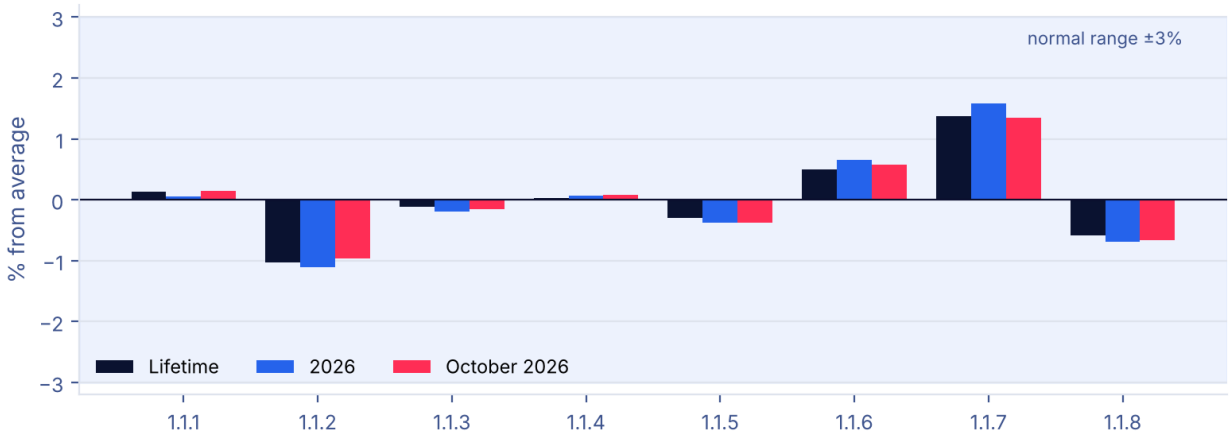
Each panel on the roof

All 8 optimizers healthy

Every panel is within ±1.4% of the average, and the order has stayed the same in every period. There is no weak, shaded or failing panel.

Panels on the roof, with each optimizer's lifetime yield (blue = within ±1% of the average)

A failing panel or optimizer drifts further below the others over time. Here 1.1.7 always leads and 1.1.2 always trails by the same small margin, which is normal factory tolerance in panel power.

3 · WATCH
Panel 1.1.2
Flag it if the gap passes 3%

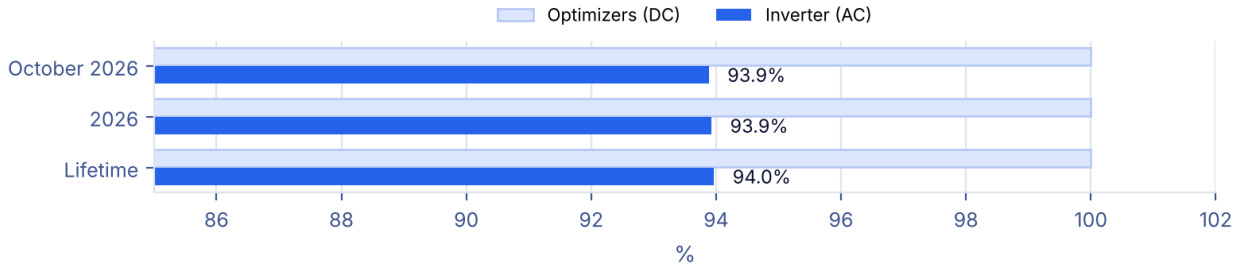
From the panels to the inverter

The inverter records about 94% of the energy the optimizers report, the same in every period. About 96–97% is typical, so roughly 3% is unaccounted for. It may be a difference between the two meters, but it is worth tightening the DC connectors and checking the cable run on the next visit.

2 · CHECK
DC connectors and cable
Look for the missing ~3%
