Case Study: PV Maintenance at a Nursing Home

A nursing home in Lampang · 25 kWp rooftop, 20 kW 3-phase inverter · Plant code SG-52000-20-01

Site visit: 14 November 2026 · PV cleaning, inspection, thermal scan and current checks

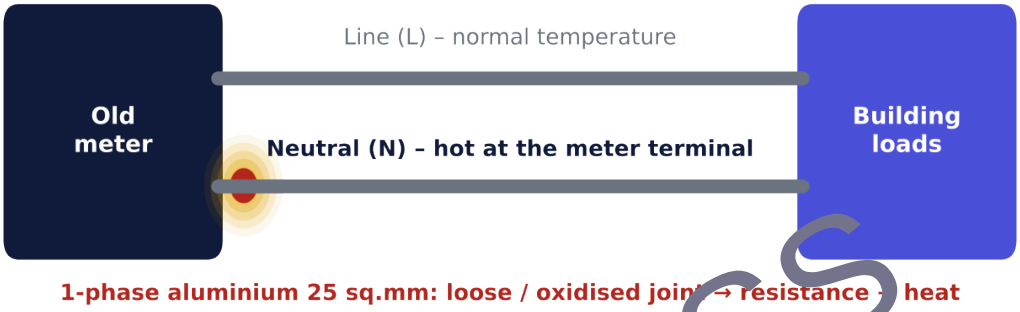
Finding 2 · Hot neutral cable at the old meter

The thermal scan showed the **neutral** of the single-phase aluminium 25 sq.mm cable to the old meter running hotter than the line conductor. Today it reached up to 65.4 °C. The system still runs, but the cause should be fixed soon before it gets worse.

Option	What we do	Result
A. Re-terminate or replace (recommended)	New bimetallic (Al–Cu) lugs with anti-oxidant compound, torqued correctly; or a new cable sized for the load	Removes the cause
B. Monitor the loads	Spread heavy loads (air conditioners, water heaters, pumps) over the day and re-scan at the next visit	Manages the risk only

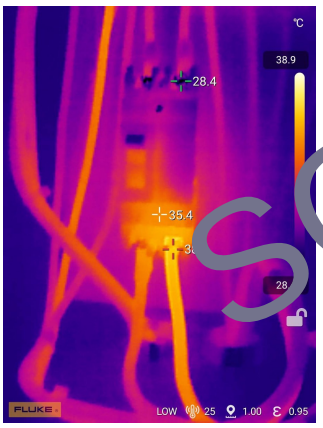
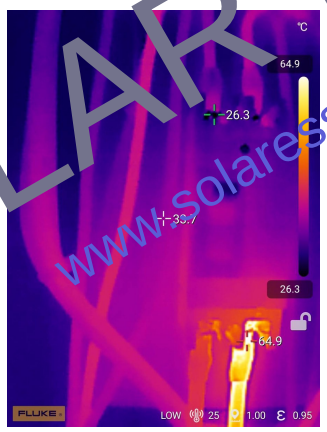
38.9 °C at the terminal (breaker body 35.4 °C)

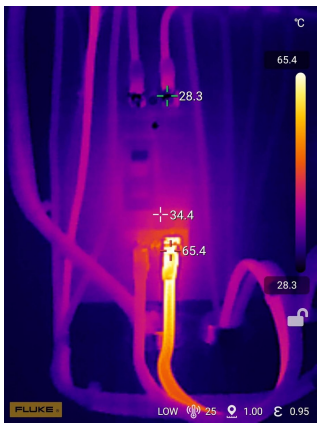
64.9 °C at the neutral terminal

65.4 °C at the neutral terminal and cable

Close to the cable limit
The neutral terminal reached 65.4 °C – about 37 °C above the surrounding parts (28.3 °C) and close to the 70 °C rating of standard PVC-insulated cable. The reading changes with the load, so at peak load it can run hotter. We recommend re-terminating it soon rather than only monitoring.

In a single-phase circuit the line and neutral carry the same current, so they should run at about the same temperature. A hotter neutral usually points to a **loose, corroded or oxidised termination** – common with aluminium – or to the neutral carrying return current from other circuits. A poor joint heats up more under load, which loosens it further over time.

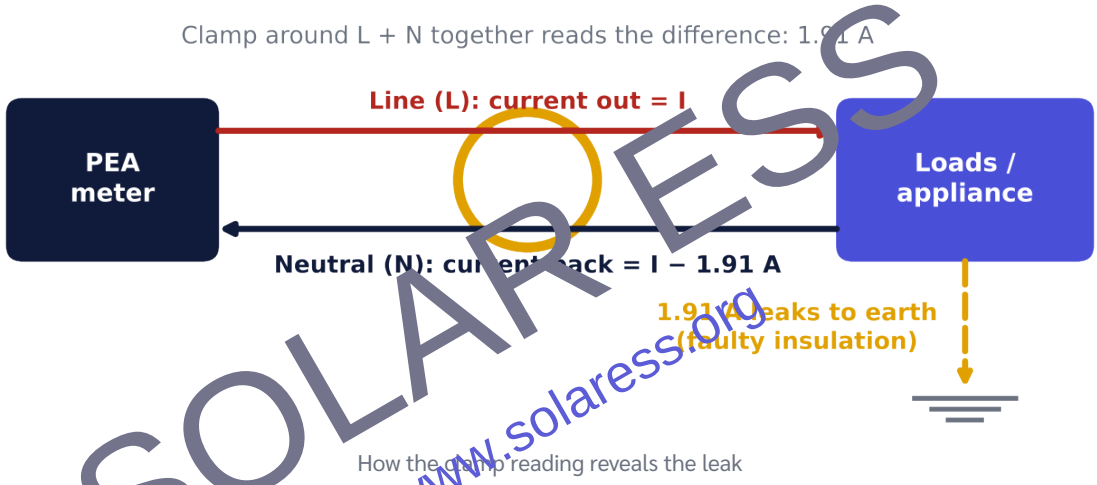
Finding 3 · Leakage current on the single-phase cable

The clamp meter, placed around the line and neutral together, read **1.91 A**.

In a healthy circuit the current going out on the line comes back on the neutral, so this reading should be close to zero. About 2 A is escaping through another path, most likely to earth through faulty insulation.

1. Switch circuits off one at a time while watching the clamp meter to find the leaking circuit or appliance (water heaters, pumps and old wiring are common causes).
2. Insulation-test that circuit and repair or replace the faulty part.
3. Make sure RCD protection is installed on the supply; add it where missing.
4. Re-measure after the repair to confirm the leakage is close to zero.

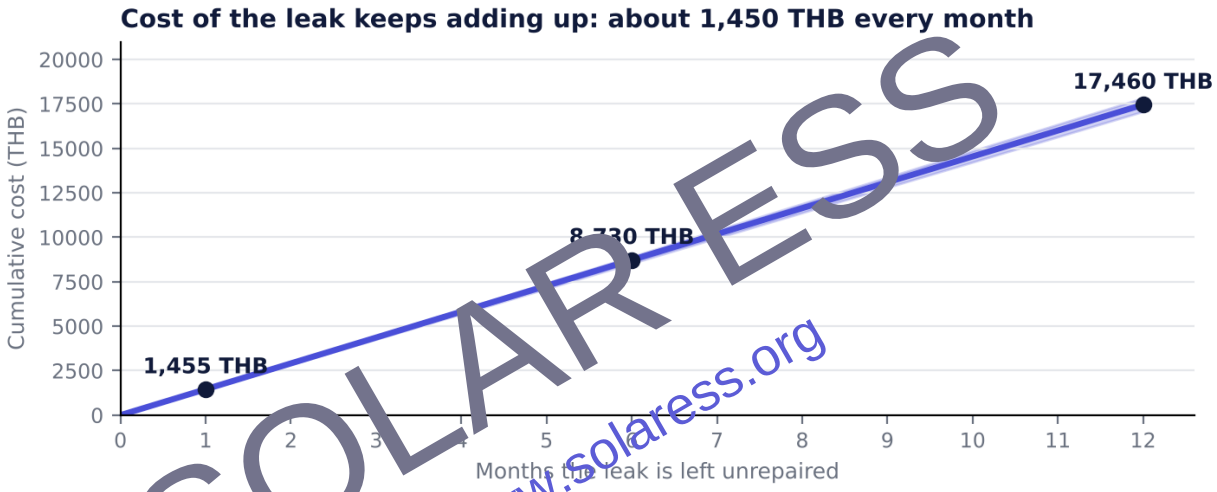
What the leakage costs

Leakage power = 230 V × 1.91 A ≈ **439 W (0.44 kW)**, assuming the leak runs continuously.

Period	Energy lost	Bill at 4.5 THB/kWh	Bill at 4.7 THB/kWh
1 hour	0.44 kWh	2.0 THB	2.1 THB
1 day (24 h)	10.5 kWh	47 THB	50 THB
1 month (30 days)	**316 kWh**	**1,420 THB**	**1,490 THB**
1 year	3,850 kWh	17,300 THB	18,100 THB

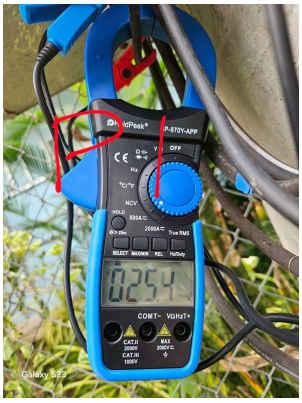
Reference: phase currents at commissioning (Sept 2025)

P1: 25.4 A

P2: 13.0 A

P3: 8.7 A

These are normal load currents per phase, recorded when the system was handed over. They are not leakage readings. After the leak is repaired, the same points will be measured again, together with a residual (L + N) reading that should be close to zero.

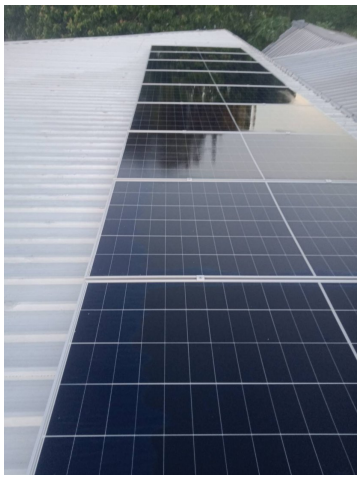
Rows after cleaning
