Ban Doo Chiangrai: why solar production has not kept up with consumption

20 kWp PV · Solis 20 kW three-phase hybrid inverter, no battery · zero export (no sell-back to PEA) · small factory with a 57–62 kW machine · Ban Du, Chiang Rai

Overheated electrical joints: fire, danger to life and the cost of heat

Research report on the distribution-board joints photographed at the Chiang Rai site, with evidence, case studies, a before-and-after comparison and recommended practice

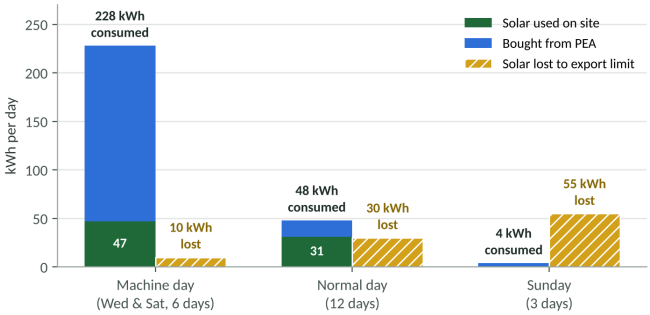
- **Small daytime load.** On days without the machine the shop draws only about 6 kW (as low as 2.8 kW at lunch). Zero export holds the inverter to that, so about 30 kWh of solar is lost each normal day and about 55 kWh each Sunday.
- **The machine is too big for the array and runs at the wrong time.** The 57–62 kW machine is about five times the array's 12–13 kW peak. It now runs on every Wednesday and Saturday; 20% of its energy is used after 17:30, and the export limit takes 45–55 minutes to release after it starts.
- **Phase imbalance.** The base load sits 67% on L1, 11% on L2 and 22% on L3. The hybrid inverter can supply each phase separately, so this does not cut production, but it overloads L1 and the neutral (about 13 A) – the same path that failed in September. **Solar ESS detected this heavy imbalance and has reported it to the factory's electrician.**

Figure 5 – Energy per day by day type, 1–21 Oct.

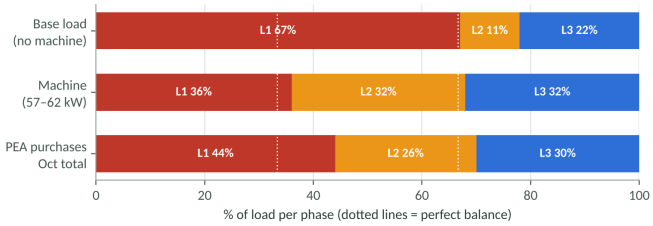
Figure 6 – Share of load per phase, October.

> **A gentle first step.** We would recommend a general check of the whole electrical system by an electrician qualified to PEA standards – the main three-phase meter connections, the boards and breakers in houses 1, 2 and 3, the main-cable wireway and conduits, and the joints on the machine's supply path – with a short written test record (insulation resistance, phase identification, RCD test and a thermal scan while the machine runs). This gives assurance on safety and on balanced use of the three phases. Solar ESS is happy to attend and to fine-tune the solar settings afterwards.

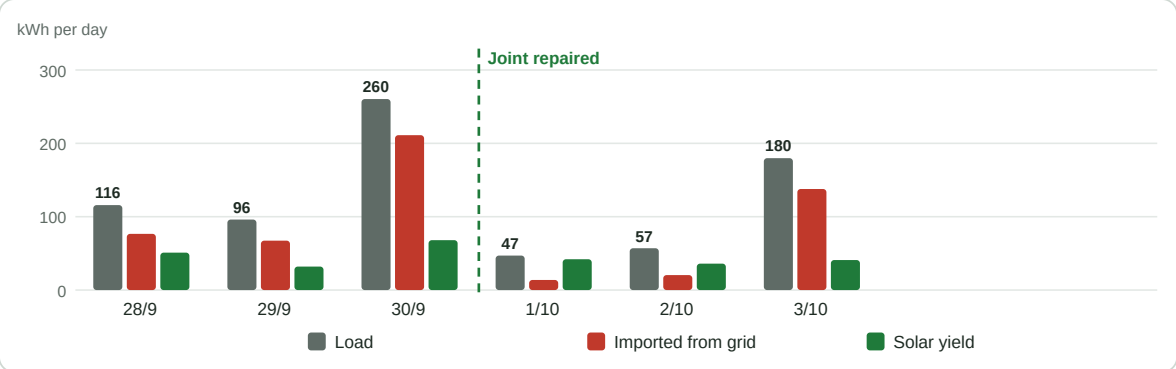
7 Measured energy before and after the repair
