Ban Doo Chiangrai: why solar production has not kept up with consumption

20 kWp PV · Solis 20 kW three-phase hybrid inverter, no battery · zero export (no sell-back to PEA) · small factory with a 57–62 kW machine · Ban Du, Chiang Rai

Overheated electrical joints: fire, danger to life and the cost of heat

Research report on the distribution-board joints photographed at the Chiang Rai site, with evidence, case studies, a before-and-after comparison and recommended practice

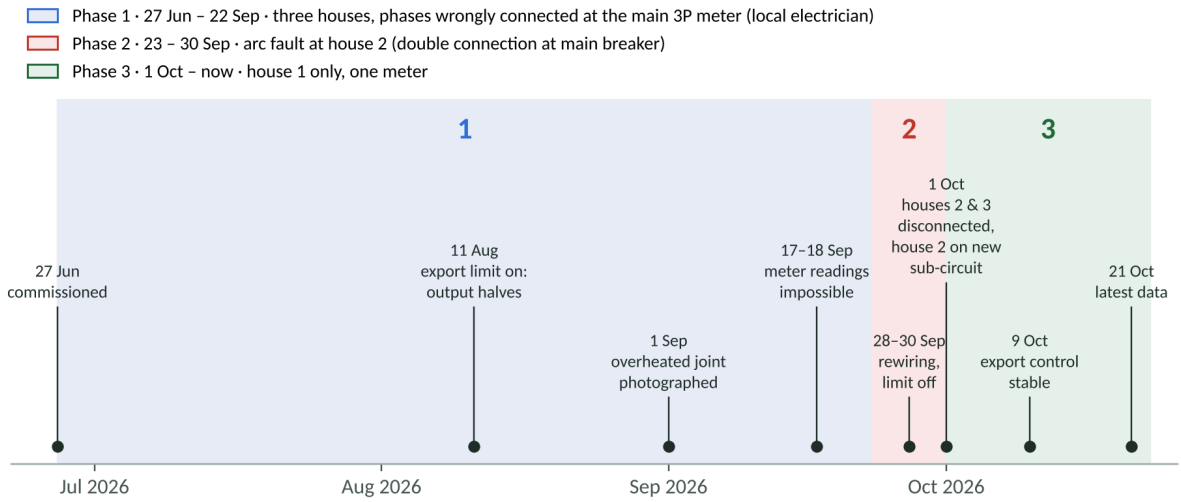
Figure 1 – Timeline of the plant from commissioning to 21 October 2026.

1. **27 Jun – 22 Sep · Three houses on one system, phases wrongly connected at the main three-phase meter by a local electrician.** The meter and CT saw the machine's load on the wrong phases, so the export control worked on false readings and output was held down.

2. **23 – 30 Sep · Arc fault at the connection to house 2.** The supply from house 1 to houses 2 and 3 was double-connected at each house at the main breaker that also feeds the 1st floor to the 2nd floor. The overloaded joint overheated, wasted energy as heat, disturbed the meter readings and created a fire and shock hazard, so the connection had to be removed.

3. **1 Oct – now · House 1 only, one meter.** The readings are now correct, but the base load is small and unbalanced (67% on L1), while the 57–62 kW machine runs only on Wednesdays and Saturdays, mostly outside sun hours. Zero export therefore curtails about half the available solar.

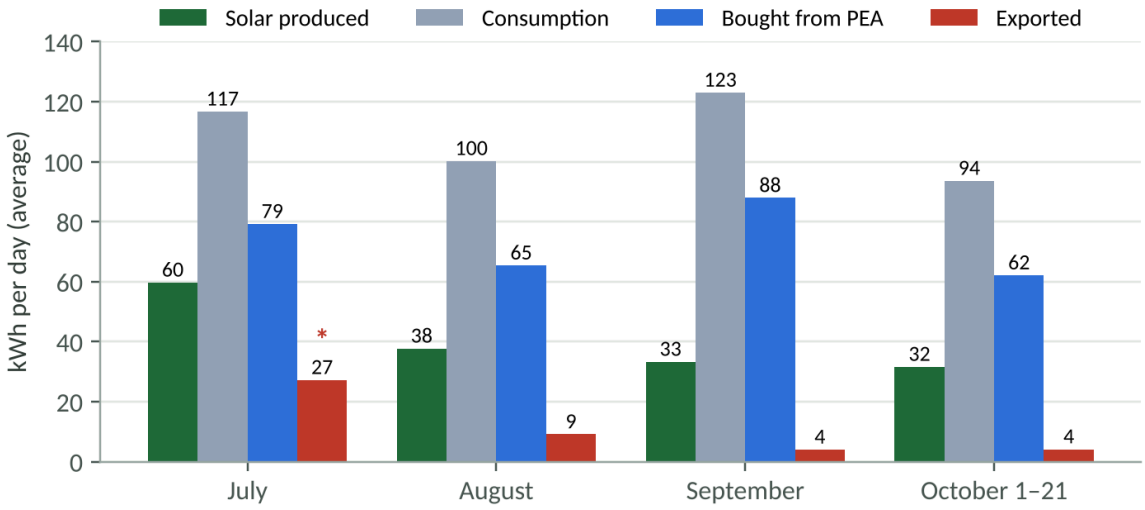
Figure 2 – Daily averages per month. * July export is overstated: with the phases swapped, part of the machine load was recorded as export. September purchases exclude the impossible readings of 17–18 September.

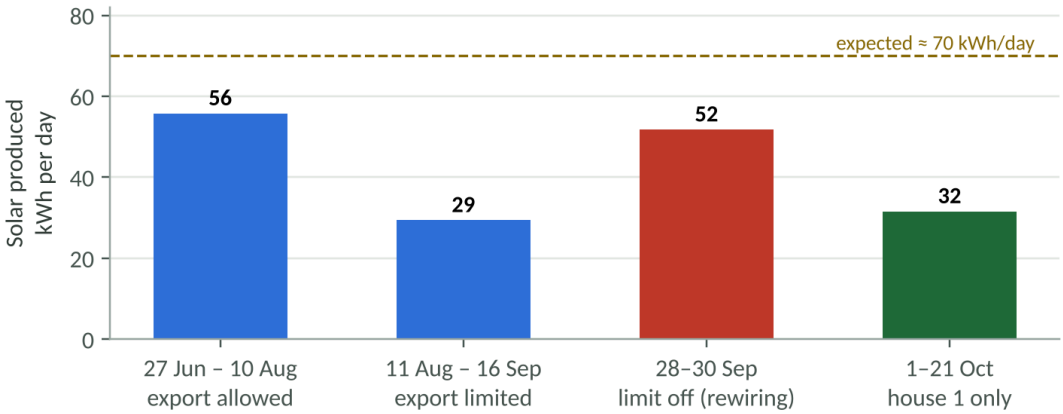
Figure 3 – Average solar production in each period against the ≈ 70 kWh/day the array can make. Only the days with no export limit (before 11 Aug, and 28–30 Sep during rewiring) came close.

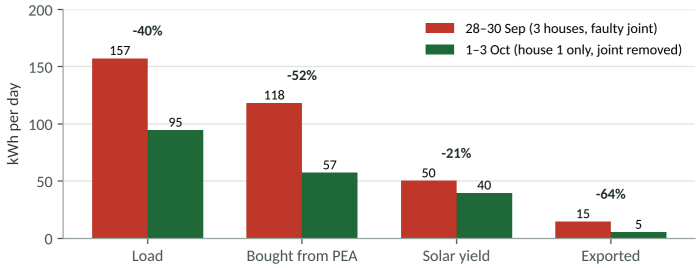
Figure 4 – Three days before and three days after the faulty connection was removed (from the attached Research Report, section 7).

- **Energy turned into heat.** A hot joint draws paid-for energy that does no work. With the machine drawing about 82–97 A per phase, a badly corroded joint can waste around 400 W.
- **Higher load.** In the three days before the repair the site used 157 kWh/day and bought 118 kWh/day. In the three days after, it used 95 kWh/day and bought 57 kWh/day. Part of that drop is the machine running less, so the saving is indicative, not proven.
- **Disturbed measurement.** The meter and CT readings were disrupted around the fault, so the export control could not follow the real load.
- **Danger.** The damage was on the line side of the RCBO, so no breaker could detect it. Exposed live copper was a shock risk and the joint was at stage 3 of 5 on the path to fire.

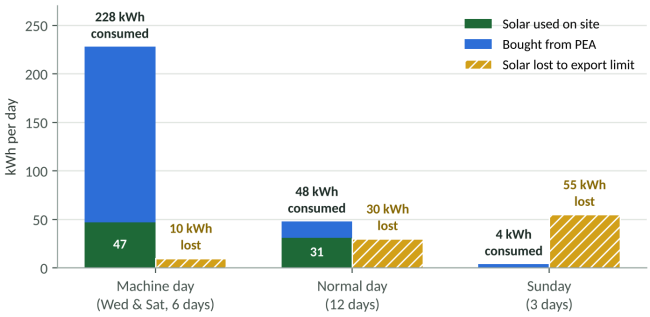
Figure 5 – Energy per day by day type, 1–21 Oct.

- **Working hours after sunset.** The load curve for 20 October shows the pattern clearly: the site starts around 09:30, dips at lunch, then keeps drawing about 5–7 kW from 17:30 until about 21:00 – after sunset (17:53), when all of it comes from PEA, roughly 20 kWh that evening – while solar from about 07:30 to 09:30 goes unused.

Per day, 1–21 Oct	Machine days (6)	Normal days (12)	Sundays (3)
Consumption	~230 kWh	~48 kWh	3–5 kWh
Solar produced	~50 kWh	~30 kWh	~0
Bought from PEA	~180 kWh	~17 kWh	~4 kWh
Solar lost to the export limit	~10 kWh	~30 kWh	~55 kWh

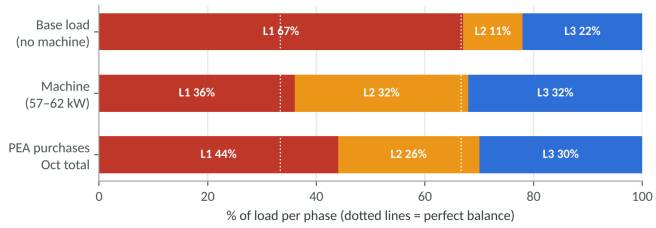
Figure 6 – Share of load per phase, October.

- **Phase imbalance.** The base load sits 67% on L1, 11% on L2 and 22% on L3. The hybrid inverter can supply each phase separately, so this does not cut production, but it overloads L1 and the neutral (about 13 A) – the same path that failed in September. **Solar ESS detected this heavy imbalance and has reported it to the factory's electrician.**

Suggestion	Benefit
General inspection by a PEA-qualified electrician, with a written test record	Safety assurance; a clear picture of the three phases
Review the main-cable wireway and conduits; give the cables more room and route CT cables apart from power cables	Cooler cables; steadier CT readings
Check that the joints repaired in September are tight and cool under machine load	Avoids repeat heating at the joints
House 3: ask the local electrician for photographs of the corrected connection, or invite Solar ESS to take a look	Confirms the double connection has been removed
Spread the single-phase loads more evenly, about 2 kW per phase (the factory's electrician is already aware of the imbalance)	Less load on L1 and the neutral

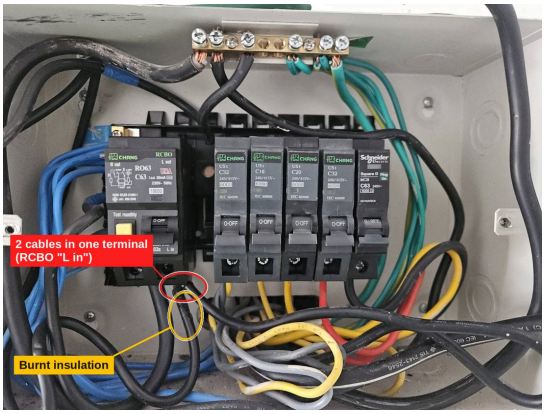
Finding
More than one cable, including a twisted bundle, is clamped in one RCBO terminal. The joint has overheated: insulation is melted and copper is corroded. A second board shows the same habit.

The board. The red circle marks the RCBO line-in terminal; the yellow outline marks scorched cable below it.

The same practice on a second board
Another board, judging by its different breakers, shows two conductors joined under tape and taken into one RCBO terminal. No burn is visible there yet. The fault looks like a working habit, not a one-off, so every board by the same installer should be opened and checked.

- ☑ **Inspect the RCBO terminal:** replace the RCBO if the terminal or body is discoloured, pitted or melted.
- ☑ **One conductor per terminal:** unless the maker states that the terminal accepts more.

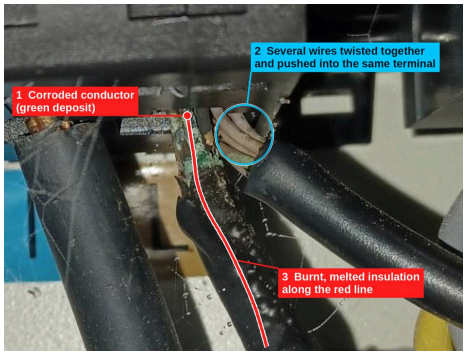
The terminal, enlarged. The numbers match the findings below.

1 Corroded conductor
Green deposit on the copper where it enters the terminal: a sign of heat, moisture and acid from overheated PVC.

2 Several wires in one terminal
Separate wires twisted into a bundle and forced in beside the main cable. The screw cannot grip them evenly.

3 Burnt, melted insulation
The damage runs down the cable from the terminal, which shows the heat started at the joint.

Stage 3: Discoloured
Melted insulation, green copper. **This site.**
