Solar ESS Co. Ltd.
53 Moo 2 Tambon Nanglae, Amphoe Muang
Chiang Rai 57100, Thailand
Tel 063 151 6694, 089 632 5829
www.solaress.org · LINE: solaress1

Home H3, Chiang Rai

Constant grid trips – about 65% of energy lost

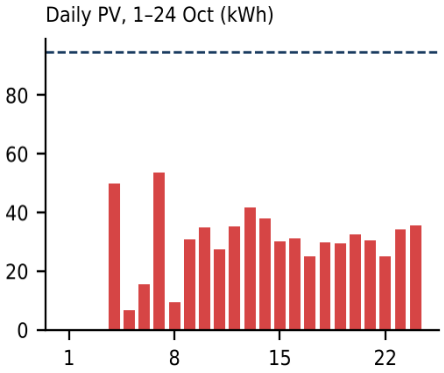
22 kWp	647 kWh	1.40	–	–	–
PV · 20 kW inverter	PV, 1–24 Oct	kWh/kWp/day	Consumption	Bought from grid	Exported

• 22 kWp on four 5 kW inverters averaged only 30.8 kWh a day (1.4 kWh/kWp) on 4–24 October. At 4.3 kWh/kWp it should make about 95 kWh a day.

• There were more than 4,800 grid trips on all four inverters in October: overfrequency (1,879), overvoltage (1,810), Grid Failed (629) and underfrequency (527). The profile shows output repeatedly dropping to zero.

• Grid voltage at the inverters was already 246–250 V at 10:00 under low load. The overvoltage trip point is about 253 V, so it trips whenever output rises.

• The frequency trips point to an unstable source, such as a weak rural line, a generator, or the output of an off-grid inverter.

• The power meter is disconnected ("Faulty Power Collector"), so FusionSolar has no consumption or grid data.

1. Find out what the inverters are actually connected to: the PEA grid, a generator, or an off-grid or backup inverter. If they are AC-coupled behind an off-grid inverter, the settings for that set-up have to be applied.

3. Fix the power meter's RS485 link (the CT/LAN cable job already planned) so that consumption and export can be measured.

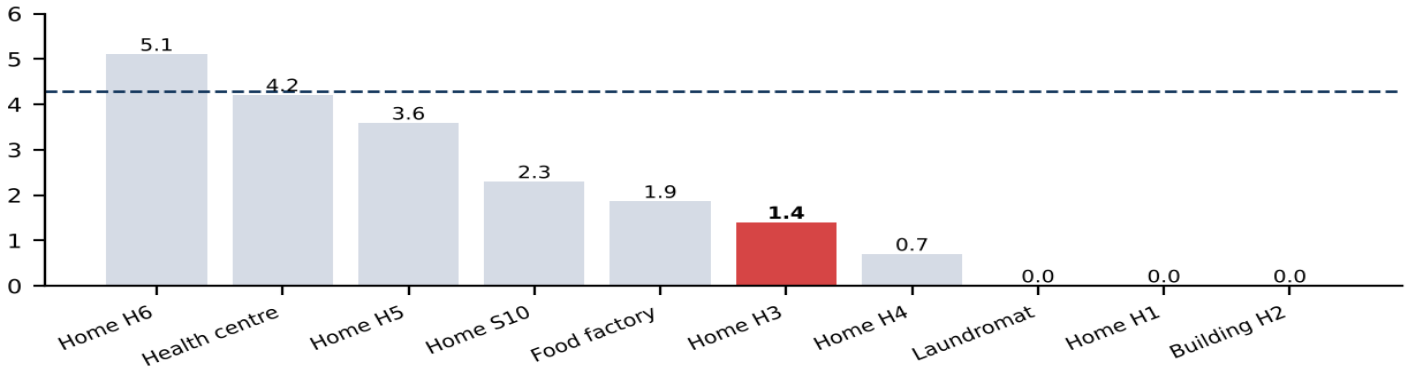
How this plant compares (kWh/kWp per day, 1–24 Oct)

Rank 6 of 10 Huawei plants. Dashed line = expected 4.3 kWh/kWp per day.
