SOLAR ESS MONTHLY REPORT · OCTOBER 2026 · SOLISCLOUD · PLANT REPORT

Restaurant A, Pathum Thani

24 kWp · 20 kW 3-phase hybrid inverter · no battery

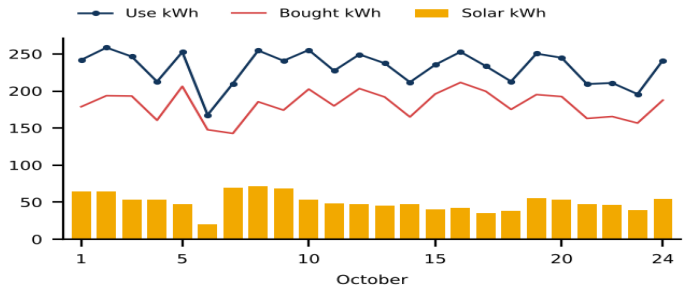
24 October, 5-minute data

About ⅔ of panels not producing

• 24 kWp but only 8.3 kW peak on 24 Oct (0.35 kW per kWp) while the restaurant was importing 15–18 kW – nothing should be limiting the panels.
• Yield 2.1 kWh/kWp/day against 3.8–4.0 at similar central/northern sites.
• Solar covers only 21% of a very large load (231 kWh/day).

• Site check of every string: DC isolators, fuses, MC4 connectors and MPPT input currents; one or two strings are probably disconnected or tripped.
• Expected gain once fixed: about 1,300–1,500 kWh/month.

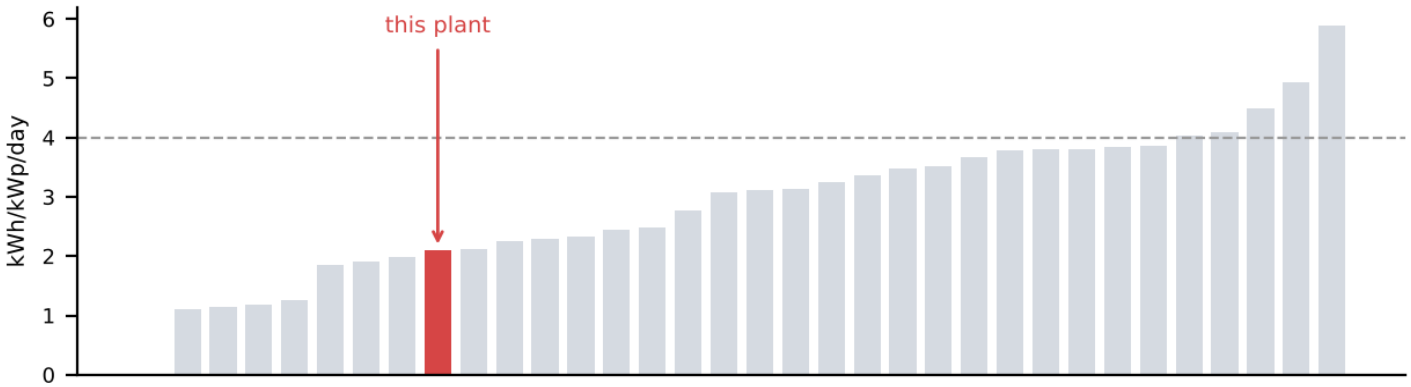
How this plant compares with the other SolisCloud plants (kWh per kWp per day, 1–24 Oct)

Rank 26 of 34 for yield per kWp. Dashed line ≈ 4.0, a typical clear month in the north and centre. A low yield is not always a fault – a full battery or little daytime load makes the inverter throttle the panels.
