Ban Doo Chiangrai: why solar production has not kept up with consumption

20 kWp PV · Solis 20 kW three-phase hybrid inverter, no battery · zero export (no sell-back to PEA) · small factory with a 57–62 kW machine · Ban Du, Chiang Rai

Overheated electrical joints: fire, danger to life and the cost of heat

Research report on the distribution-board joints photographed at the Chiang Rai site, with evidence, case studies, a before-and-after comparison and recommended practice

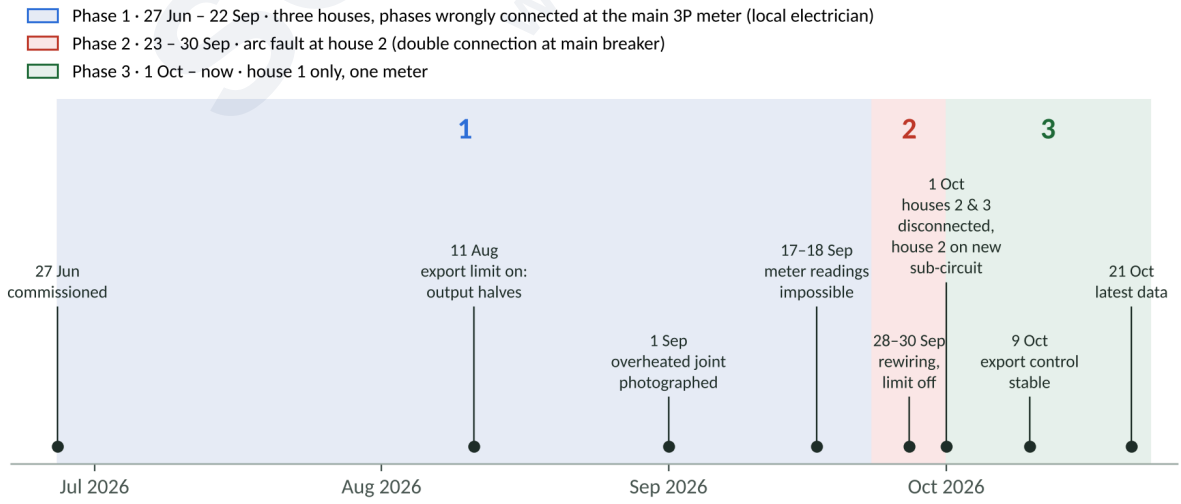
Figure 1 – Timeline of the plant from commissioning to 21 October 2026.

Since commissioning on 27 June the panels and inverter have worked normally. Production has fallen short of consumption for three different reasons, one after the other:

1. **27 Jun – 22 Sep · Three houses on one system, phases wrongly connected at the main three-phase meter by a local electrician.** The meter and CT saw the machine's load on the wrong phases, so the export control worked on false readings and output was held down.

2. **23 – 30 Sep · Arc fault at the connection to house 2.** The supply from house 1 to houses 2 and 3 was double-connected at each house at the main breaker that also feeds the 1st floor to the 2nd floor. The overloaded joint overheated, wasted energy as heat, disturbed the meter readings and created a fire and shock hazard, so the connection had to be removed.

3. **1 Oct – now · House 1 only, one meter.** The readings are now correct, but the base load is small and unbalanced (67% on L1), while the 57–62 kW machine runs only on Wednesdays and Saturdays, mostly outside sun hours. Zero export therefore curtails about half the available solar.

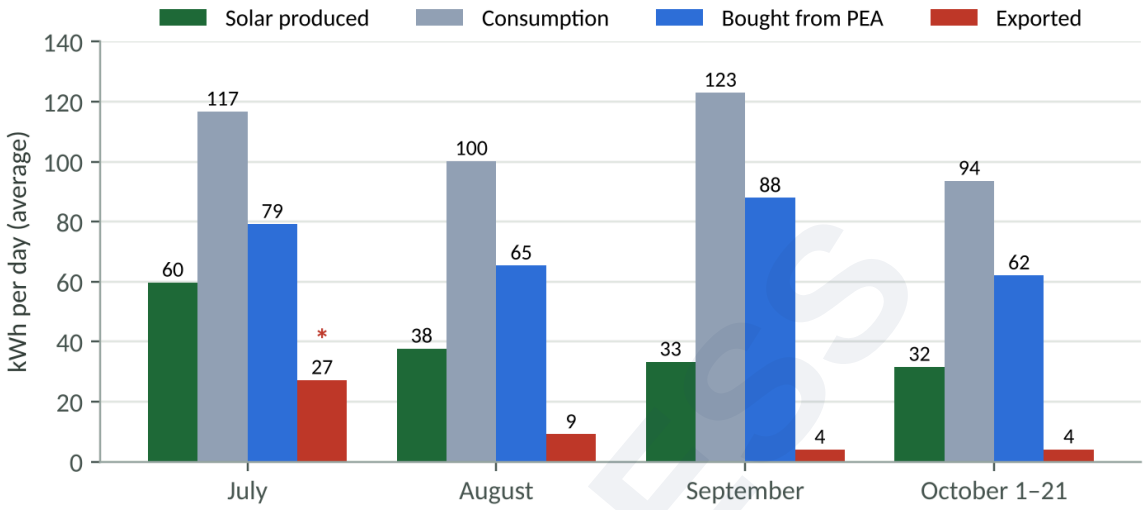
Figure 2 – Daily averages per month. * July export is overstated: with the phases swapped, part of the machine load was recorded as export. September purchases exclude the impossible readings of 17–18 September.

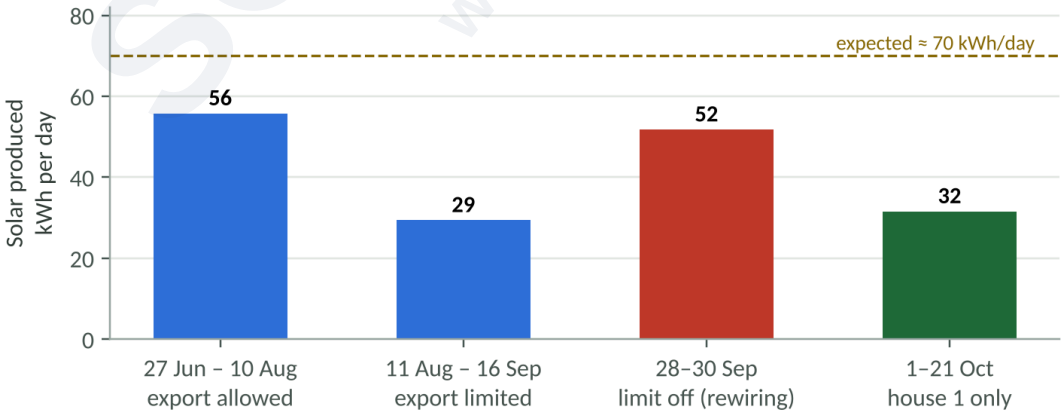
Figure 3 – Average solar production in each period against the ≈ 70 kWh/day the array can make. Only the days with no export limit (before 11 Aug, and 28–30 Sep during rewiring) came close.

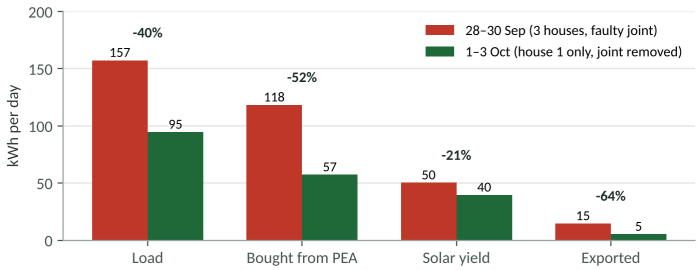
Figure 4 – Three days before and three days after the faulty connection was removed (from the attached Research Report, section 7).

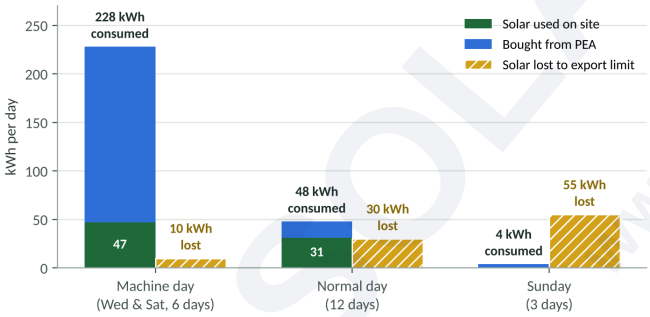
Figure 5 – Energy per day by day type, 1–21 Oct.

- **Small daytime load.** On days without the machine the shop draws only about 6 kW (as low as 2.8 kW at lunch). Zero export holds the inverter to that, so about 30 kWh of solar is lost each normal day and about 55 kWh each Sunday.

- **The machine is too big for the array and runs at the wrong time.** The 57–62 kW machine is about five times the array's 12–13 kW peak. It now runs on every Wednesday and Saturday; 20% of its energy is used after 17:30, and the export limit takes 45–55 minutes to release after it starts.

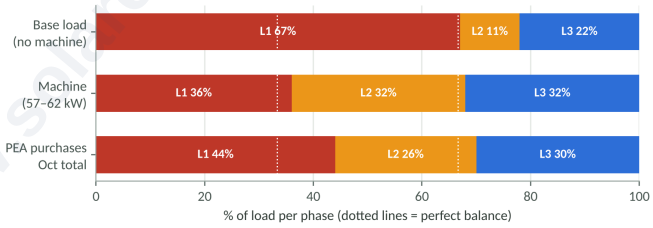
Figure 6 – Share of load per phase, October.

- **Phase imbalance.** The base load sits 67% on L1, 11% on L2 and 22% on L3. The hybrid inverter can supply each phase separately, so this does not cut production, but it overloads L1 and the neutral (about 13 A) – the same path that failed in September. **Solar ESS detected this heavy imbalance and has reported it to the factory's electrician.**

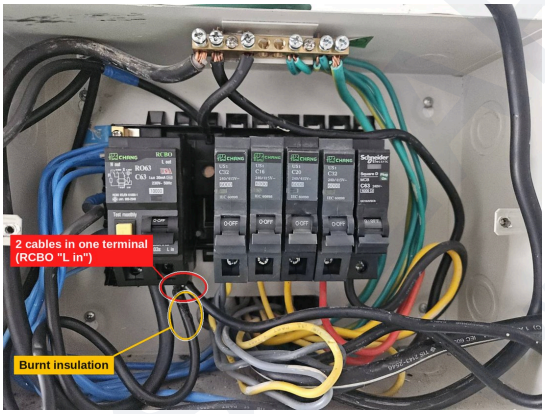
More than one cable, including a twisted bundle, is clamped in one RCBO terminal. The joint has overheated: insulation is melted and copper is corroded. A second board shows the same habit.

The board. The red circle marks the RCBO line-in terminal; the yellow outline marks scorched cable below it.

The damage runs down the cable from the terminal, which shows the heat started at the joint.

- ☑ **Inspect the RCBO terminal:** replace the RCBO if the terminal or body is discoloured, pitted or melted.
- ☑ **One conductor per terminal:** unless the maker states that the terminal accepts more.

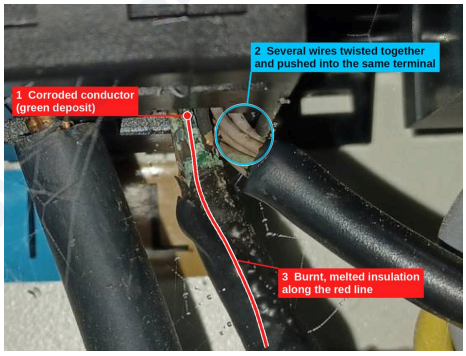
The terminal, enlarged. The numbers match the findings below.

1 Corroded conductor

Green deposit on the copper where it enters the terminal: a sign of heat, moisture and acid from overheated PVC.

2 Several wires in one terminal

Separate wires twisted into a bundle and forced in beside the main cable. The screw cannot grip them evenly.

3 Burnt, melted insulation
