# Monthly Report: an AC-Coupled Inverter That Stopped and How the Hybrid's Data Showed It

Rev01 · 10 November 2026 · Monthly Report · 14.19 kWp solar with battery, zero export · a shop in Surat Thani province · Data: SolisCloud, April – 10 November 2026

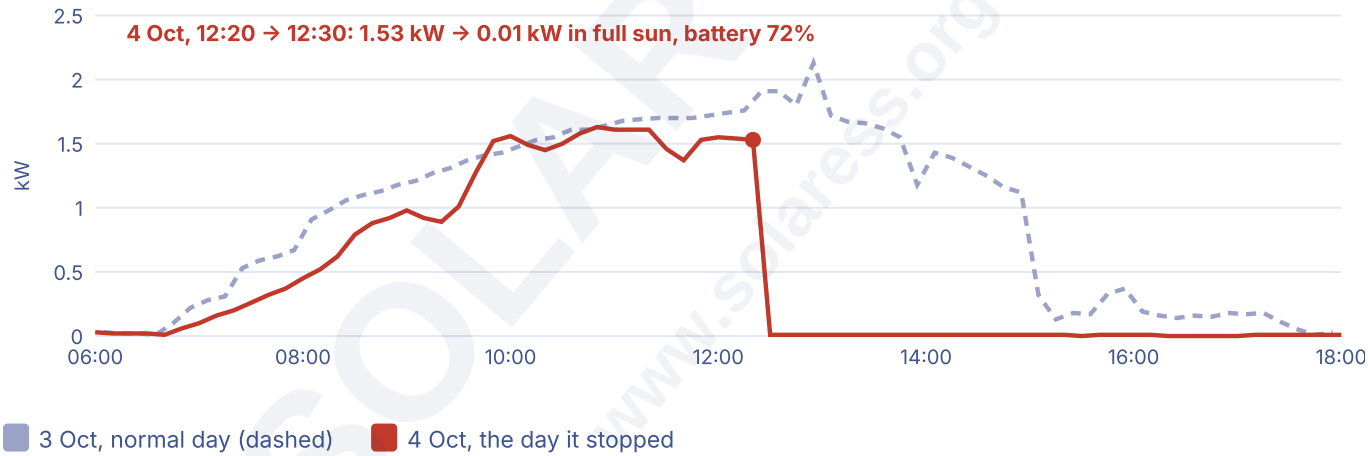
5-minute power of the second inverter. The drop was sudden, in full sun, while the battery still had room. The Solis hybrid did not cause it, and the meter still reports (a steady ≈ 10 W). So the second inverter itself switched off: a tripped breaker or isolator, a latched fault, or a failure.

1. **Find the second inverter.** It is a separate box from the Solis, usually near the main board or under the roof.
2. **Take photos** of its screen or lights, and of its label (brand, model, serial number).
3. **Check its AC breaker** in the board and its **DC isolator**. Photograph any switch that is off.
4. **If it shows a fault, restart it:** AC breaker off, then DC isolator off. Wait 5 minutes. DC on, then AC on.
5. **Send the photos to Solar ESS** by LINE (solaress1). We confirm on the monitoring platform the next sunny day that the "AC Coupled" reading is back.

If it trips again or shows no lights at all, Solar ESS will arrange a site visit. With the label photo we can also find its monitoring app, or plan a repair or replacement.
