# Laundromat, Songkhla

**Offline since March 2026 – check if replaced**

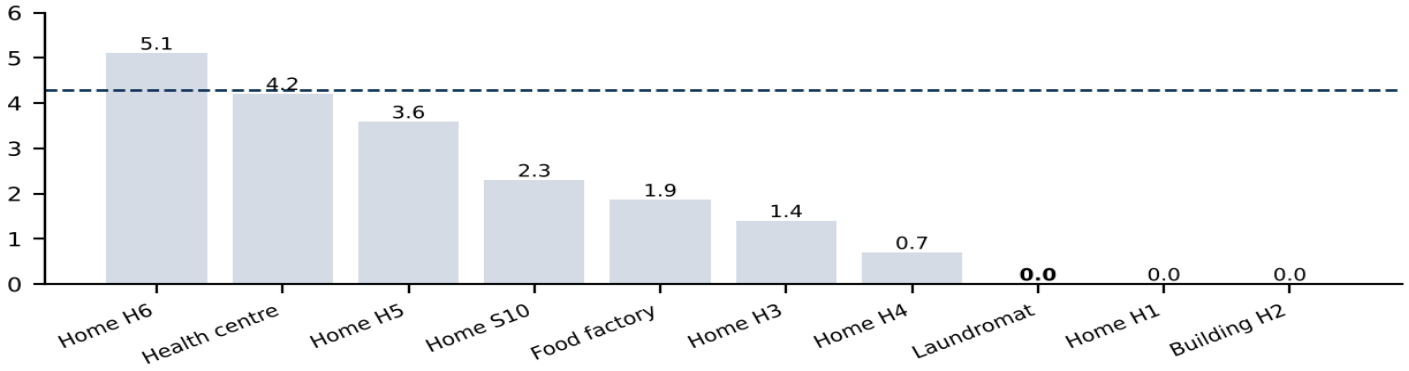
• The Huawei inverter and dongle have been disconnected since March 2026, with a "Network Connection Error" alarm since 23 March. The plant capacity is set to 0 kWp.

• It made 590–770 kWh a month in 2025. The same laundromat also appears on SolisCloud, so the Huawei inverter may have been replaced.

1. Confirm with the owner or technician whether the Huawei inverter is still installed.

2. If it was replaced, close this plant in FusionSolar so it stops showing as faulty. If it is still installed, reconnect the dongle to Wi-Fi.
