Case Study: PV Maintenance at a Nursing Home

A nursing home in Lampang · 25 kWp rooftop, 20 kW 3-phase inverter · Plant code SG-52000-20-01

Site visit: 14 November 2026 · PV cleaning, inspection, thermal scan and current checks

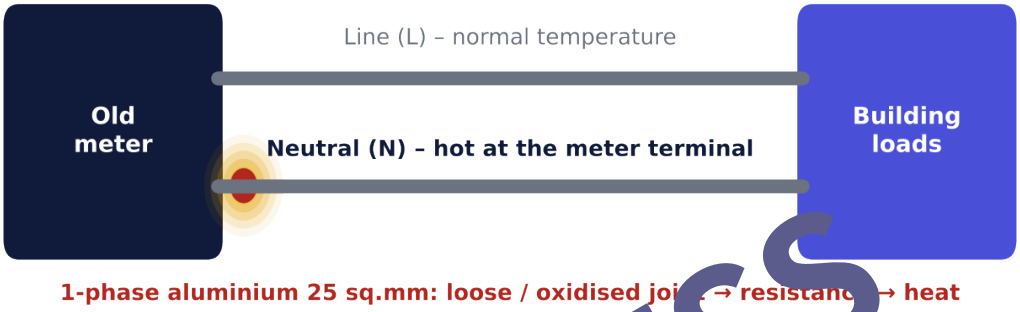
Finding 2 · Hot neutral cable at the old meter

The thermal scan showed the **neutral** of the single-phase aluminium 25 sq.mm cable to the old meter running hotter than the line conductor. Today it reached up to 65.4 °C. The system still runs, but the cause should be fixed soon before it gets worse.

Option	What we do	Result
A. Re-terminate or replace (recommended)	New bimetallic (Al–Cu) lugs with anti-oxidant compound, torqued correctly; or a new cable sized for the load	Removes the cause
B. Monitor the loads	Spread heavy loads (air conditioners, water heaters, pumps) over the day and re-scan at the next visit	Manages the risk only

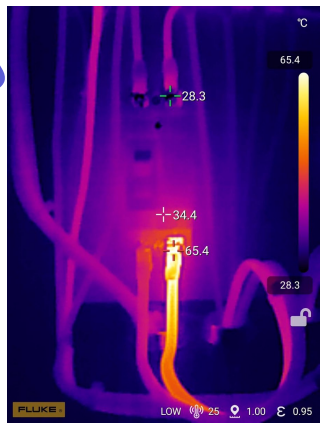
64.9 °C at the neutral terminal

65.4 °C at the neutral terminal and cable

Close to the cable limit
The neutral terminal reached 65.4 °C – about 37 °C above the surrounding parts (28.3 °C) and close to the 70 °C rating of standard PVC-insulated cable. The reading changes with the load, so at peak load it can run hotter. We recommend re-terminating it soon rather than only monitoring.

In a single-phase circuit the line and neutral carry the same current, so they should run at about the same temperature. A hotter neutral usually points to a **loose, corroded or oxidised termination** – common with aluminium – or to the neutral carrying return current from other circuits. A poor joint heats up more under load, which loosens it further over time.

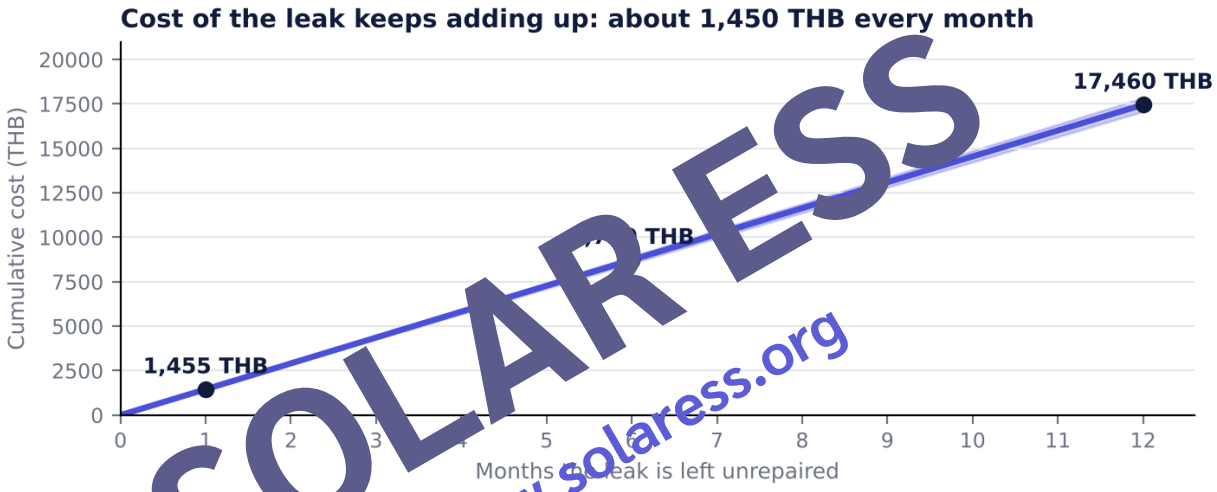
Leakage power = 230 V × 1.91 A ≈ **439 W (0.44 kW)**, assuming the leak runs continuously.

At 220 V the loss is abou ≈ 1,[illegible]–1,420 THB a month). If the leak comes from one appliance that only runs part of the day, the loss is lower. During sunny hou the leak is fed by s , so that share does not show on the PEA bill but is still lost solar energy. Rates include Ft and VAT; we will recalculate from the site's actual PEA bill.

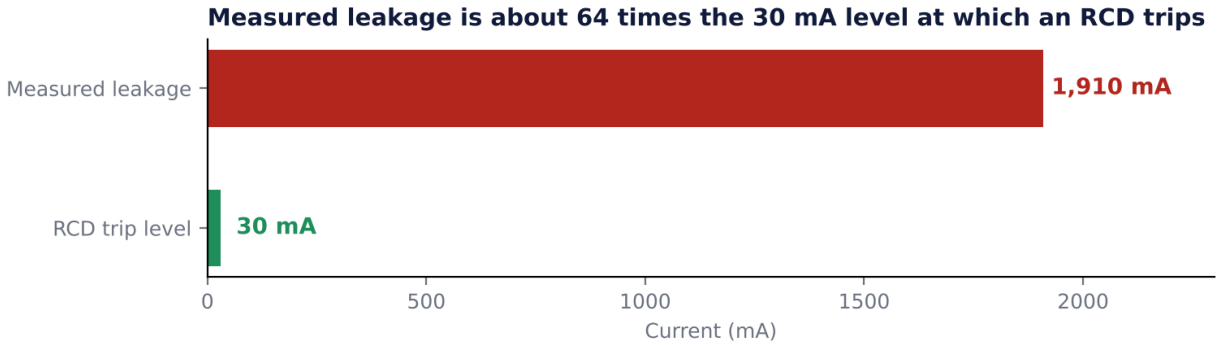
Safety

Electric-shock risk
Either this supply has no residual-current protection (RCD/RCBO), or current is returning through earth or another circuit's neutral. Both can give an electric shock – important in a nursing home with elderly residents.

1. Switch circuits off one at a time while watching th[illegible]an[illegible]meter [illegible]fi[illegible]the leaking circuit or appliance (water heaters, pumps and old wiring are common causes).
2. Insulation-test that circuit and repair or repl[illegible]e the fa[illegible]ty part.
3. Make sure RCD protection is insta[illegible]d on the [illegible]ply, add it where missing.
4. Re-measure after the rep[illegible]r to [illegible]nfi[illegible] the leakage is close to zero.
