Home H1, Chiang Mai

No production since 2 May 2026

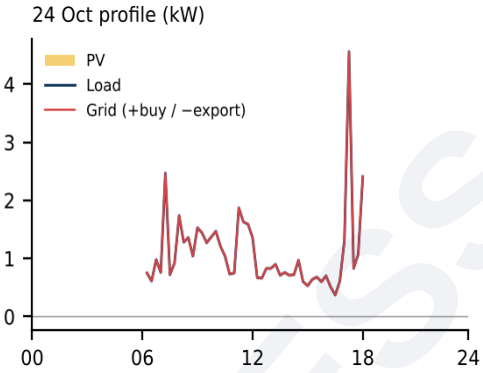
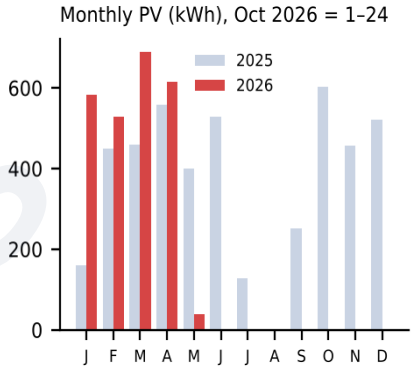
5.55 kWp	0 kWh	0.00	416 kWh	416 kWh	0 kWh
PV · 5 kW inverter	PV, 1–24 Oct	kWh/kWp/day	Consumption	Bought from grid	Exported

• The inverter has produced nothing since 2 May 2026 at 12:14. It still reports "Grid Failed" and reads 0 V and 0 Hz on the grid side, so it cannot see the grid at all.

• The house keeps buying all its power from the grid: 416 kWh in 1–24 October, and 360–720 kWh a month since May.

• In January–April 2026 the system made 530–690 kWh a month. About 6 months of production, roughly 3,500 kWh, has been lost so far.

1. Site visit: check the AC breaker or isolator between the inverter and the main board, then the AC cable and terminals at the inverter. A tripped or switched-off AC breaker is the most likely cause.

2. If the breaker trips again, test the cable insulation and the inverter's AC relay before switching back on.

3. Once it's running again, confirm that FusionSolar shows a grid voltage of about 230 V and normal production the next sunny day.
