Home H3, Chiang Rai

Constant grid trips – about 65% of energy lost

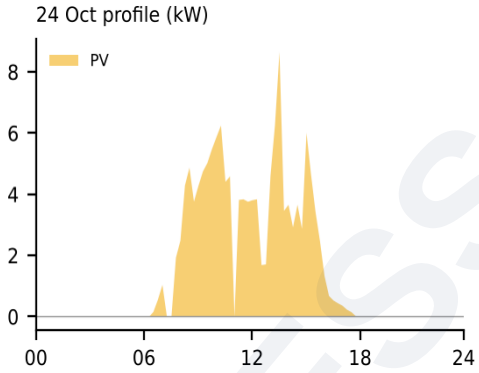
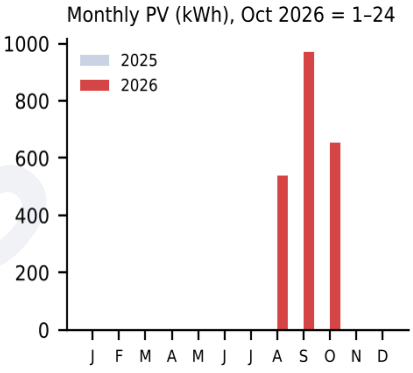
• 22 kWp on four 5 kW inverters averaged only 30.8 kWh a day (1.4 kWh/kWp) on 4–24 October. At 4.3 kWh/kWp it should make about 95 kWh a day.

• There were more than 4,800 grid trips on all four inverters in October: overfrequency (1,879), overvoltage (1,810), Grid Failed (629) and underfrequency (527). The profile shows output repeatedly dropping to zero.

• Grid voltage at the inverters was already 246–250 V at 10:00 under low load. The overvoltage trip point is about 253 V, so it trips whenever output rises.

• The frequency trips point to an unstable source, such as a weak rural line, a generator, or the output of an off-grid inverter.

• The power meter is disconnected ("Faulty Power Collector"), so FusionSolar has no consumption or grid data.

1. Find out what the inverters are actually connected to: the PEA grid, a generator, or an off-grid or backup inverter. If they are AC-coupled behind an off-grid inverter, the settings for that set-up have to be applied.

2. Measure voltage at the meter and at the inverters through a sunny day. If the PEA voltage is high, ask PEA to check the transformer tap. Check that the AC cable to the main board is large enough to keep voltage rise below 2%.

3. Fix the power meter's RS485 link (the CT/LAN cable job already planned) so that consumption and export can be measured.
