Home H4, Samut Songkhram

Very low yield – 0.7 kWh/kWp

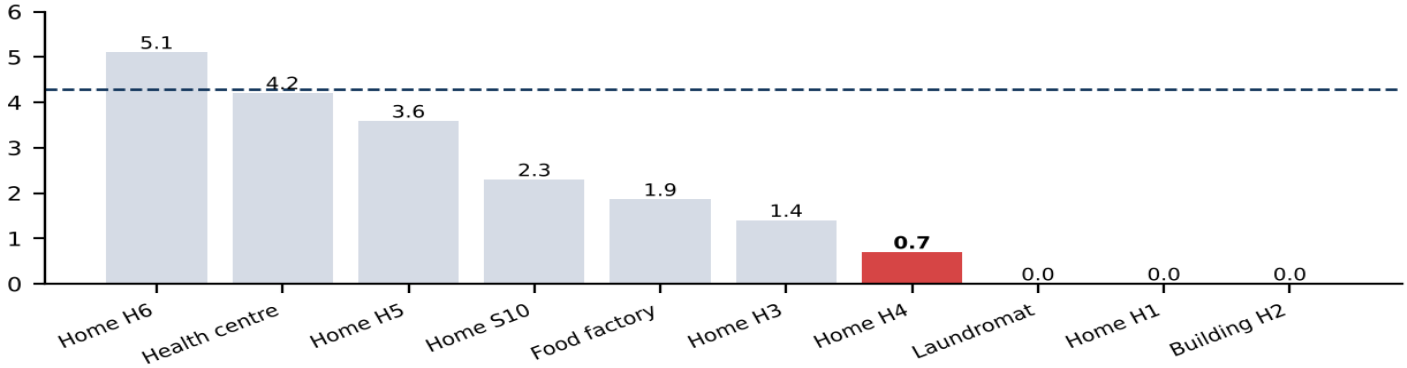
How this plant compares (kWh/kWp per day, 1–24 Oct)

• It made only 83.7 kWh in 24 days, or 0.70 kWh per kWp per day. A healthy system makes about 4–5 (Home H6 made 5.1).

Rank 7 of 10 Huawei plants. Dashed line = expected 4.3 kWh/kWp per day.
