Arnava अर्णव
Vol. VII No.2 Half Yearly Year 2018 ISSN 2320-0103

K.S. Chandra*

Some Historic Sites in Nagpur District – Present Status

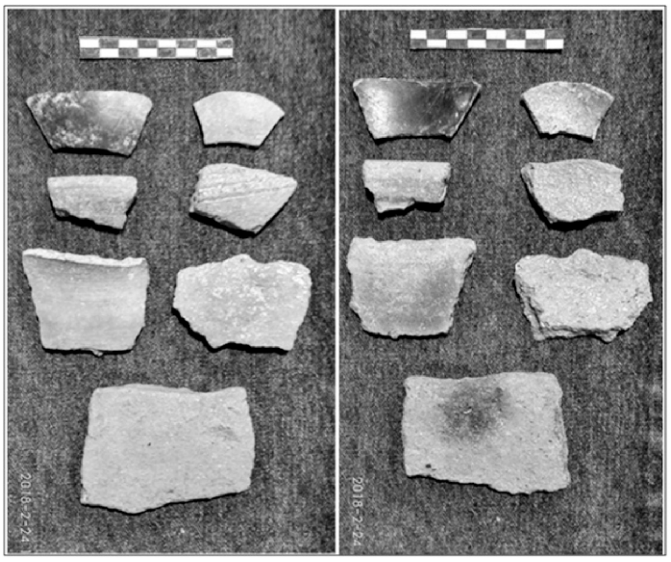
Fig. 23 : Pot Shards from Exposed Sections

Different types of potshards from

exposed sections, proving that this site had multicultural habitation.
