PROPERTY INSPECTION REPORT FORM

251 N Bristol Ave, Los Angeles, CA 90049
Address of Inspected Property

08/13/2025, 6:00 AM
Date of Inspection

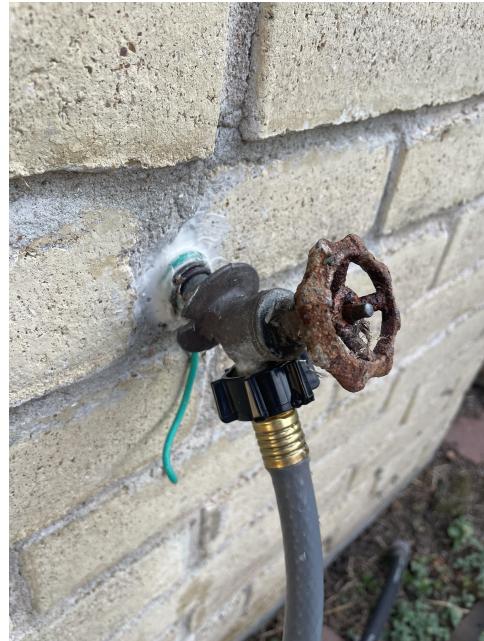
6. Exterior Hose Bib Not Functioning

The exterior hose bib is not functioning properly. Repair or replacement is recommended to restore water flow and prevent potential water damage. Consult a licensed plumber for evaluation and repair.

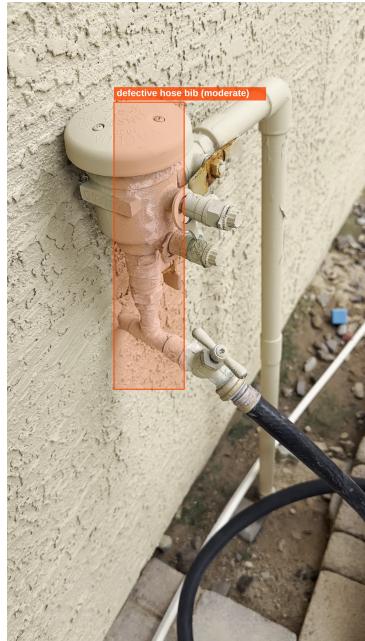
Annotated image: defective hose bib at Back Yard

Original image: defective hose bib at Back Yard

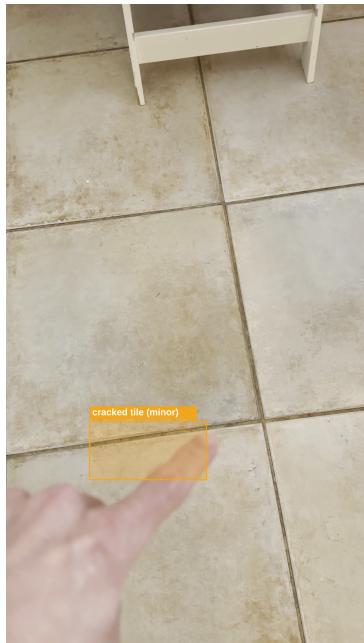
I. Interior Flooring Surfaces

1. Cracked Floor Tile

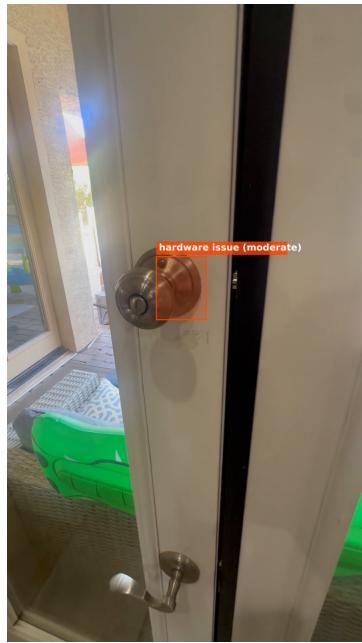
L. Exterior Door Systems

1. Inoperable or Difficult Door Handle Lock

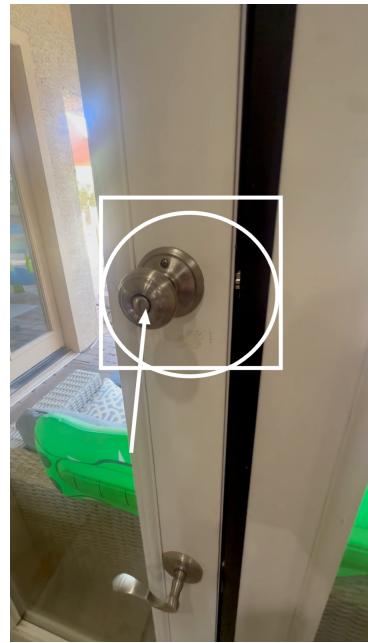
Annotated image: hardware issue at Living Room

Original image: hardware issue at Living Room

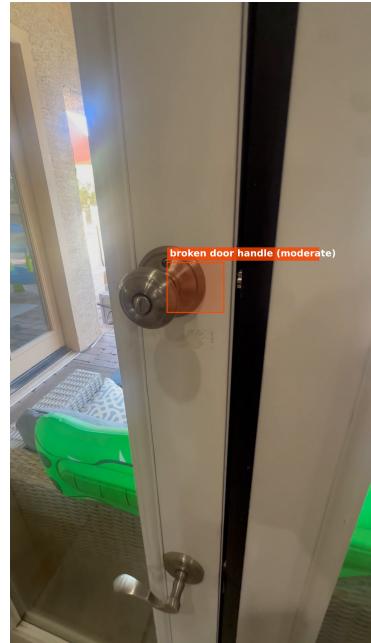
2. Loose, Damaged, or Missing Door Hardware

Various exterior door hardware components, including locksets, hinges, and pulls, were observed to be inoperable, damaged, loose, or absent. It is advised that a qualified contractor perform necessary repairs or replacements.

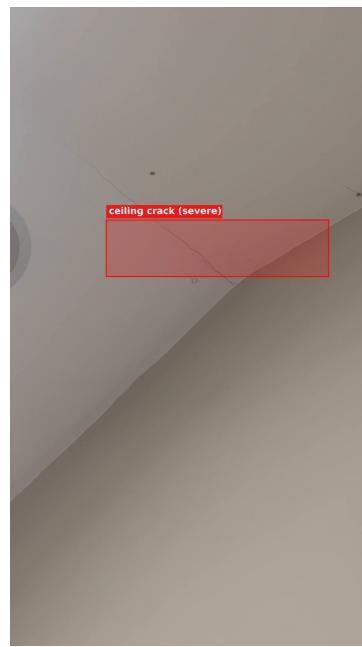
E. General Structural Information

1. Ceiling Crack — Possible Structural Concern

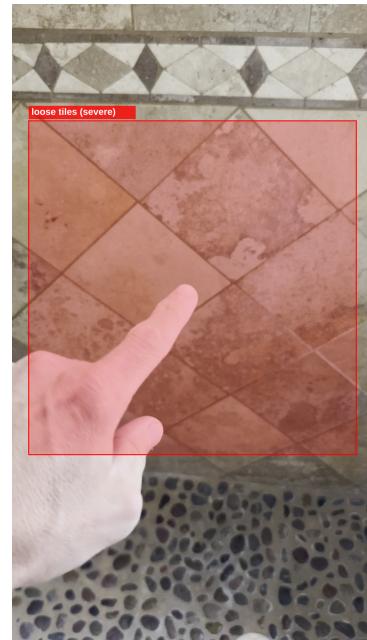
Annotated image: loose tiles at Master Bathroom Shower
