PROPERTY INSPECTION REPORT FORM

251 N Bristol Ave, Los Angeles, CA 90049
Address of Inspected Property

08/13/2025, 6:00 AM
Date of Inspection

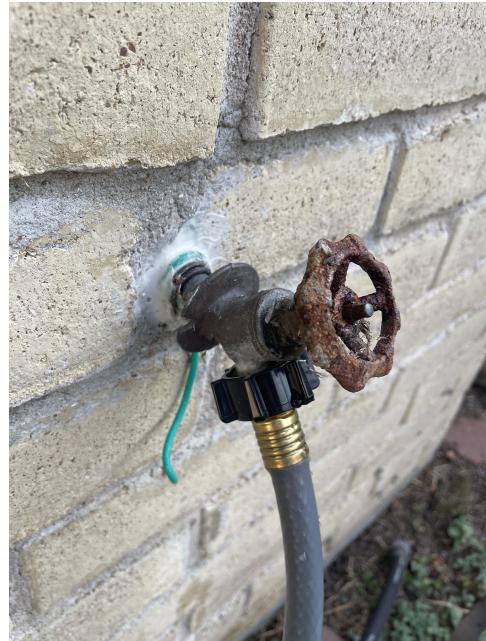
6. Exterior Hose Bib Not Functioning

The exterior hose bib is not functioning properly. Repair or replacement is recommended to restore water flow and prevent potential water damage. Consult a licensed plumber for evaluation and repair.

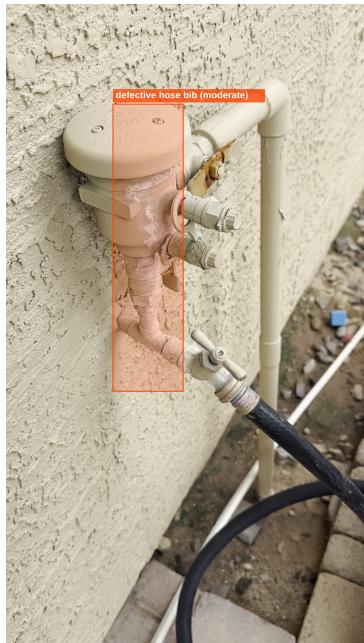
Annotated image: defective hose bib at Back Yard

Original image: defective hose bib at Back Yard

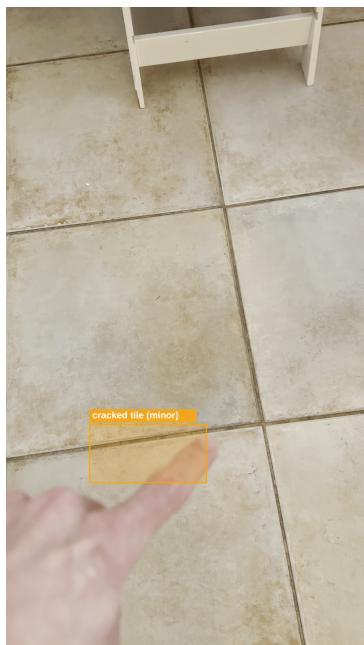
1. Cracked Floor Tile

Two small cracks were observed in the kitchen floor tile. Cracked tile can allow moisture to penetrate the substrate and may deteriorate further over time. Recommend repair or replacement of the affected tile(s) by a qualified flooring contractor and verify the integrity of the surrounding substrate and grout. Obtain estimates as needed.

Annotated image: cracked tile at Kitchen

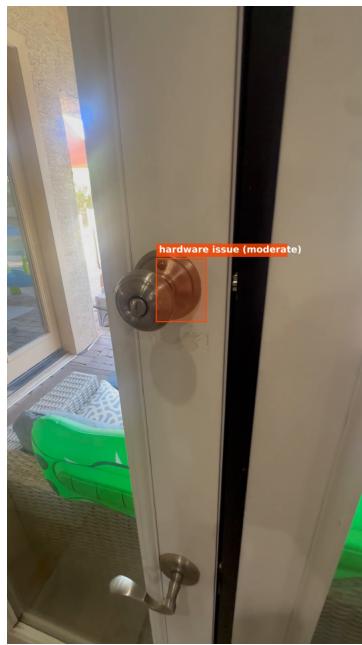
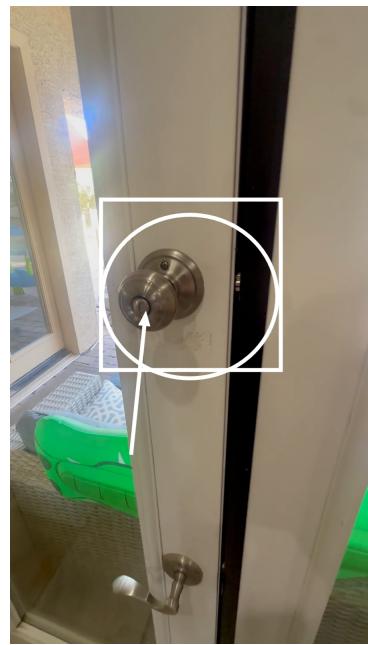
Annotated image: hardware issue at Living Room

Original image: hardware issue at Living Room

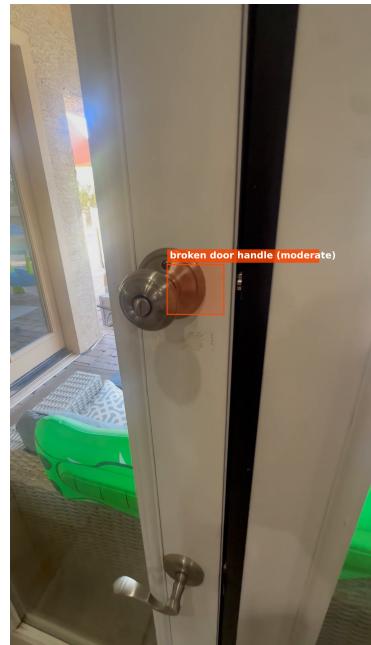
Original image: broken door handle at Living Room

Annotated image: broken door handle at Living Room

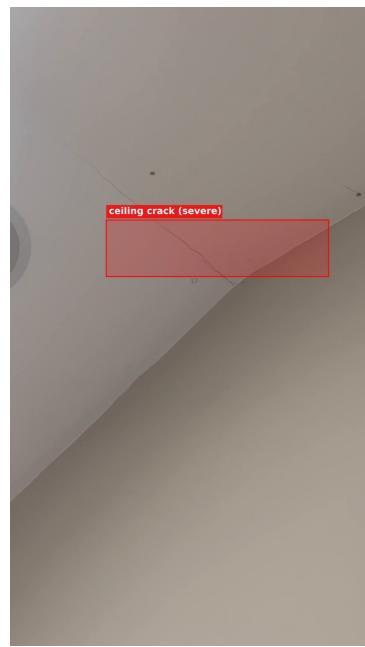
1. Ceiling Crack — Possible Structural Concern

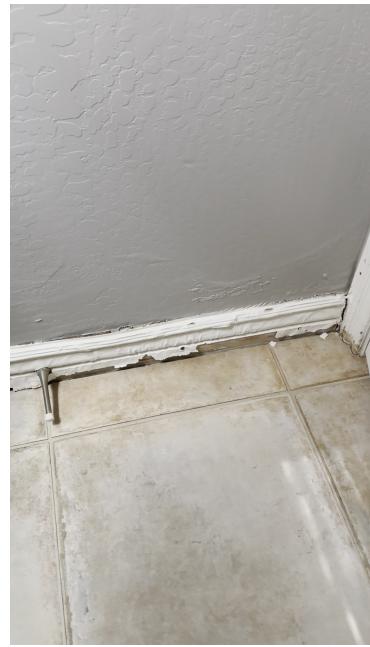
1. Evidence of Active Moisture Intrusion

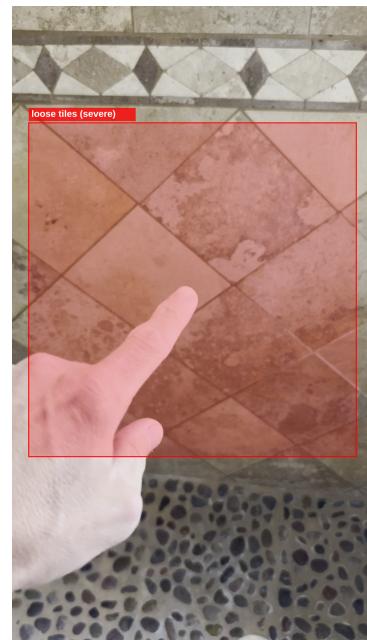
Original image: loose tiles at Master Bathroom Shower

Annotated image: loose tiles at Master Bathroom Shower
