PROPERTY INSPECTION REPORT FORM

TEXAS REAL ESTATE COMMISSION

251 N Bristol Ave, Los Angeles, CA 90049

08/13/2025, 6:00 AM

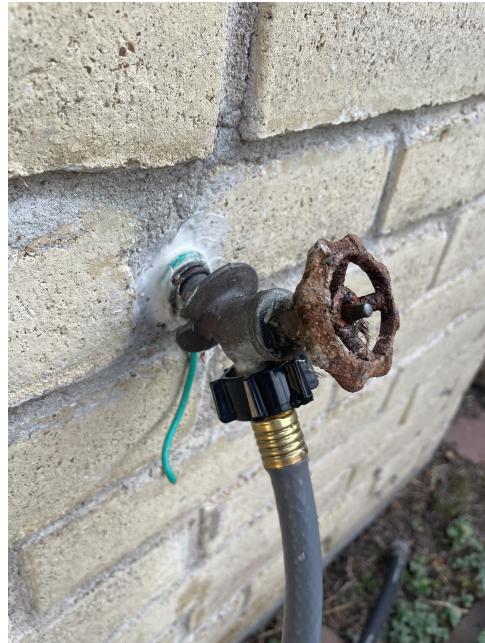
6. Exterior Hose Bib Not Functioning

The exterior hose bib is not functioning properly. Repair or replacement is recommended to restore water flow and prevent potential water damage. Consult a licensed plumber for evaluation and repair.

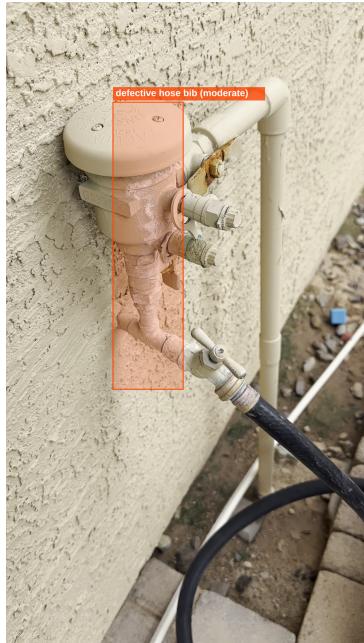
10. Hose Bib Handle Damaged or Missing

The handle for the exterior spigot was damaged or missing. Repairs or replacement as needed are recommended to be performed by a qualified individual to ensure proper operation.

Annotated image: defective hose bib at Back Yard

Original image: defective hose bib at Back Yard

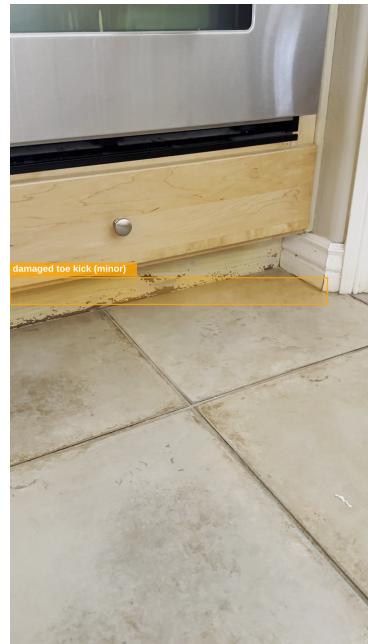
2. Damaged, Faulty, or Missing Cabinet Door

One or more cabinet doors were observed to be damaged, faulty, or otherwise amiss. Repairs by a qualified contractor are recommended.

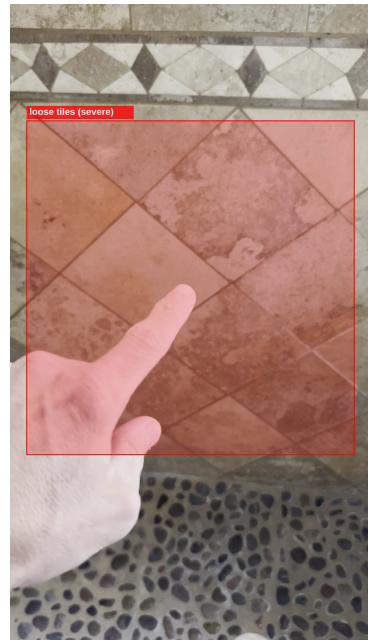
Original image: loose tiles at Master Bathroom Shower

Annotated image: loose tiles at Master Bathroom Shower
