PROPERTY INSPECTION REPORT FORM

251 N Bristol Ave, Los Angeles, CA 90049
Address of Inspected Property

08/13/2025, 6:00 AM
Date of Inspection

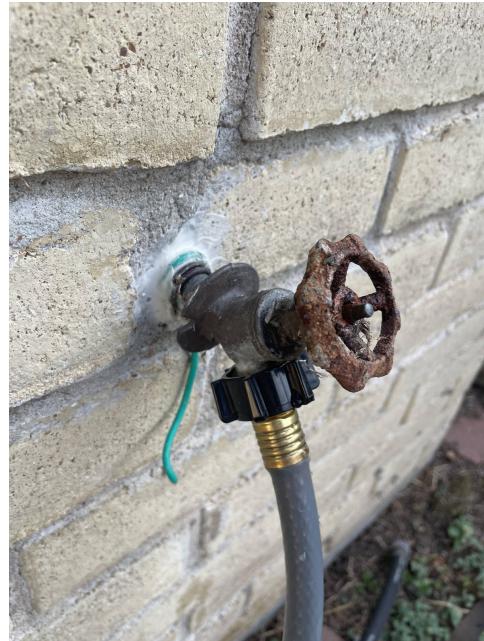
6. Exterior Hose Bib Not Functioning

The exterior hose bib is not functioning properly. Repair or replacement is recommended to restore water flow and prevent potential water damage. Consult a licensed plumber for evaluation and repair.

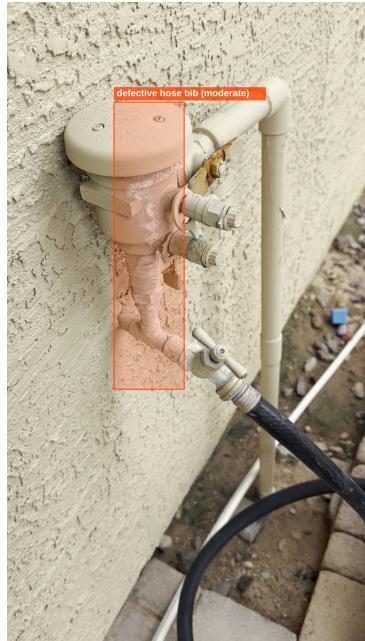
Annotated image: defective hose bib at Back Yard

Original image: defective hose bib at Back Yard

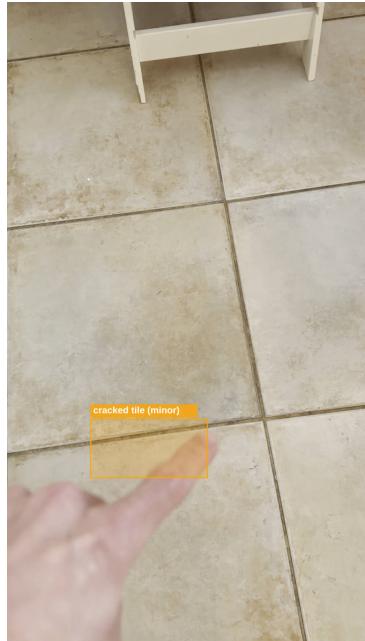
I. Interior Flooring Surfaces

1. Cracked Floor Tile

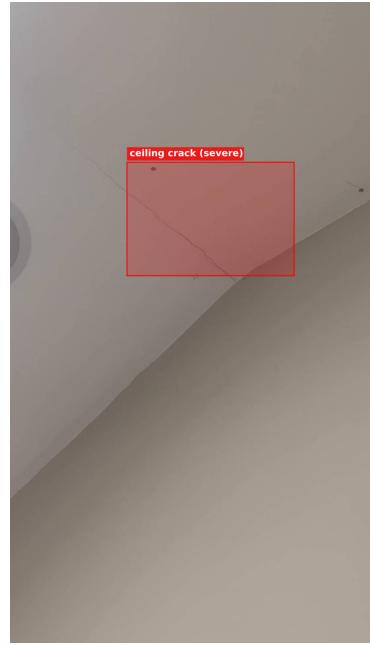
1. Significant Drywall Cracking

Significant drywall imperfections, including damage, cracking, or inconsistencies, were noted in the referenced area(s). It is advisable to inquire with the current homeowner(s) regarding any past alterations. Repairs should be undertaken by a drywall contractor as desired.

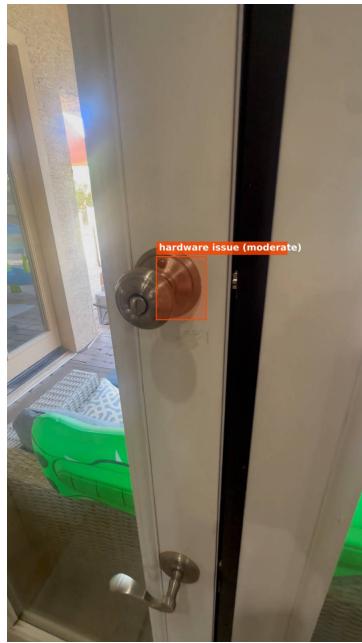
L. Exterior Door Systems

1. Inoperable or Difficult Door Handle Lock

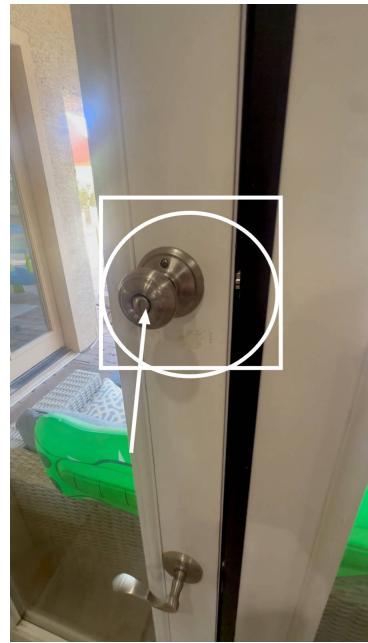
Annotated image: hardware issue at Living Room

Original image: hardware issue at Living Room

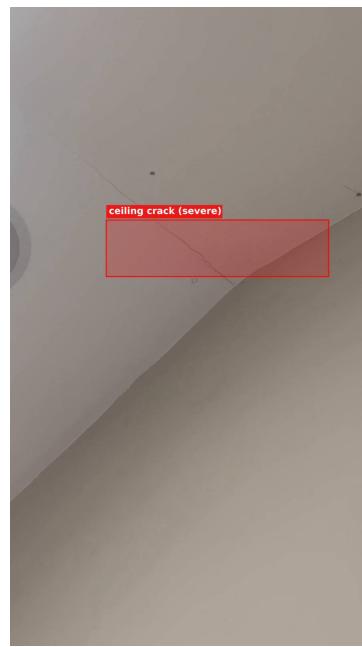
E. General Structural Information

1. Ceiling Crack — Possible Structural Concern

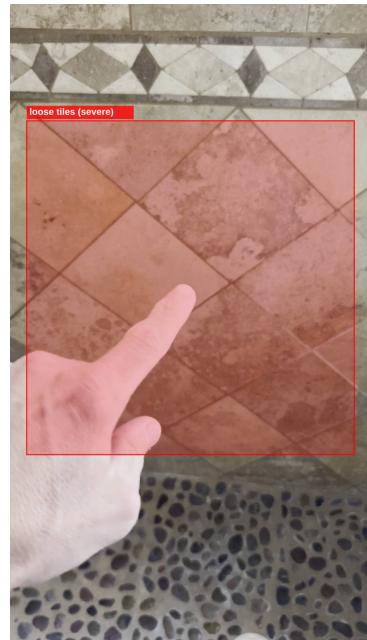
Original image: loose tiles at Master Bathroom Shower

Annotated image: loose tiles at Master Bathroom Shower
