NON-FRIABLE ASBESTOS REMOVAL CLEARANCE CERTIFICATE

107 Shumack St,
Weetangera

Job Reference
LDJ06430

Clearance Date
4 March 2026

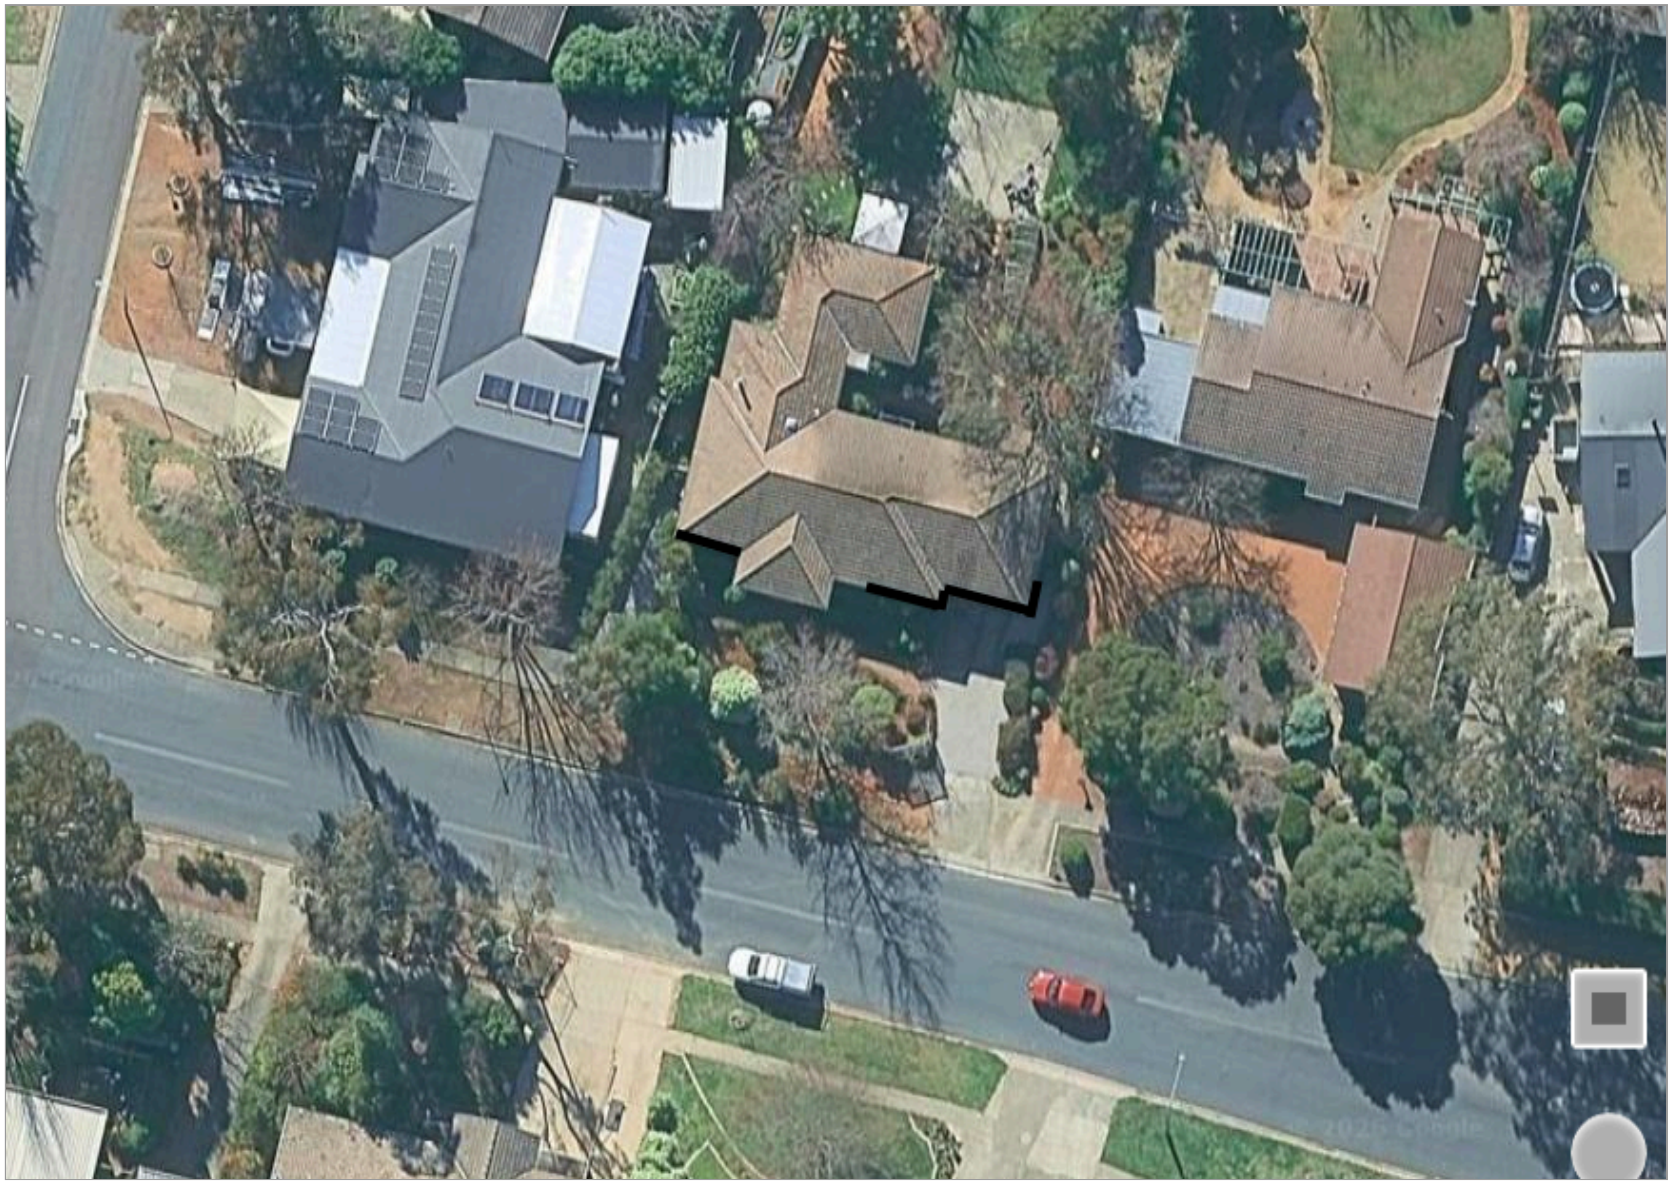
Figure 1: Asbestos Removal Site Plan

Approximate location of eave sheet removal
