The role of stacking faults for the formation of shunts during potential-induced degradation of crystalline Si solar cells

rrl solar

Volker Naumann*¹, Dominik Lausch¹, Andreas Graff², Martina Werner¹, Sina Swatek¹, Jan Bauer³, Angelika Hähnel³, Otwin Breitenstein³, Stephan Großer¹, Jörg Bagdahn¹, and Christian Hagendorf¹

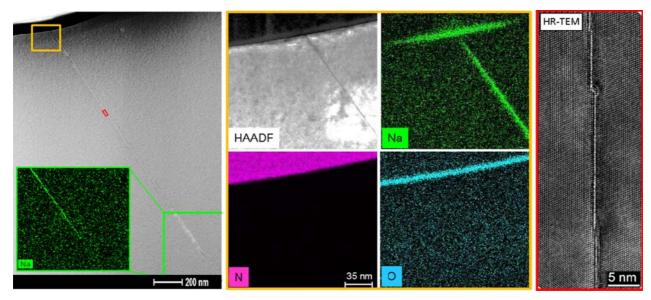
For the purpose of an elaborate ToF-SIMS experiment, first the SiN $_x$ layer of a monocrystalline cell with PID-shunts was removed by O_2^+ ion etching on an area of $700 \times 700 \ \mu m^2$ until the Si substrate was eroded to a depth of $\sim 0.05 \ \mu m$. In the following, a ToF-SIMS depth profile with increased sensitivity for Na was found inside the Si in PID-shunt regions, i.e. at the stacking faults. Figure 2 shows details of secondary-electron (SE) (a) and EBIC (b) images acquired at 30 kV. The corresponding ToF-SIMS ion images (Fig. 2c and d) are integrated over a depth profile between 0.05 μm and $\sim 1 \ \mu m$ below the SiN $_x$ /Si interface. The ToF-SIMS total ion image (Fig. 2c) proves congruence with the SEM/EBIC images.

A thorough estimation based on this ToF-SIMS depth profile measurement yields a number of $\sim\!10^8$ Na-atoms per stacking fault up to the depth of $\sim\!1~\mu m$. Projected on the stacking fault plane this corresponds to a density of $\sim\!10^{15}$ Na-atoms per cm². This number is in the same order of magnitude as the area density of Si atoms within a $\{111\}$ plane. Thus, roughly a monolayer of Na can be assumed to lay in the stacking faults analyzed in Fig. 2.

Figure 2 Small-section view $(80 \times 80 \ \mu m^2)$ of a monocrystalline cell imaged by SEM (a, b). The ToF-SIMS images (c, d) have been integrated over a depth of 0.05 to $\sim 1 \ \mu m$ below the SiN_x/Si interface after removal of the SiN_x layer. (a) Surface topography (SE image) in correlation to the total ion mapping (c). The corresponding EBIC view (b) shows dark spots at exactly the same two positions where Na is measured within the uppermost $\sim 1 \ \mu m$ of Si substrate (d).
