Analysis of the degradation of single-crystalline silicon modules after 21 years of operation

Abstract

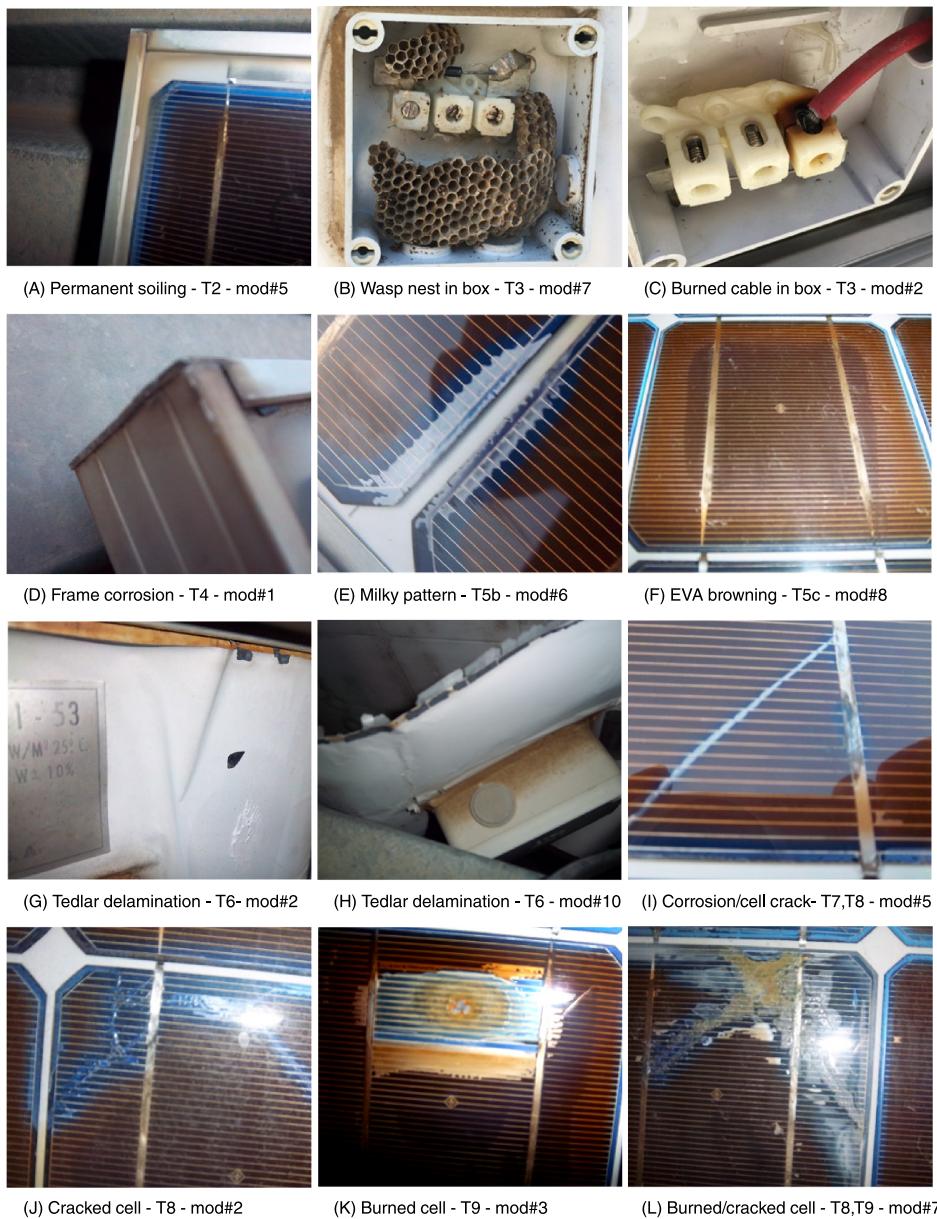
FIGURE 2 Result of the visual inspection of the modules under study. EVA, ethylene vinyl acetate [Colour figure can be viewed at wileyonlinelibrary.com]

Type	Description	Figures	#1	#2	#3	#4	#5	#6	#7	#8	#9	#10
T1	Glass break	-	0	0	0	0	0	0	0	0	0	0
T2	Permanent soiling	2A	1	1	1	1	2	1	1	1	1	2
T3	Connection-box anomalies	2B,C	1	2	1	1	1	1	1	1	1	2
T4	Frame corrosion	2D	1	1	1	1	1	1	1	1	1	1
T5a	EVA bubbles	-	0	0	0	0	0	0	0	0	0	0
T5b	EVA milky pattern	2E	1	0	0	0	1	2	2	2	0	0
T5c	EVA browning	2F	1	1	1	1	2	2	1	2	1	1
T6	Back layer detachment	2G,H	1	2	2	0	2	0	0	0	0	2
T7	Bus-bars corrosion	2I	1	2	1	1	2	2	1	2	1	1
T8	Cell cracking	2I,J,L	1	2	2	1	2	2	1	2	2	1
T9	Burned cell	2K,L	0	0	2	0	0	0	2	0	0	0

All the PV modules present a permanent soiling band (defect T2, Figure 2A) between the edge of the lower frame and the row of cells closest to that side. Because the distance between the frame and the first row of the cells is very small in the module type I-53, this could have consequences on the electrical behavior. However, it is not sufficient to generate a clear step in the I - V curves as a consequence of the activation of a bypass diode, as it can be seen in Figure 3. This is a typical defect on modules operating for long periods of time.^{6,36,37} This anomaly is significantly more intense in Modules #5 and #10 that are the only ones with burned cables (defect T3, Figure 2C). Burned cables and defective boxes are much more common than one might expect.³⁸ All the modules present detachment of the screw terminal block inside the connection box (classified as T3 and also reported in the literature³⁹).

All the PV modules have a slight level of frame corrosion (defect T4, Figure 2D). This could be considered a security risk, but according to previous findings,⁴⁰ its impact on the electrical performance can be neglected. In many cases, the back layer surface has been partially detached (defect T6, Figure 2G,H). This defect has been reported also in previous works.^{2,9,41} Another type of defect, which is not present in all the modules, is T5b (known as milky pattern^{6,9}), being more intense in Modules #6–#8.

However, there are other visual defects (T5c, T7, T8, and T9) that are more important from the point of view of the degradation of the energy output of the modules. All the modules suffer browning of the EVA layer (defect T5c), which results in a bicolor pattern (Figure 2F) and an important loss of transparency identified in previous works^{39,42} and analyzed in depth by Kaplanis and Kaplani.⁴³ In addition, there is a presence of corrosion of the interconnecting ribbons in all the modules (defect T7 also documented by Sastry et al.³⁹ Figure 2I). This last defect implies an increase in the series resistance of all the modules. There are also a large number of visible cell cracks in every module

(defect T8, Figure 2J). This problem and its effect on the electrical performance is studied by Dhimish et al.⁴⁴ Two modules have a cell that is completely burned (Modules #3 and #7, as it can be seen in Figure 2K,L, respectively). This phenomenon has been also identified by Köntges et al.² In both modules, there is a loss of transparency of the EVA between the glass and the cell. Nevertheless, both modules are operational, and as it will be evident hereafter, the consequences have not been as severe as it might have been expected.

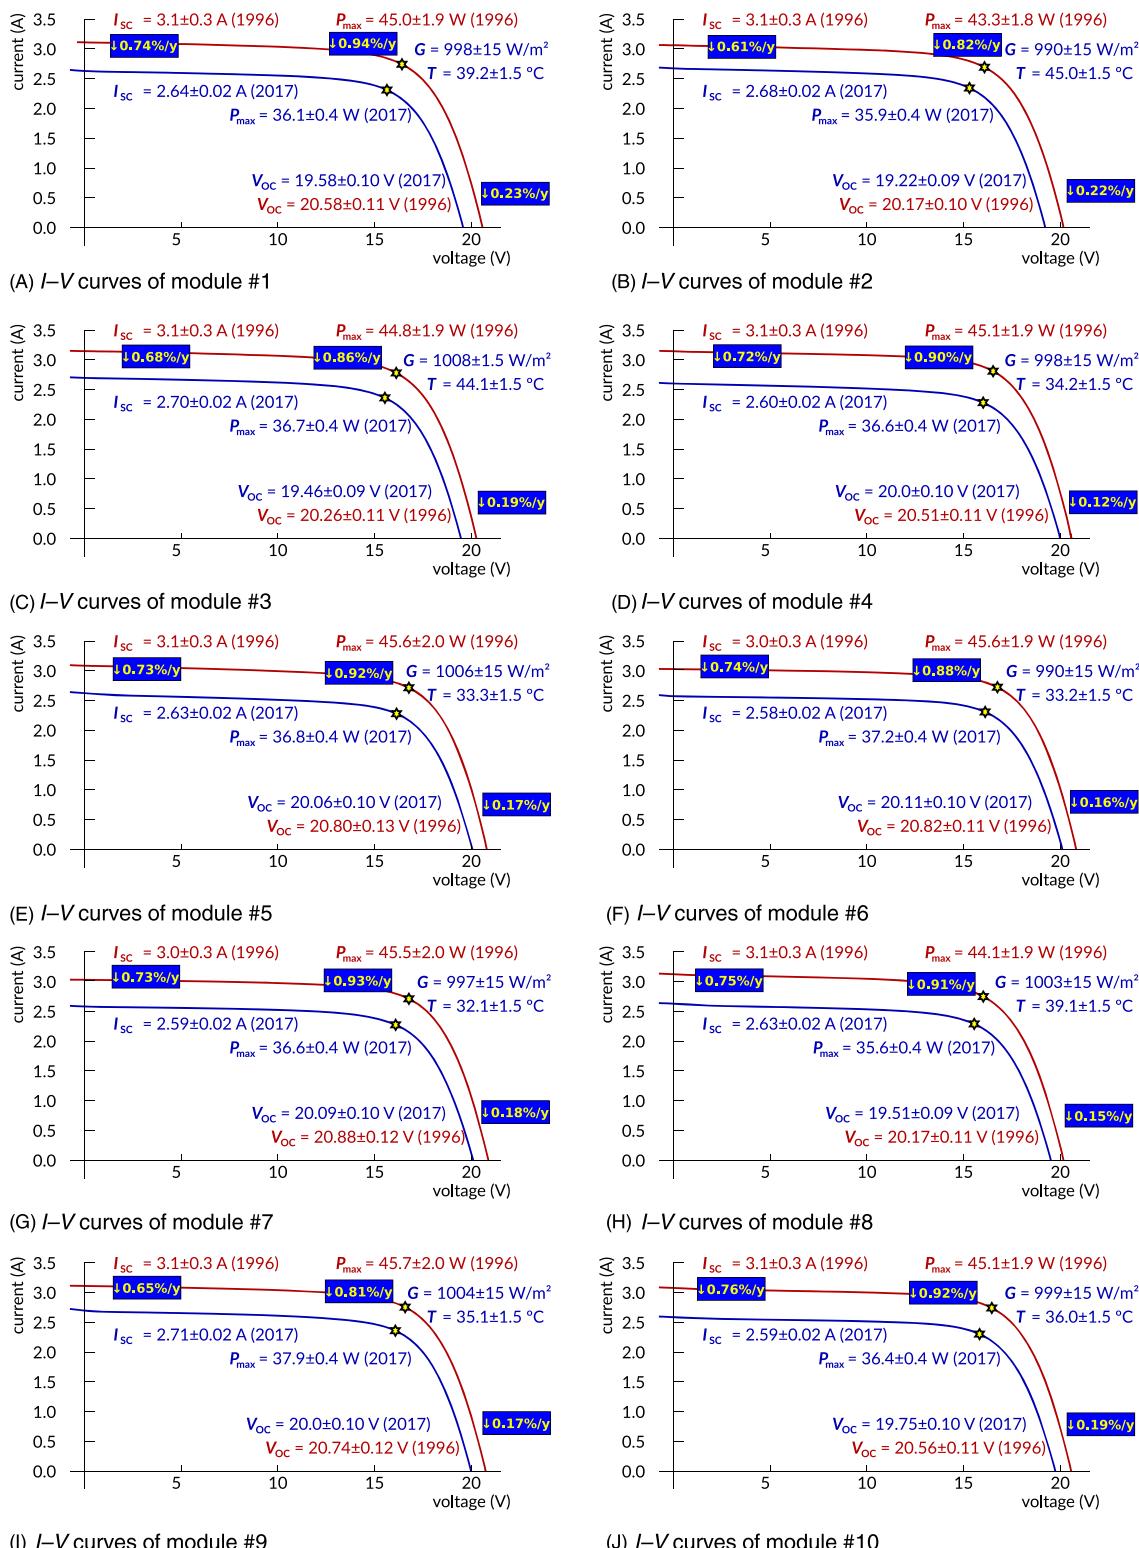
FIGURE 3 Analysis of the curves measured in 2017 and the curves of 1996 corrected to the conditions in 2017 (given at the upper right corner of each subfigure) [Colour figure can be viewed at wileyonlinelibrary.com]

For each module, two I - V curves are shown in Figure 3: the one measured in 1996 and the one measured in 2017 at an irradiance and temperature conditions that are the closest to the conditions of the former curve of 1996, which has also been translated to the conditions of the curve acquired in 2017. For each module, the values of P_{max} , I_{sc} , V_{oc} are shown, both for the curve of 1996 (corrected to the conditions in 2017) and for the measured one of 2017. In addition, an annual degradation rate is provided for each parameter.

In the case of P_{max} , the annual degradation for almost all the modules is around 0.9%, but Modules #2 and #9 have only a degradation rate slightly higher than 0.8%. This result is in line with the values reported in the previous work over the modules of the same installation 9 years before.⁶ In addition, other works in the literature estimate similar annual degradation rates in terms of power for mc-Si modules.^{4,7,45,46}

Comparing these numbers with the data in Table 9, we see that the two modules with burned cells (Modules #3 and #7) have degraded in terms of power similarly to the others. On the one hand, the modules that present the best visual appearance (Modules #1 and #4) have not experienced lower drops in P_{max} (see Table 10). On the other hand, Module #3, which is one of those with a burned cell and an overall

poor appearance, is surprisingly one of the modules with the lowest power degradation rate.

Clearly, the main contributor factor in the power annual degradation rate is the decrease of the short-circuit current. For almost all the modules, the annual degradation rate in terms of I_{SC} is around to 0.7%, ranging from 0.65%/year to 0.76%/year. This relative small dispersion means that all the modules have degraded their I_{SC} in a similar way. This decrease in current might be a consequence of the reduction of the number of photons able to reach the p-n junction. It is mainly related to the loss of transparency of the encapsulating materials, which is evident by the visual inspection. Regarding to the cover glass, in the visual inspection, defect T2 (permanent soiling) is present in all the modules. In addition, as it is stated by Sánchez-Friera et al.⁶ the loss of transparency is not equal for all the wavelengths, so that the glass becomes more spectral selective while aging.
