WATER LEAKS—FRONT PASSENGER COMPARTMENT DURING HEAVY RAINS AND/OR GOING THROUGH CAR WASH—VEHICLES BUILT FROM 11/2/1999 THROUGH 11/22/1999 EQUIPPED WITH 2.5L ENGINES AND CD4E TRANSAXLES

Article No. 00-6-3

MERCURY: 2000 COUGAR

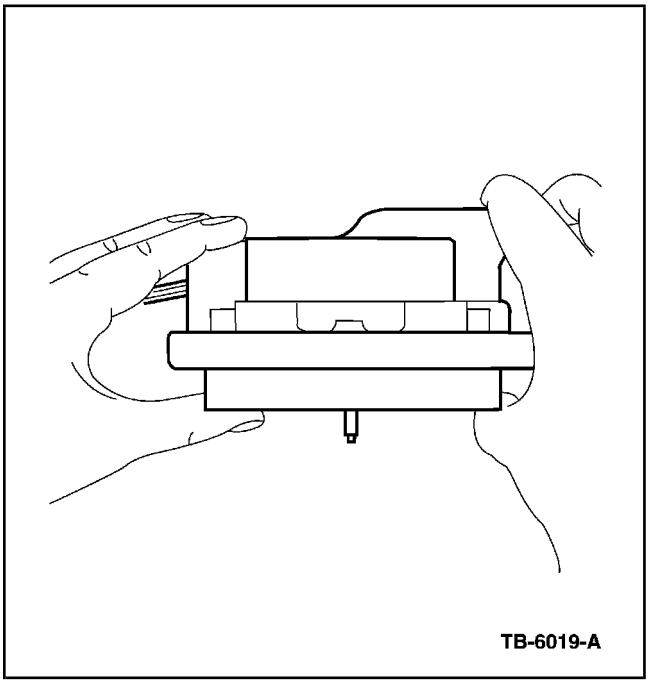
Figure 1 - Article 00-6-3

Water may leak into the passenger compartment between the Powertrain Control Module (PCM) module connector and mounting bracket during heavy rains and/or when going through a car wash. This may be due to improper sealing of the PCM harness connector.

3. Loosen the 10mm fastener and disassemble the PCM connector from module, then remove the ground lead from the fender.
4. Inspect the connector assembly to ensure bolt tower is not damaged/cracked. If damaged or cracked, replace the -12A522- harness. Inspect the connector cover to ensure it is fully seated to the connector: press cover and base together firmly as a verification that all tabs are fully engaged (Figure 1).
