DRIVEABILITY—UNABLE TO REACH WIDE OPEN THROTTLE (WOT)—LACK OF POWER	Article No. 01-18-7

FORD: 2001 RANGER

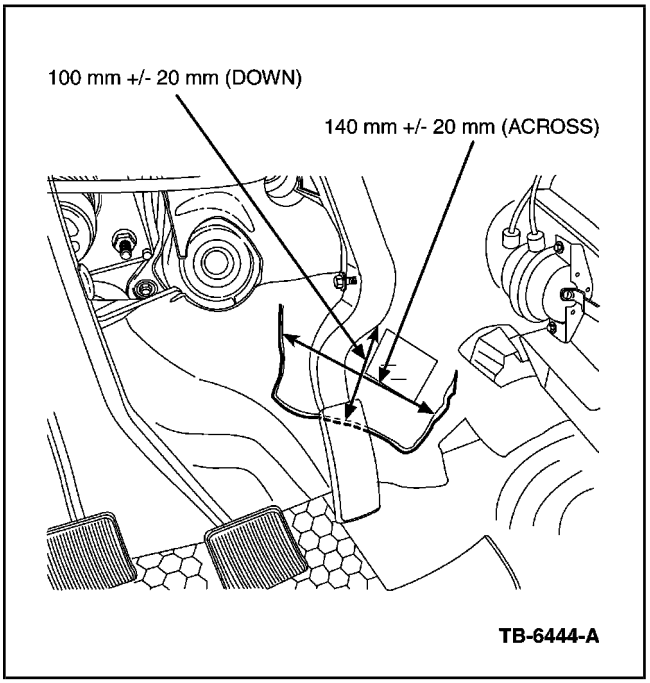
Figure 1 - Article 01-18-7

Some Vehicles may exhibit an inability to reach Wide Open Throttle Mode (WOT). This inability to reach WOT can cause a lack of power condition. This may be caused by the Dash Panel Insulator under the carpet at the accelerator pedal.

1. Position carpet to gain access to the area below the throttle pedal.
2. Make a “u-shaped” cut in the insulator below the throttle pedal bracket, 140 mm wide and 100 mm down ± 20 mm (5.5″ wide by 4″ down ± .75 ″), as seen in Figure 1. Make sure to line up the bottom/center of the “U” cut with the throttle pedal bracket, as seen in Figure 2. This will help relieve any tautness in the insulator, so it will sit flush with the floor panel.
3. Reposition the carpet.
4. Using NGS or WDS, verify that WOT mode can be reached without excessive force on the throttle pedal.
