FRONT AXLE MOUNTING BOLT INSPECTION

AFFECTED VEHICLES: **CERTAIN 2001 MODEL YEAR U.S. POSTAL SERVICE 4X4 EXPLORER VEHICLES**

01B75B

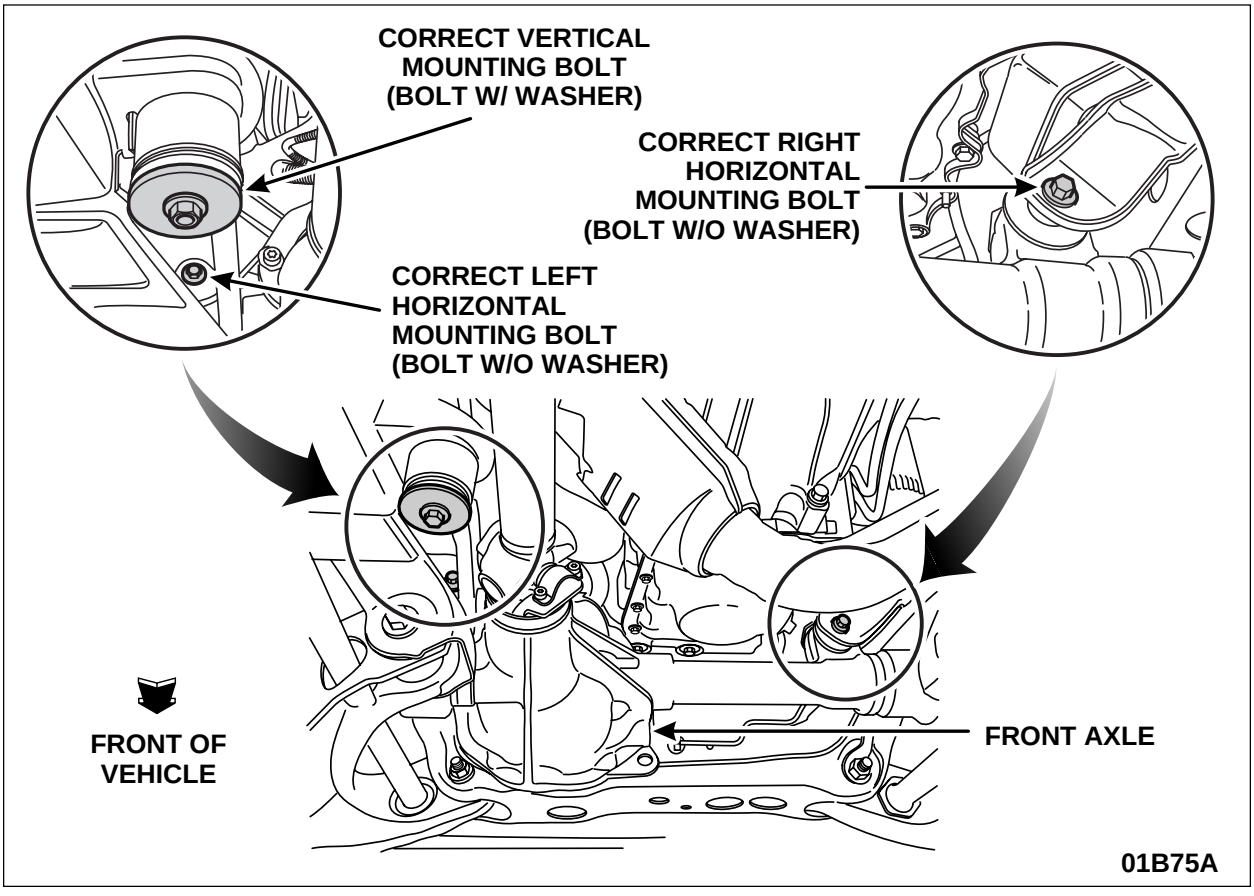
FIGURE 1

Some of the affected vehicles may be assembled with missing or incorrect front axle mounting bolt(s). The following instruction provides the details for identifying and replacing incorrect or missing mounting bolts.

1. Raise the vehicle on a hoist.
2. Inspect the three front axle mounting bolts. The vertical mounting bolt has a large washer; the right and left horizontal mounting bolts do not have a washer. See Figure 1.
   - If the correct bolts have been installed, no repair is required. Lower and release the vehicle.
   - If the incorrect bolt(s) have been installed in any of the three locations, the incorrect bolt(s) must be replaced with the correct (***new***) bolt and a ***new*** nut. Go to Mounting Bolt Replacement.
   - If any bolt(s) is missing, follow the steps in Inspection and Installation for Missing Mounting Bolts.

1. Position a jackstand under the front axle, below the mount with the incorrect bolt.
2. Remove and discard the incorrect bolt and nut.
3. Install the correct (***new***) bolt (vertical bolt N811242-S426; horizontal bolt N808403-S426) and a ***new*** nut (N811623-S426). Tighten to 70 Nm (52 lb-ft).
4. Remove the jackstand and repeat steps 1-3 as necessary.
5. Lower and release the vehicle.

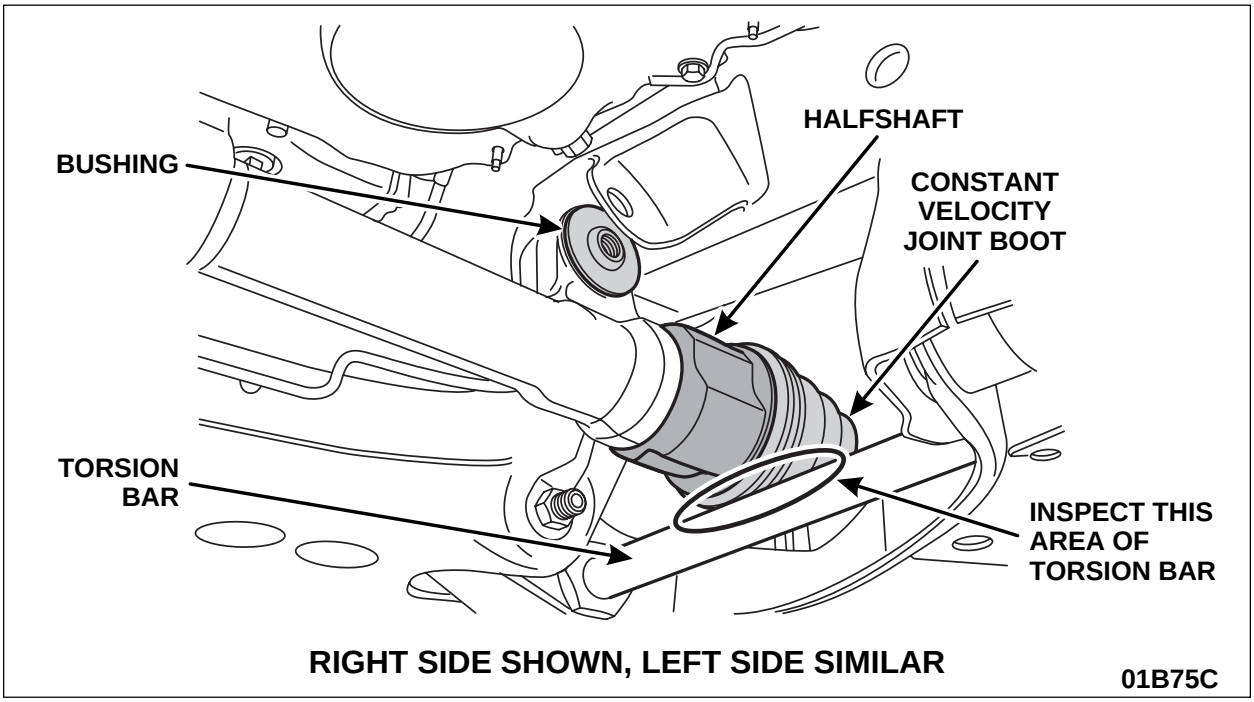
FIGURE 2

1. Inspect the horizontal mounting bushings and constant velocity joint boots for tears or missing chunks. Inspect the axle halfshaft for signs of damage. Also, inspect the area of the torsion bar as indicated in the illustration for missing paint or nicks from contact with the halfshaft. See Figure 2.
   - If any damage is found, contact the Special Service Support Center at 1-800-325-5621 for further instruction.
   - If damage is not found, go to step 2.

2. Position an adjustable jackstand under the front axle below the mount with the missing bolt.
3. Raise the axle up until the center of the bushing is aligned with the hole in the frame.
4. Install the correct ***(new)*** bolt (vertical bolt N811242-S426; horizontal bolt N808403-S426) and ***new*** nut (N811623-S426). Tighten to 70 Nm (52 lb-ft).
5. Remove the jackstand, and repeat steps 2-4 as necessary.
6. Lower the vehicle.
7. Test drive the vehicle in 4x2 and 4x4 mode.
   - If any abnormal noise is heard coming from the front axle or halfshafts, contact the Special Service Support Center at 1-800-325-5621 for further instruction.
   - If abnormal noise is not present, release the vehicle to the owner.
