BODY—BACKGLASS/LIFTGATE—XENOY MATERIAL BACKGLASS AVAILABLE TO SERVICE CRACKS, WARPAGE, SEPARATION—SERVICE TIPS

Article No. 02-25-6

FORD: 2002 EXPLORER

MERCURY: 2002 MOUNTAINEER

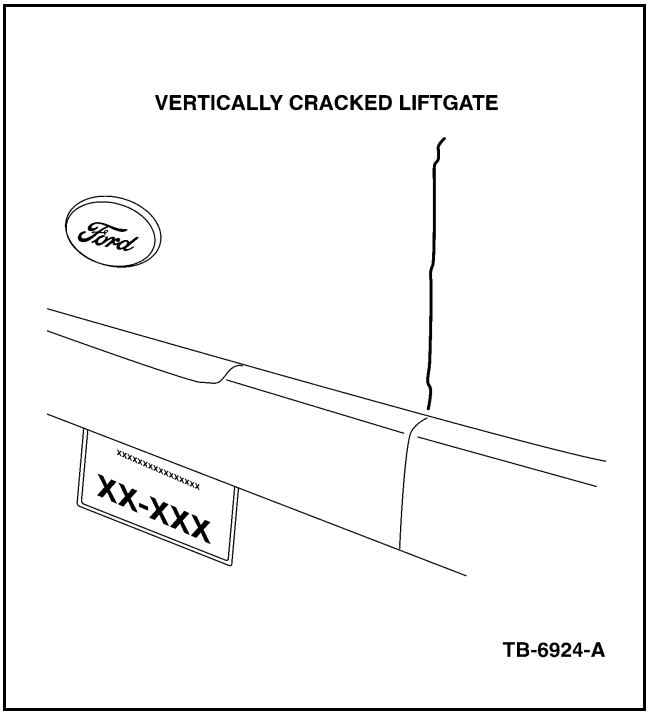
Figure 1 - Article 02-25-6

Some 4 Door Explorer/Mountaineer vehicles may exhibit cracking, warpage or separation of the rear liftgate applique (exterior trim panel below the backglass). This may be caused by the adhesive bond strength of the original part. Highly concentrated washer fluid (not properly diluted) can also act as a trigger to induce this condition.

1. This is the area above the license plate and below the rear glass, by the Ford or Mercury emblem. Typical failures include vertical crack (Figure 1), horizontal crack (Figure 2), and warpage or separation (Figure 3).
2. Check the VIN number to determine if the 11th digit is a "U" or a "Z".
   a. Louisville Plant Built - 11th VIN digit "U":
      - If vehicle build date prior to 3/4/02, order 2002/J1 backglass (1L2Z)
      - If vehicle build date 3/4/02 or later, order 2002.5/J2 backglass (3L2Z)
   b. St. Louis Plant built - 11th VIN digit "Z":
      - If vehicle build date prior to 3/11/02, order 2002/J1 backglass (1L2Z)
      - If vehicle build date 3/11/02 or later, order 2002.5/J2 backglass (3L2Z)

Replace the backglass assembly with revised part number which contains a new "Xenoy" applique material. Refer to the following Service Procedure for details.

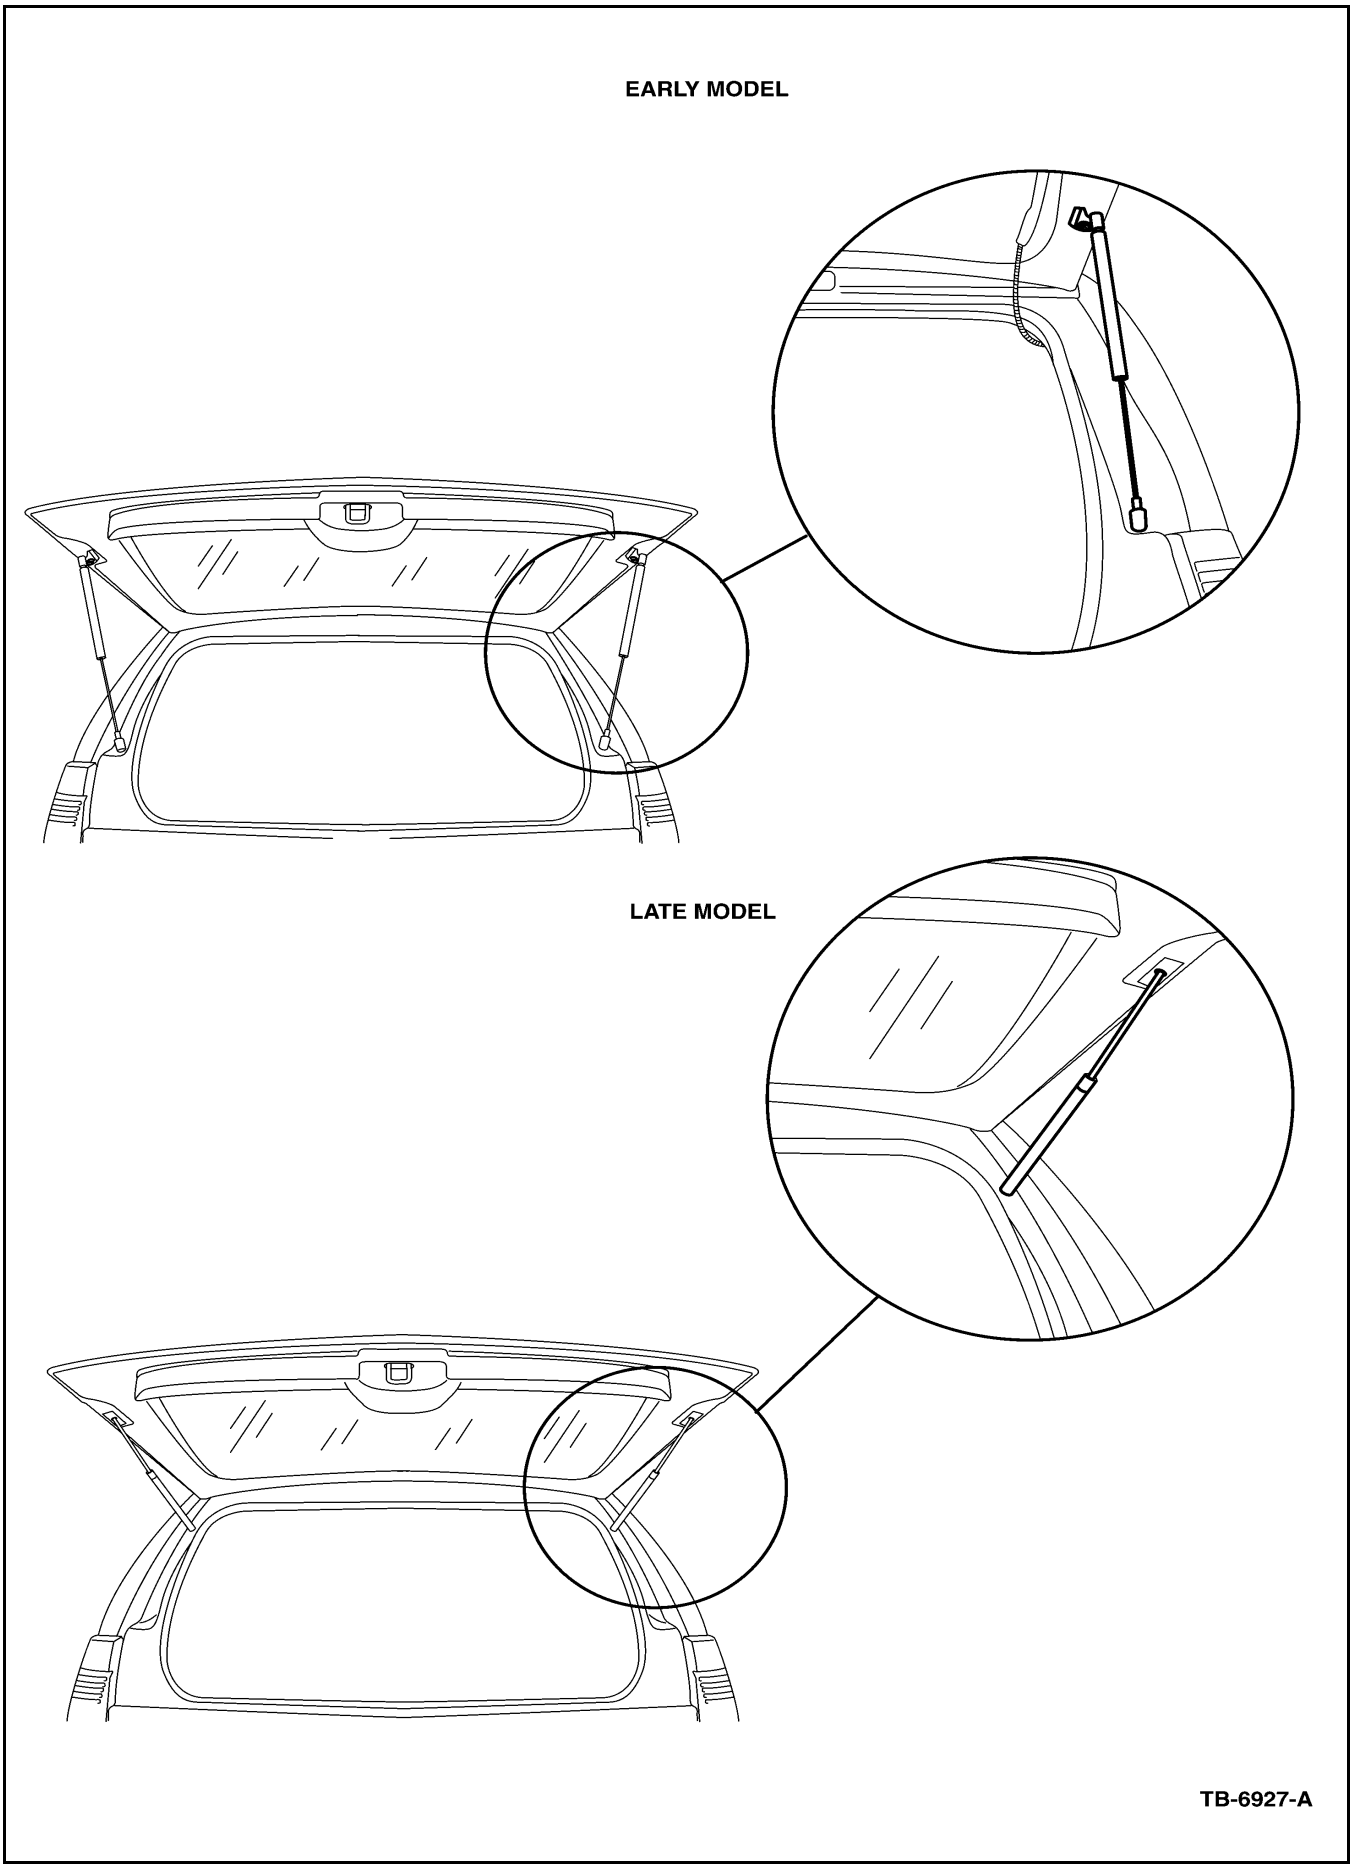
Figure 4 - Article 02-25-6

AS AN ADDITIONAL IDENTIFIER, 2002/JOB 1 VEHICLES ARE BUILT WITH LIFTGATE SUPPORTS MOUNTED TO A BRACKET THAT IS FASTENED HIGH UP ON THE GLASS. IN CONTRAST THE 2002.5/JOB 2 MOUNTING DESIGN ATTACHES THE SUPPORT ARMS ONTO BALL STUDS AT A LOWER MOUNTING POINT ON THE GLASS (FIGURE 4).

IF LIFTGATE SHEETMETAL REPLACEMENT IS NECESSARY FOR ANY REASON ON AN EARLY BUILD VEHICLE, CURRENTLY THE BACKGLASS AND SUPPORTS MUST BE UPDATED TO LATER BUILD STYLE (FIGURE 4). TO IDENTIFY BY BUILD DATE, SEE STEP 2 IN SERVICE PROCEDURE. PLANNED FOR 1ST PART OF 2003, THE EARLY BUILD LIFTGATE STYLE WILL AGAIN BECOME AVAILABLE SO THIS WILL NOT BE NECESSARY.
