TRIM—REAR COAT HOOK/LAMP LOOSE IN HEADLINER	Article No. 03-1-2

FORD: 1999-2003 WINDSTAR

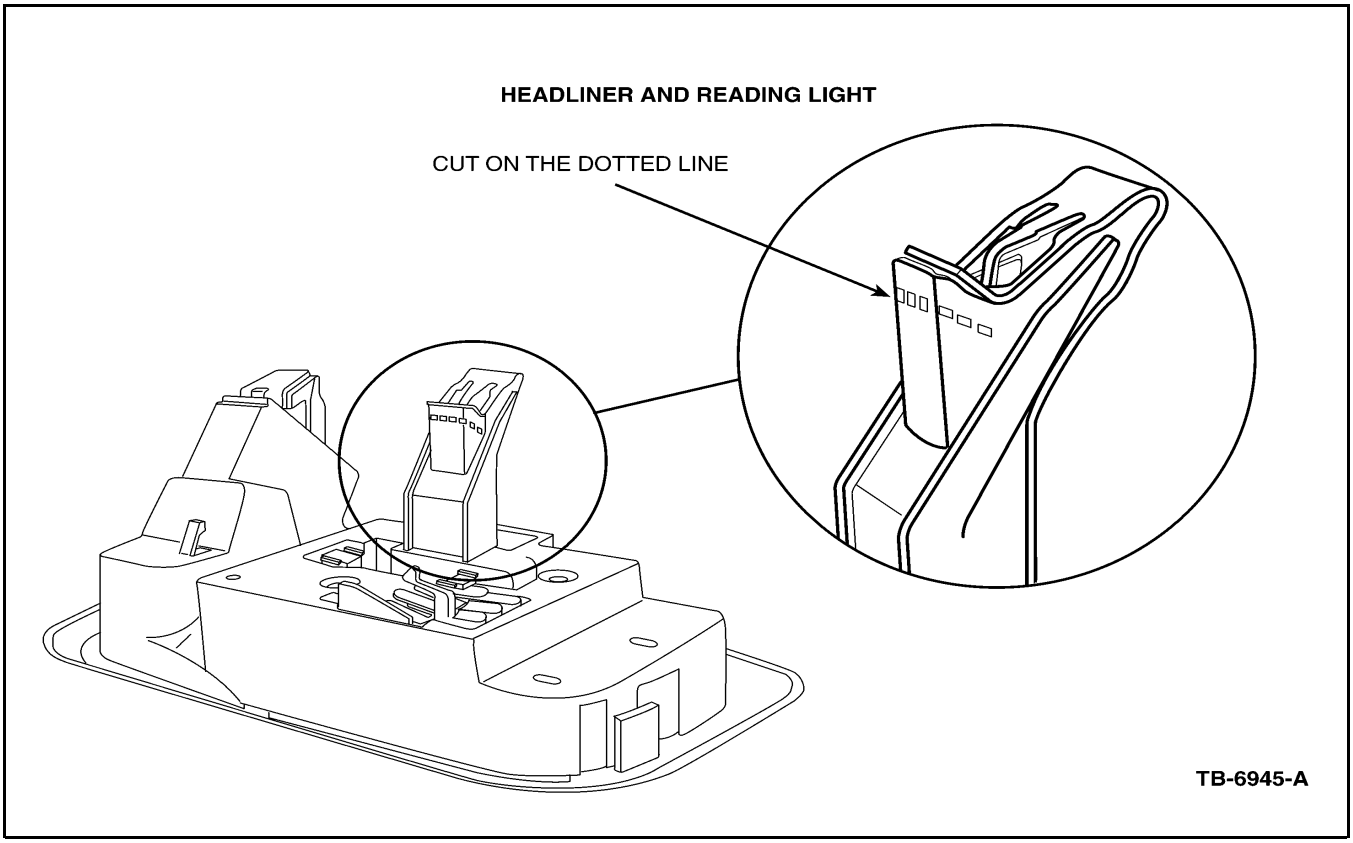
Figure 1 - Article 03-1-2

Some vehicles may exhibit a rear coat hook/reading lamp not secured properly in the headliner. This may be caused by the attachment procedure used.

1. Remove the reading lamp from the headliner and unplug the wire connector.
2. Remove the clip from the back side of the lamp.
3. Measure 2-3 mm from the edge of clip support (along dotted line shown in Figure 1).
4. Cut/remove the 2-3 mm of material (as per dotted line in Figure 1). This will allow the clip to travel further down tab, and once engaged in sheet metal the gap will be reduced.
5. Reinstall the clip on the back of the lamp.
6. Reinstall the connector on the lamp and reinstall the lamp into the headliner. Make sure that it is flush against the headliner.
